State of California
California Natural Resources Agency
DEPARTMENT OF WATER RESOURCES
Division of Engineering

CALIFORNIA AQUEDUCT SUBSIDENCE STUDY

San Luis Field Division
San Joaquin Field Division

June 2017

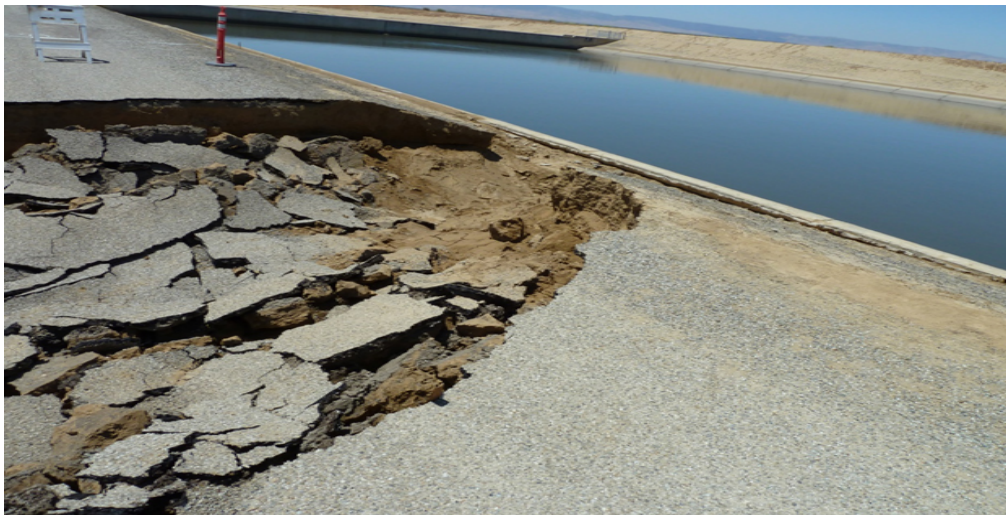
Figure 7-4 Milepost 208.08 Embankment Failure

Figure 7-4 is a photograph of the access road failure at Milepost 208.08. Shortly after the breach was reported, the water surface was dropped in Pool 25 and the flow ceased. Figure 7-4 also shows very little lined freeboard and little to no gap between the water surface and the overchute that is just downstream at Milepost 208.11.
