STATE OF CALIFORNIA  
DEPARTMENT OF WATER RESOURCES  
DIVISION OF RESOURCES PLANNING

BULLETIN NO. 81

INTRUSION OF SALT WATER  
INTO GROUND WATER BASINS OF  
SOUTHERN ALAMEDA COUNTY

December 1960

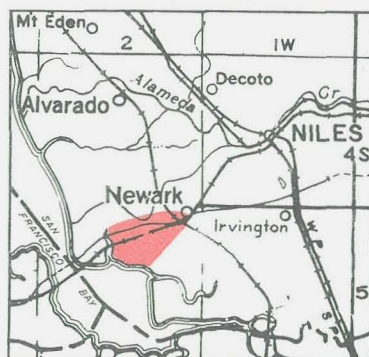
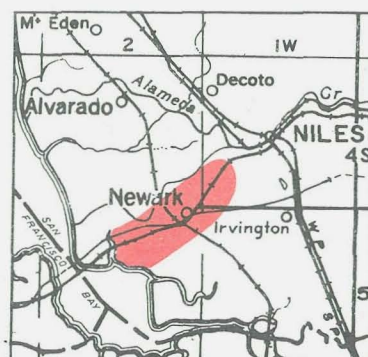
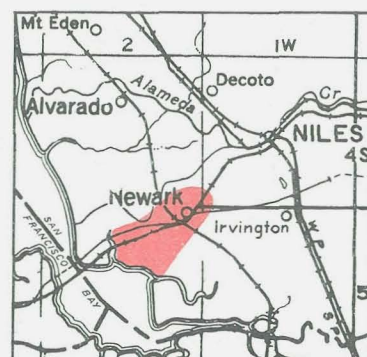
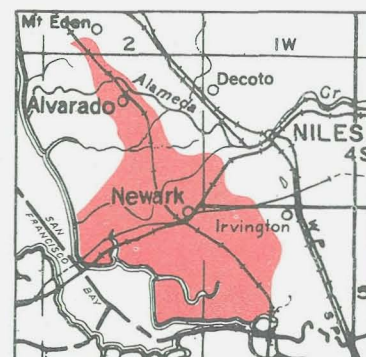
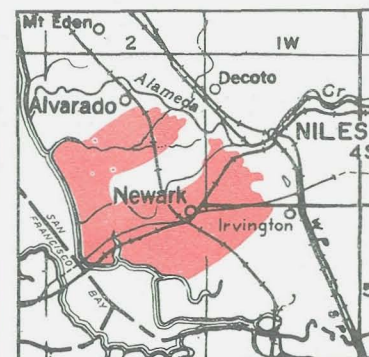
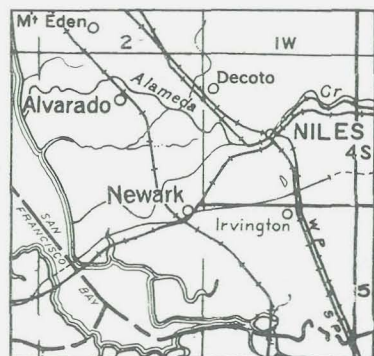
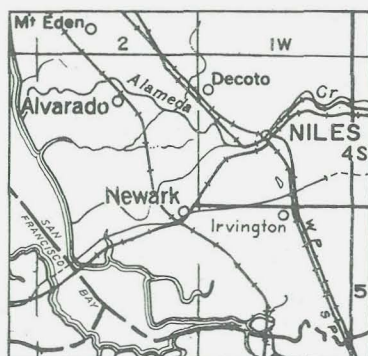
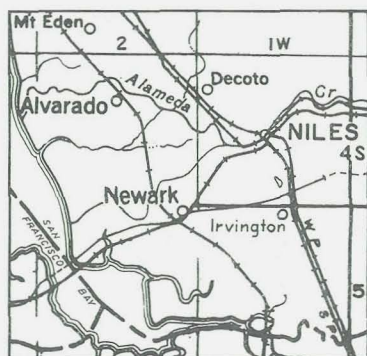
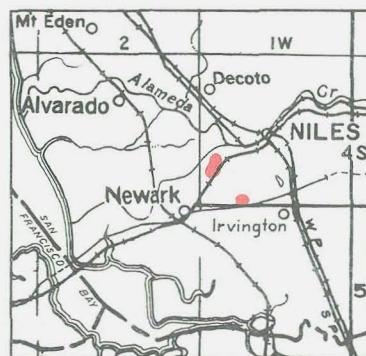
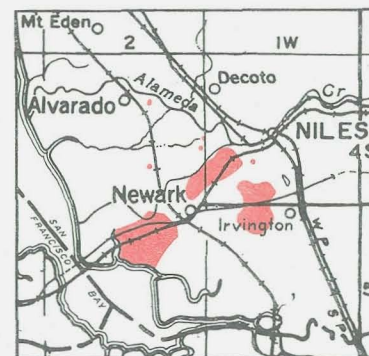
During the six-year period from 1936 to 1942, there was a moderate improvement in the quality of water from shallow wells, probably due to effects of above normal rainfall. In 1950, and again in 1957, however, it was found that bay water had intruded further inland in the Niles cone area. The progressive degradation of waters in the Newark aquifer is illustrated on Figure 1.

DEGRADATION OF SHALLOW (NEWARK AQUIFER) AND DEEP (CENTERVILLE AQUIFER) GROUND WATER

The foregoing observations, summarized on Figure 1, clearly show a progressive increase in the area of degraded water in the Centerville aquifer.

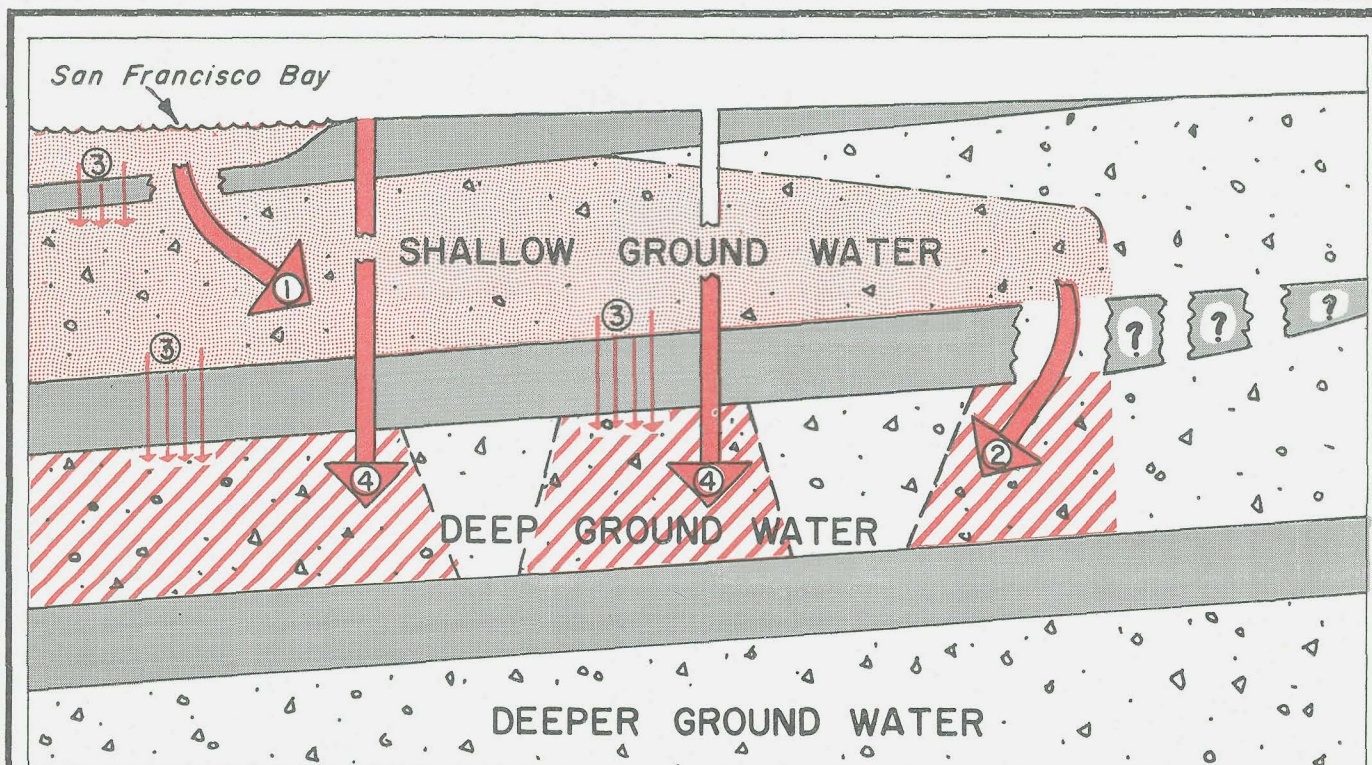
FIGURE 2

Possible means for entry of salt water into ground waters are delineated on Figure 2. It is seen that there are three natural routes for subsurface movement of salt water into ground-water reservoirs. The one man-made route permits leaking or cascading of saline surface or ground water through wells. The shallow ground-water reservoir corresponds to the Newark aquifer and the deeper reservoirs correspond to the Centerville and Fremont aquifers.

1. Direct movement of bay waters through natural "windows".
2. Spilling of degraded ground waters.
3. Slow percolation of salt water through reservoir roof.
4. Spilling or cascading of saline surface waters or degraded ground water through wells.

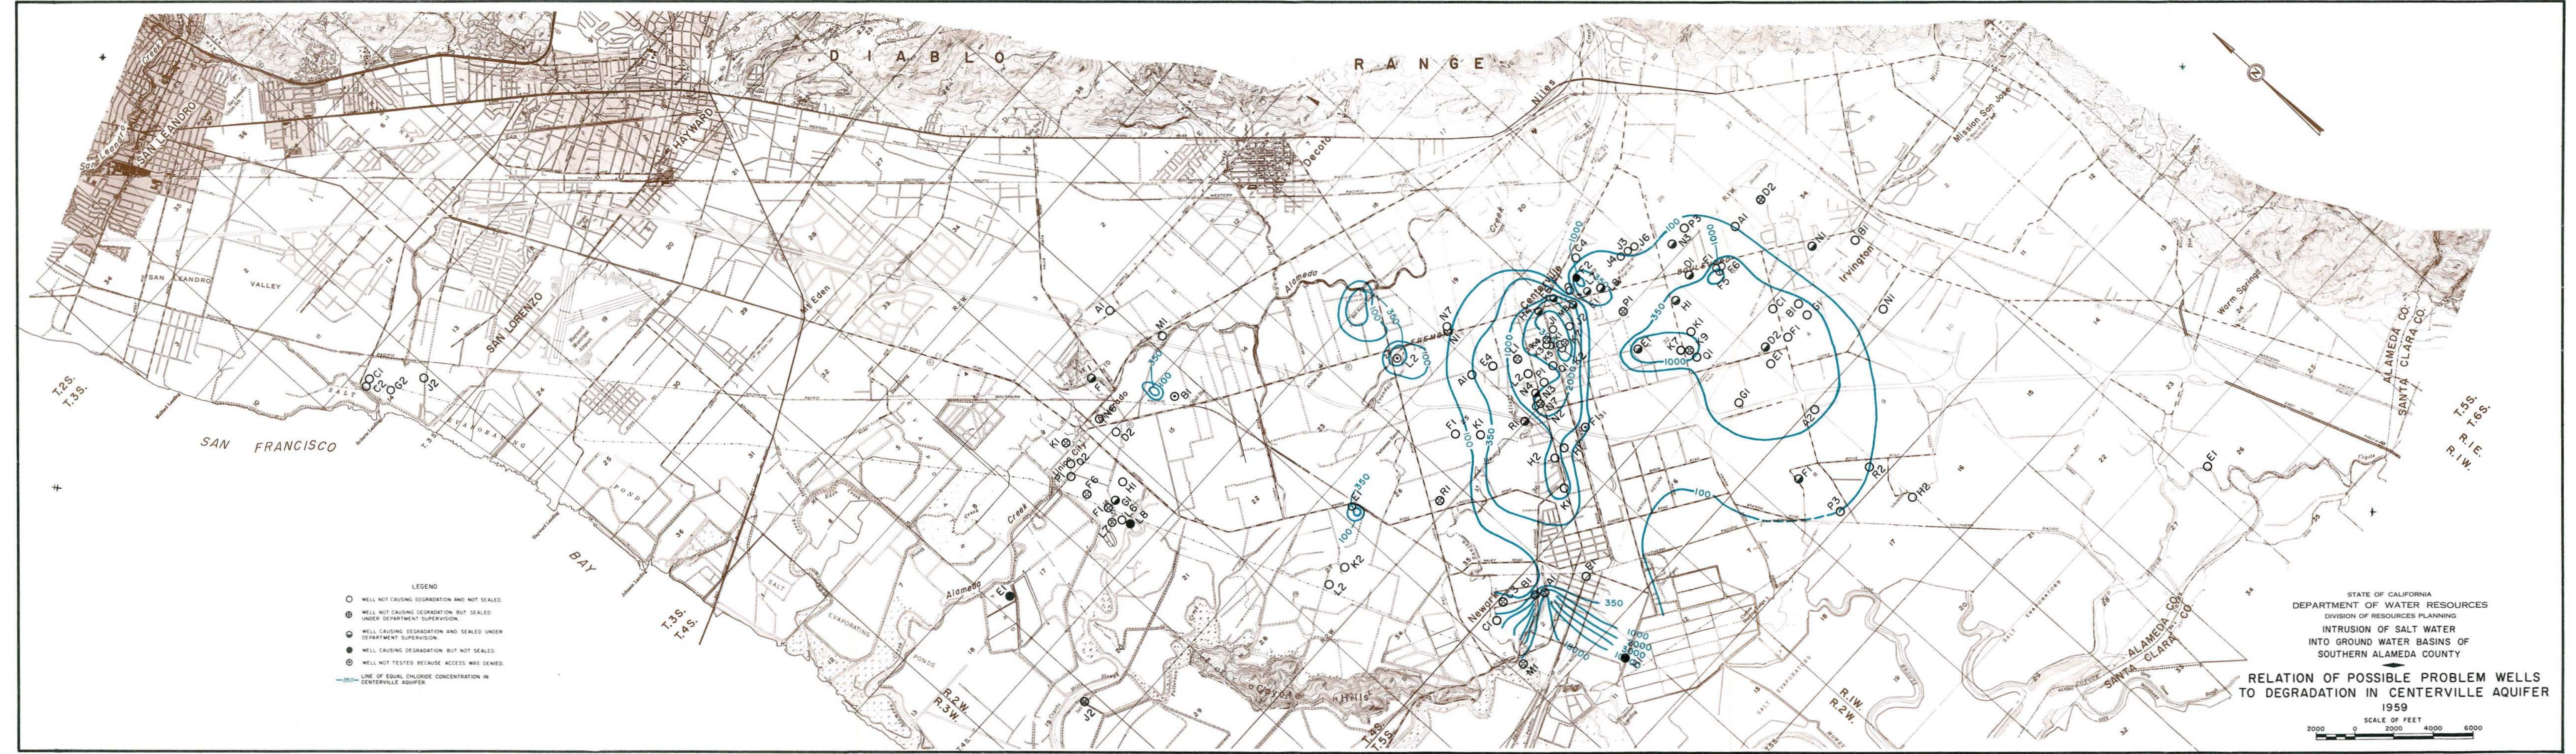
| 7 | Relation of Possible Problems to Degradation<br>in Centerville Aquifer |

10. During the investigation, 100 possible problem wells were tested of which 20 were found to be allowing interchange of saline water between aquifers. Sixteen of these defective wells were sealed or repaired under supervision of the department. Information concerning the remaining four wells was referred to the San Francisco Bay Regional Water Pollution Control Board (No. 2). In addition to the 16 problem wells mentioned, 17 additional wells were sealed under department supervision.
