Historical Ecology and Landscape Change
IN THE CENTRAL
LAGUNA DE SANTA ROSA

Historical Ecology
and Landscape Change
in the Central
**LAGUNA
DE
SANTA ROSA**

MARCH 2017

SFEI-ASC PUBLICATION #820

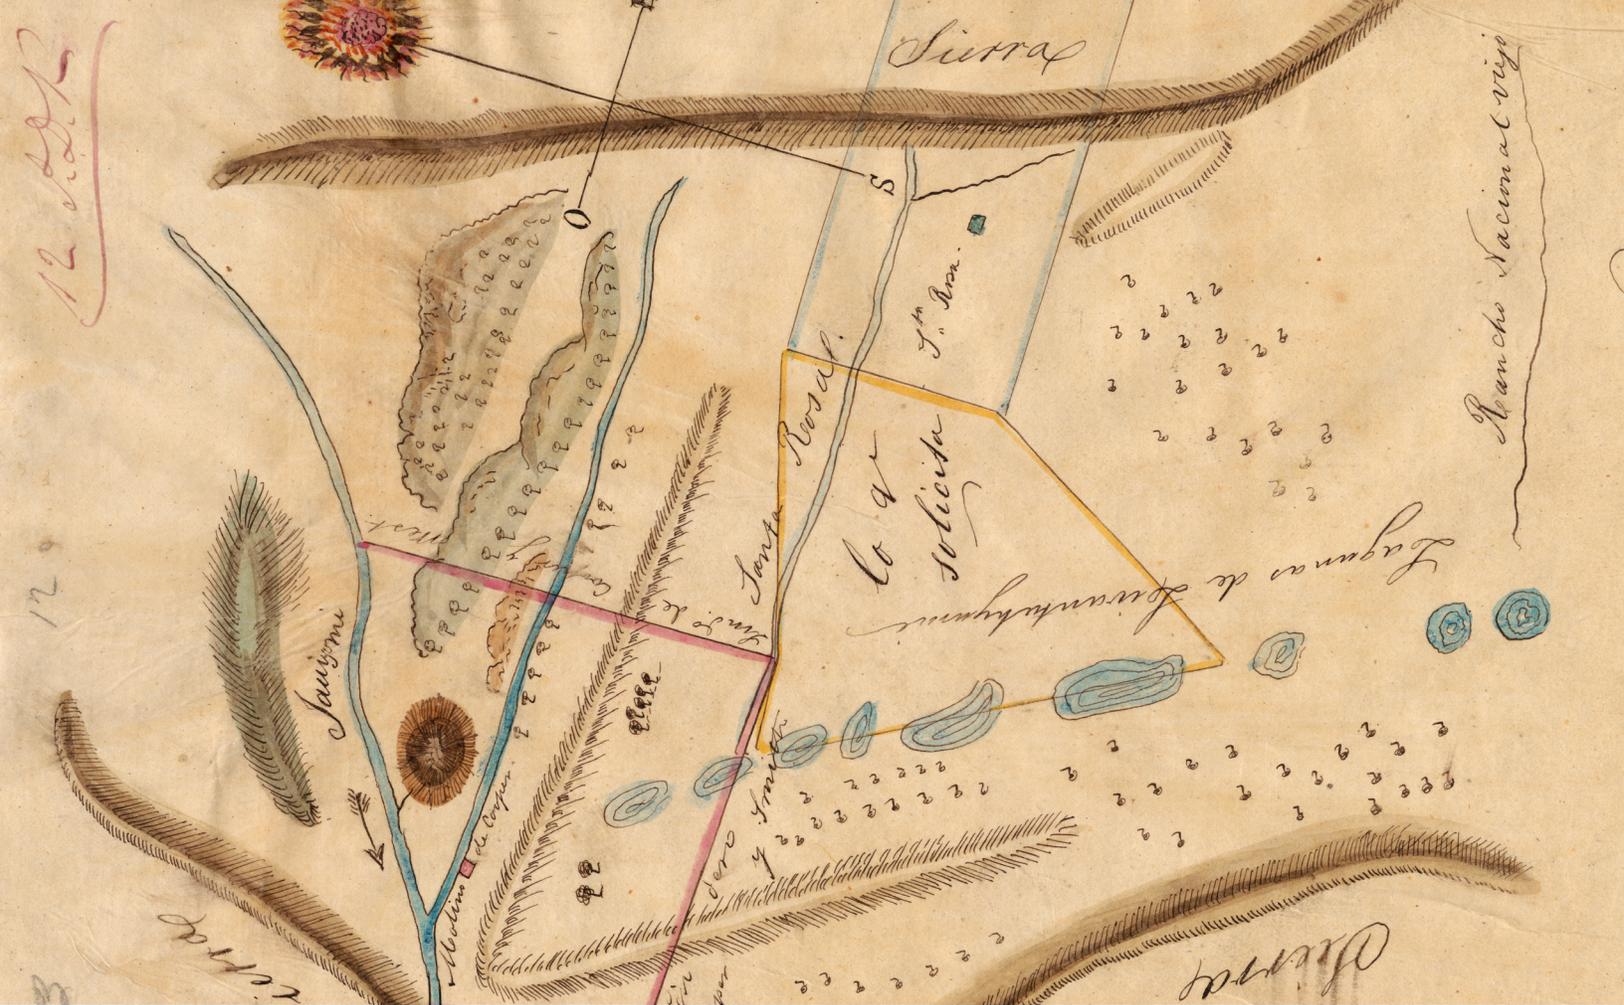
The historical (ca. 1850) distribution of habitat types in the study area, including freshwater ponds and wetlands, riparian areas, and stream channels.

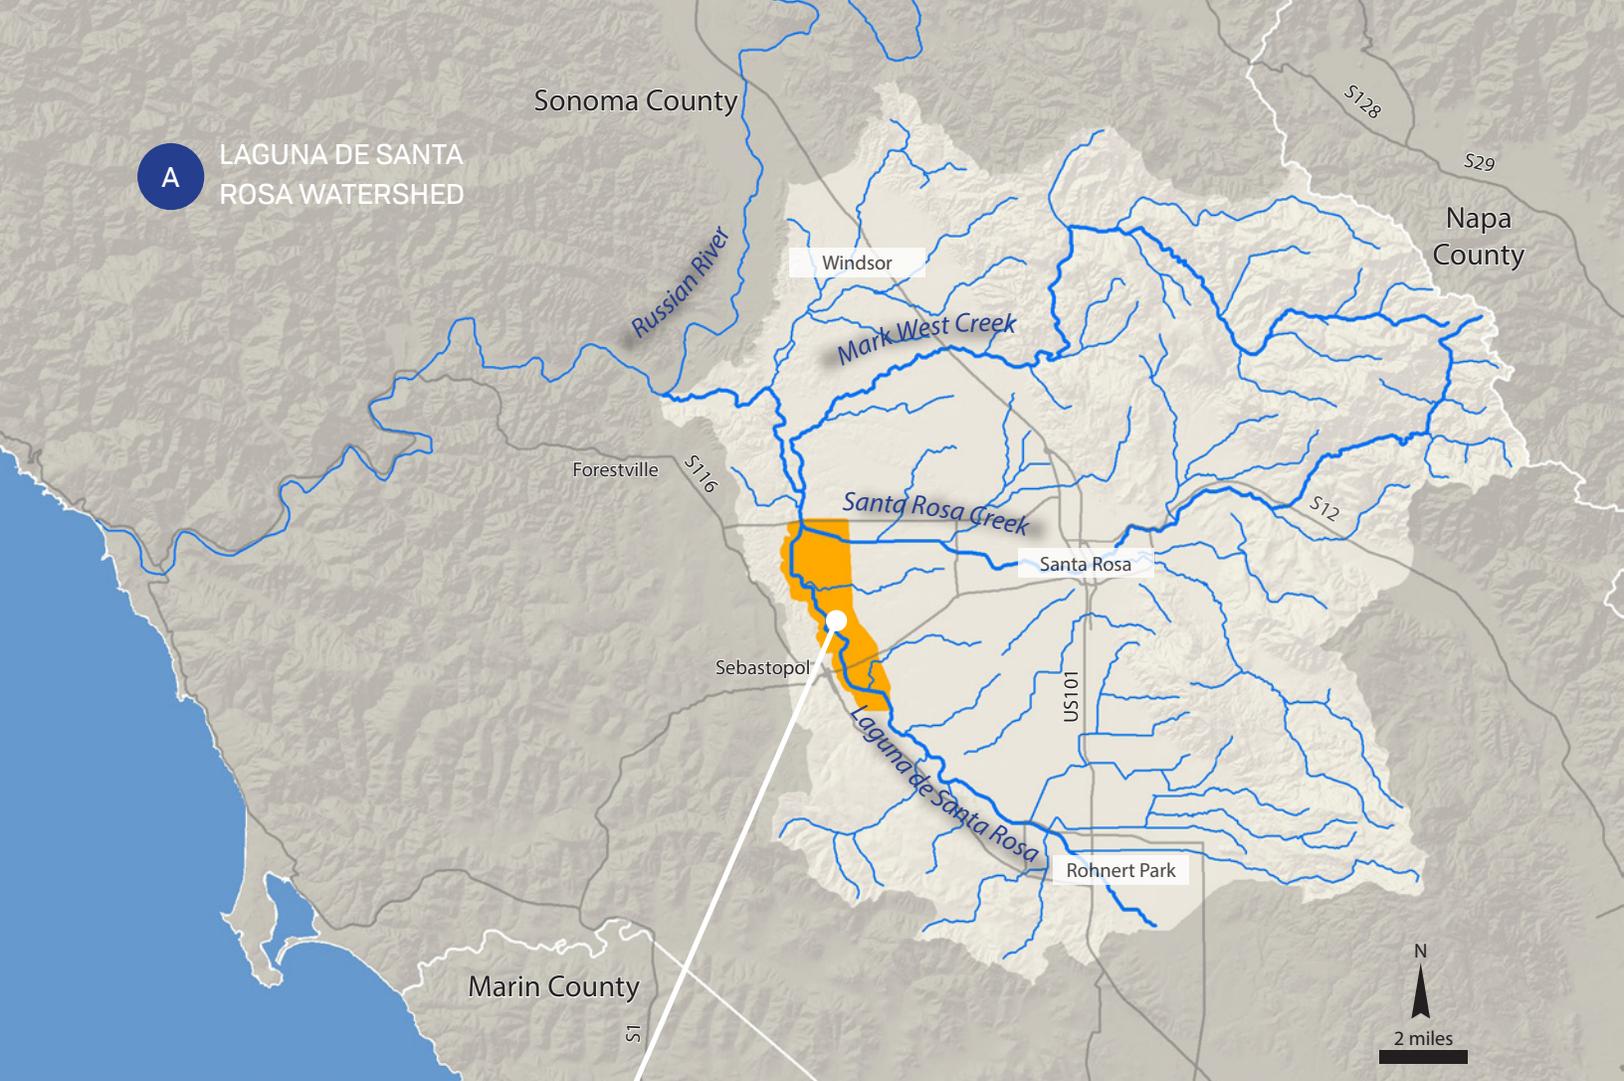
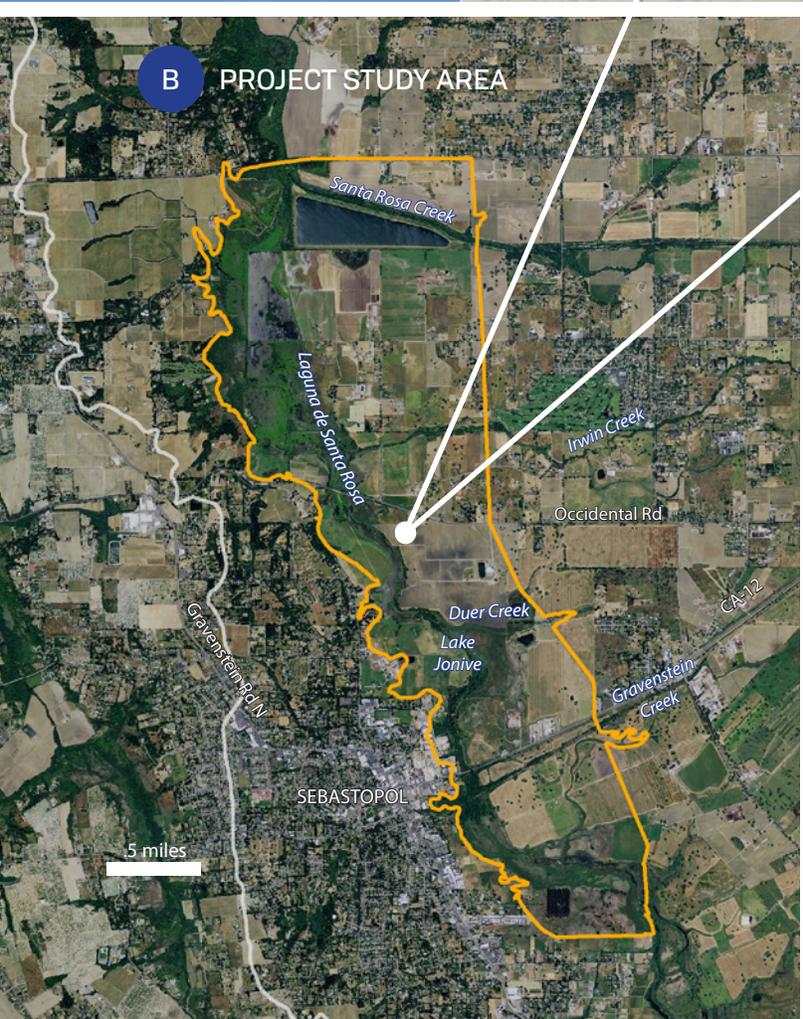
Fig. 1. The Laguna de Santa Rosa watershed (A) and project study area (B) are situated in Northern California. The study area, highlighted in orange, encompasses approximately 13 km² (5 mi²) of a central portion of the central Laguna de Santa Rosa and surrounding areas.

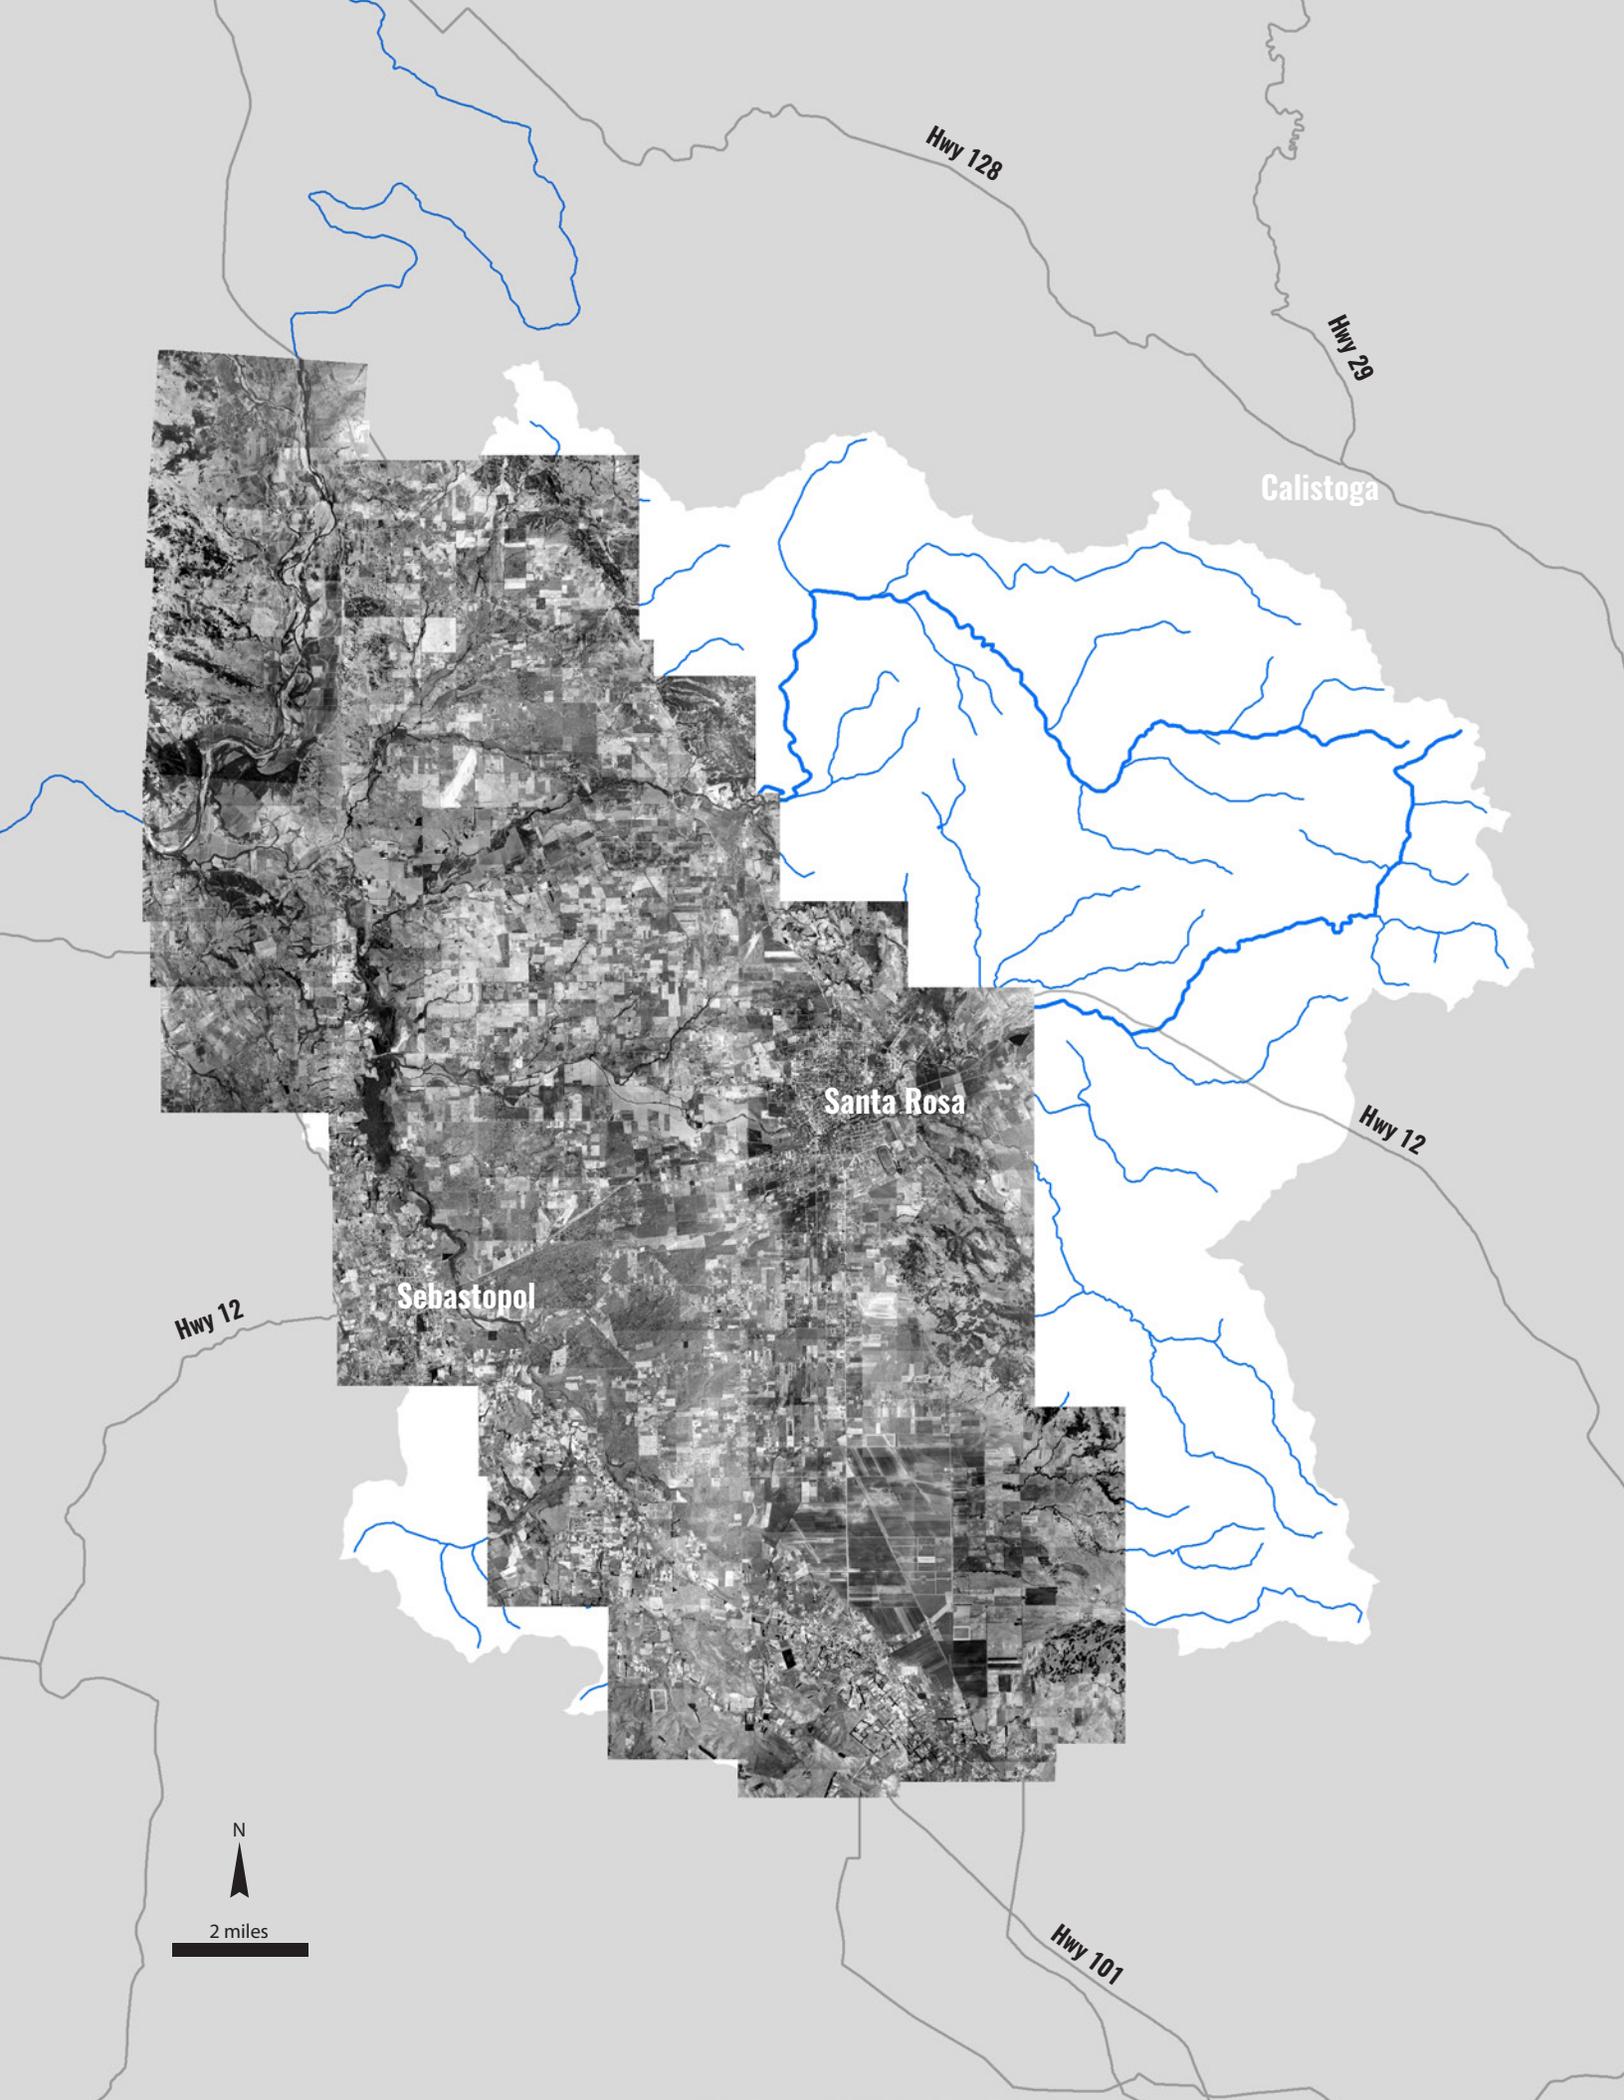
Fig. 3. (opposite) Photomosaic of historical aerial imagery, flown in 1942, of the Santa Rosa Plain. (USDA 1942)

One key data source for the study was a historical aerial photomosaic of the entire Santa Rosa Plain (Fig. 3) comprised of orthorectified and mosaicked aerial photos from 1942 (the earliest year for which coverage of the region is available). The photomosaic was created by SFEI in 2014 with funding from the Sonoma County Agricultural Preservation and Open Space District, and is viewable on the Sonoma Veg Map website (<http://www.sonomavegmap.org/1942/>).

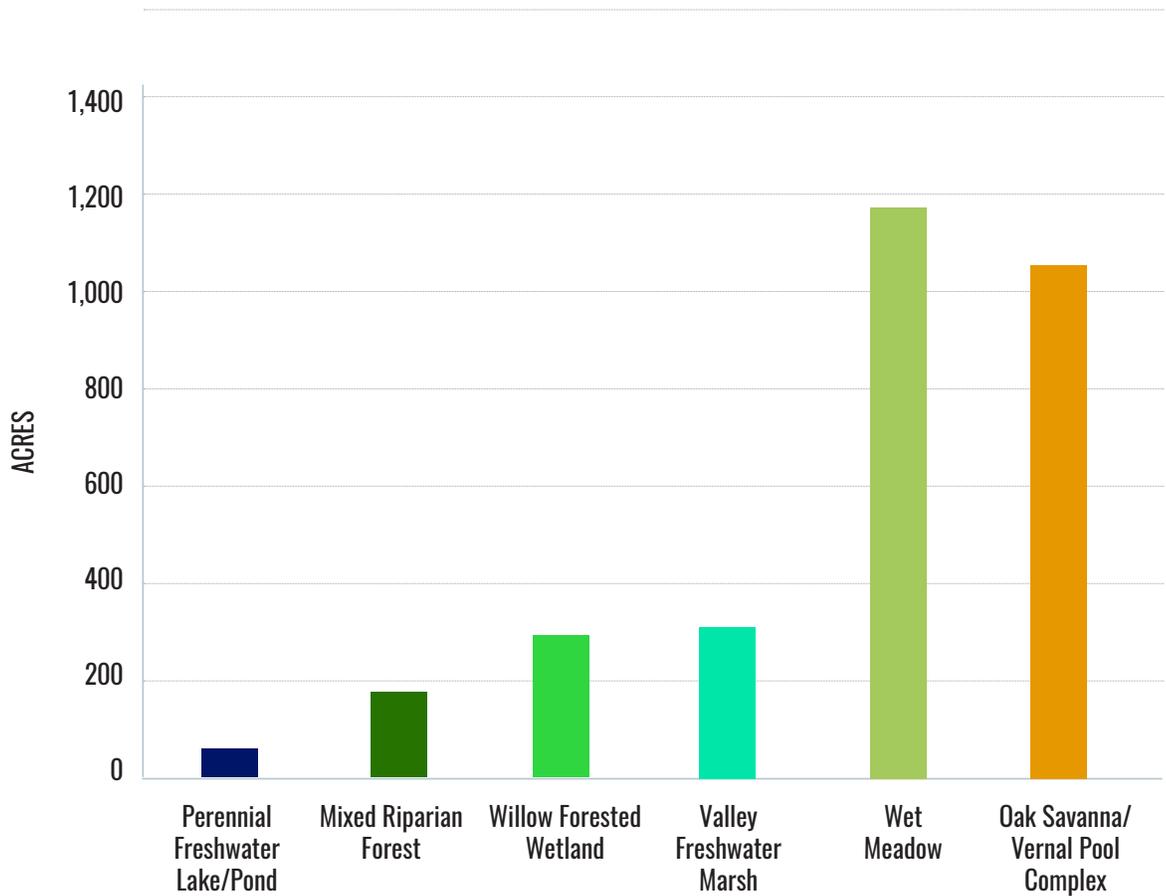
Fig. 5. Total area of each historical (ca. 1850) habitat type mapped within the study area. Perennial freshwater lake/pond, mixed riparian forest, willow forested wetland, and valley freshwater marsh composed the core of the Laguna wetland complex, while extensive areas of wet meadow and oak savanna/vernal pool complex occupied higher surrounding areas.

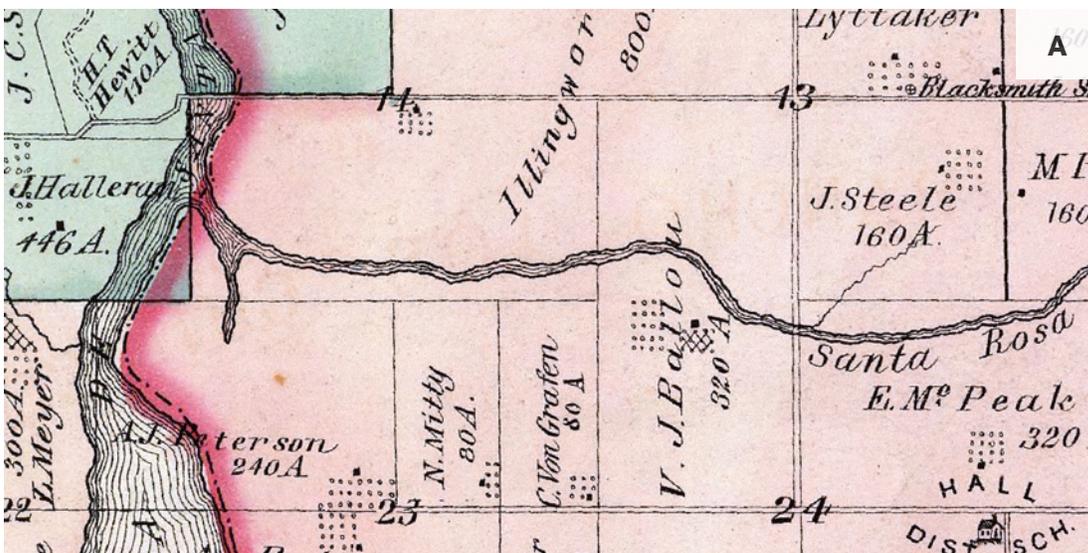
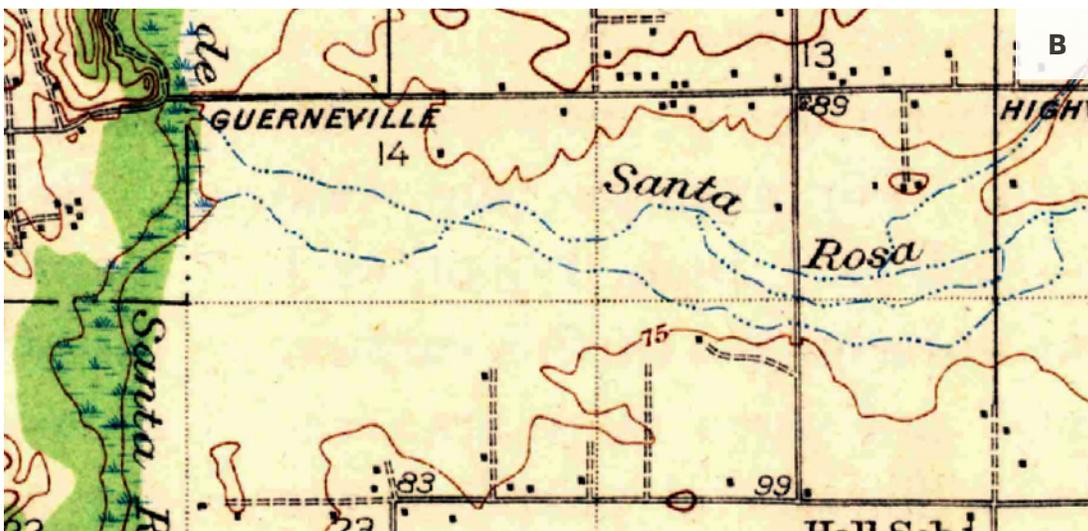
Fig. 8. While many 19th-century maps depict Santa Rosa Creek's confluence with the Laguna as a single channel (e.g., A), early-to mid-20th-century sources tend to show multiple channels approaching the Laguna (B). It is unknown whether these differing representations are reflective of changes in channel morphology or differences in cartography. (A: Thompson 1877b, courtesy of David Rumsey Map Collection; B: USGS [1933-5]1942)

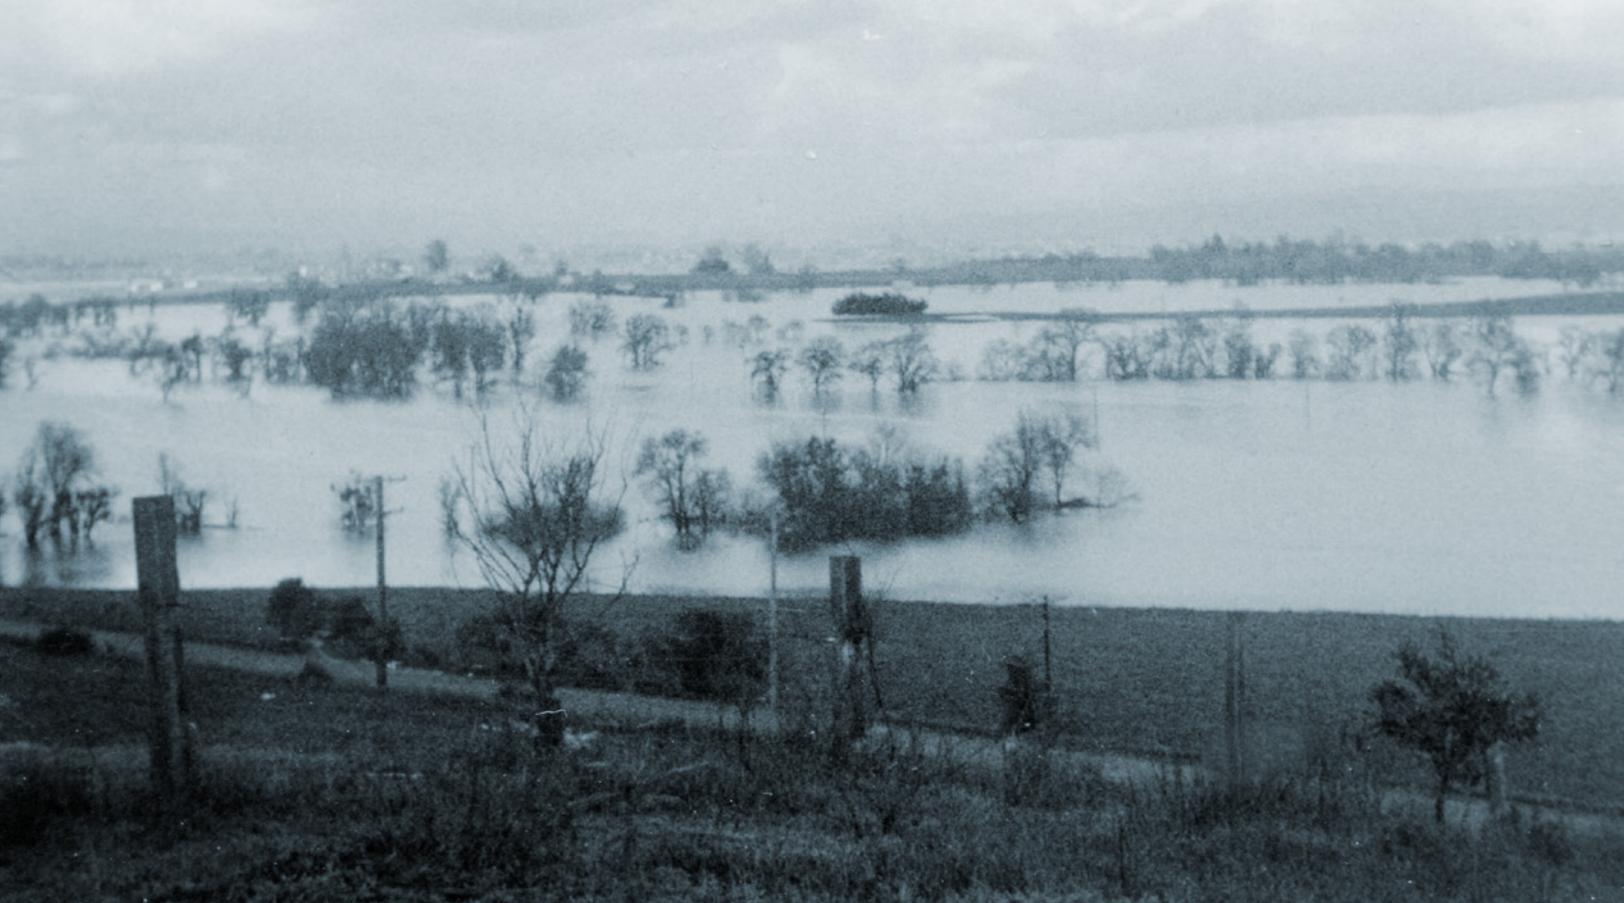
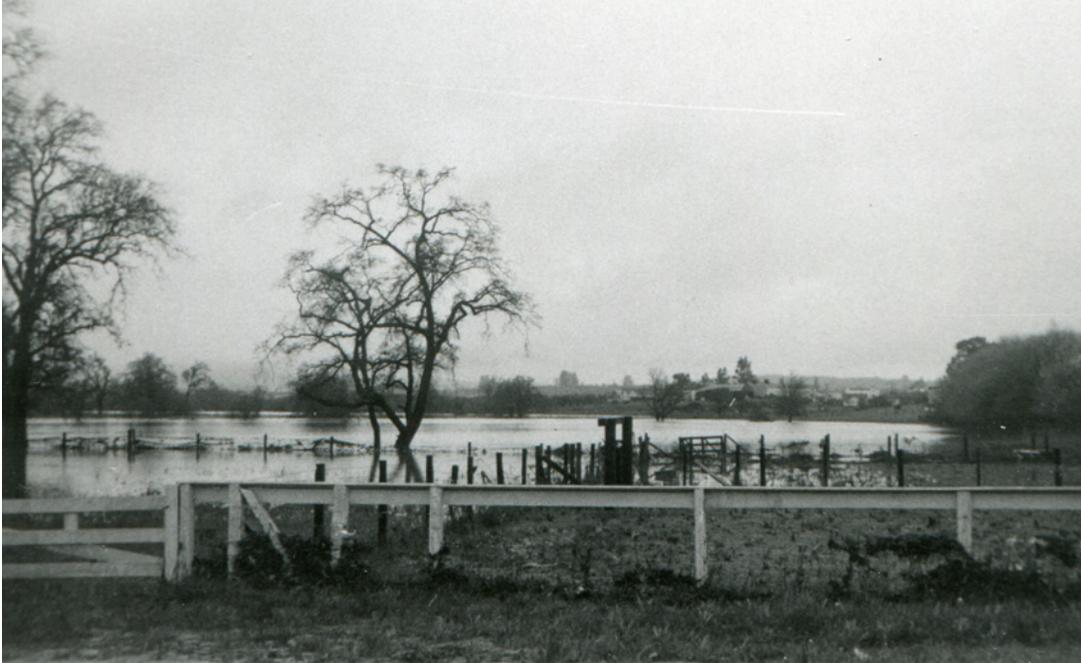
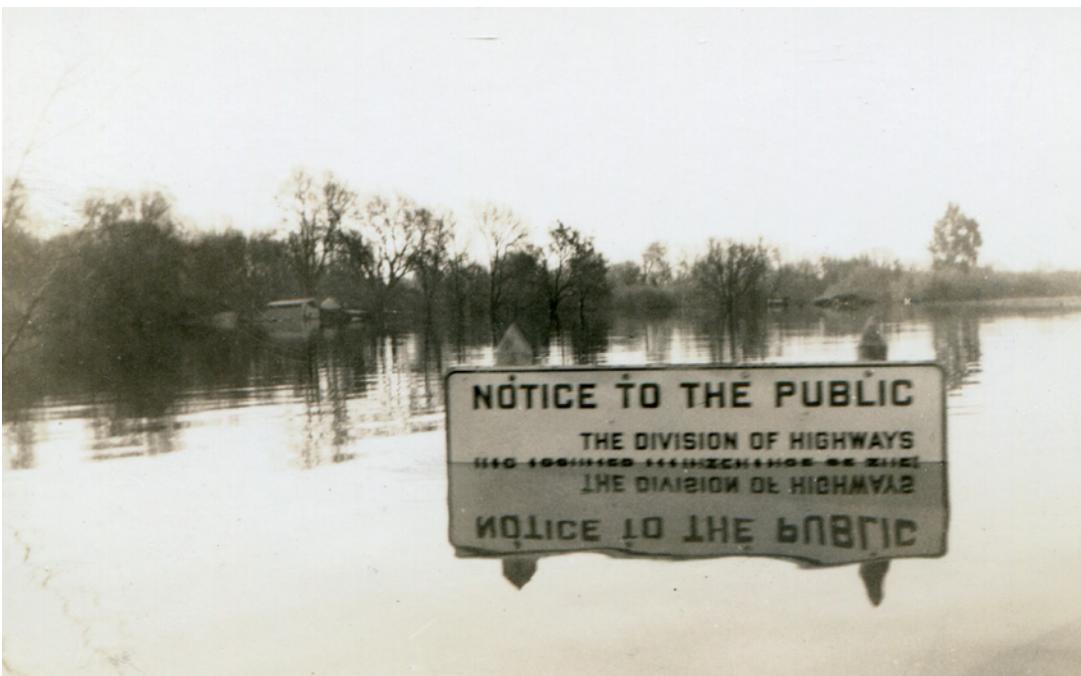
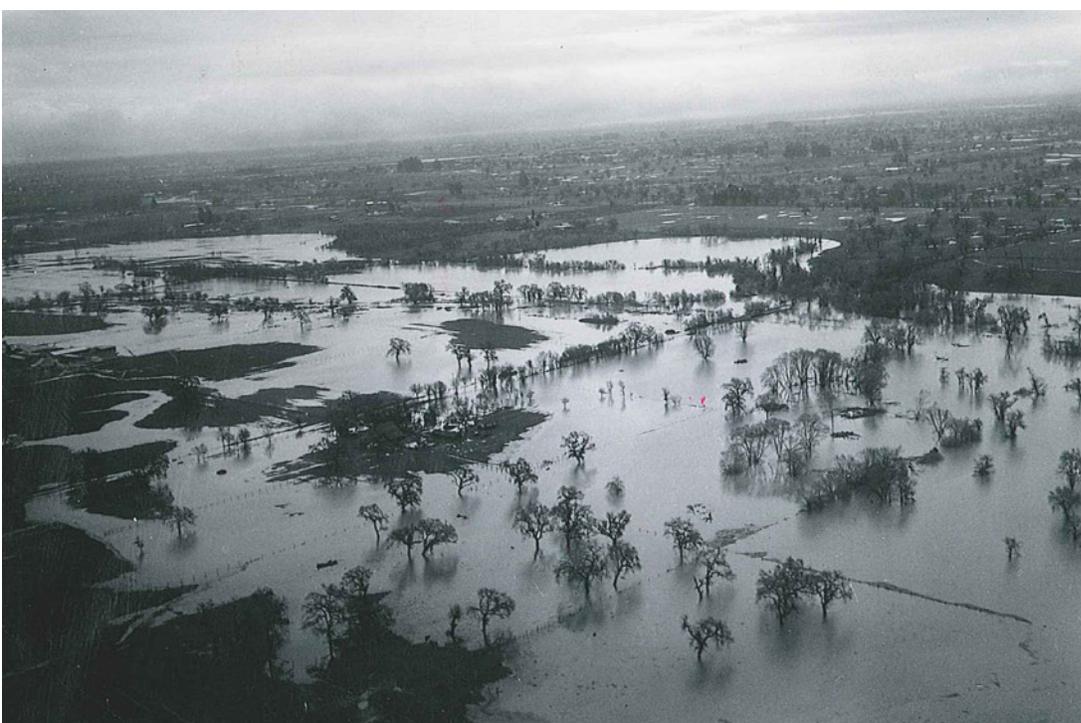
Fig. 9. The Laguna complex was frequently inundated by wet-season flood events, which often covered much of the study area with shallow open water. This series of images depicts a series of mid-20th-century floods. **Opposite:** Flooded pastures near Sebastopol in 1951. **Top:** Floodwaters at Occidental and High School roads during the 1951 flood. **Center:** Flooding on Highway 12 near the Laguna, ca. 1940. **Bottom:** Flooding on Santa Rosa Creek just upstream of the Laguna confluence, December 19, 1955. (Opposite: Photo #13266, courtesy of Western Sonoma County Historical Society; Top: Photo #13219, courtesy of Western Sonoma County Historical Society; Center: Photo #2036, courtesy of Western Sonoma County Historical Society; Bottom: C-1967-6, courtesy of Sonoma County Water Agency)

Historically, the extent of inundation in the Laguna wetland complex varied dramatically throughout the year. During wet-season floods, shallow open water likely covered much of the mapped wetland area (Fig. 9). Accounts of late 19th-century floods, for instance, describe flooding between half a mile and several miles wide (e.g., *Daily Alta California* 1866, *Daily Courier and Petaluma Imprint* 1895 in Cummings 2006).

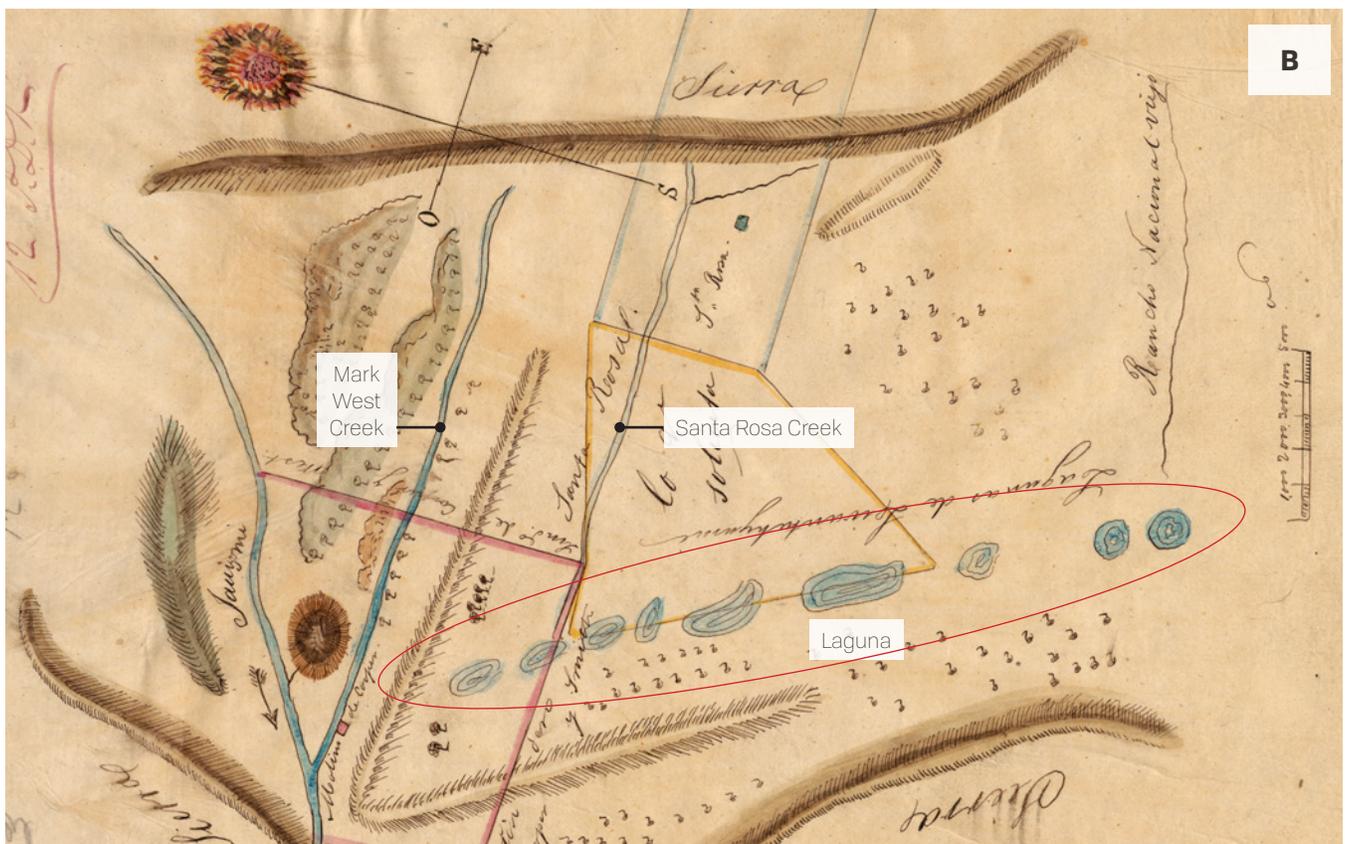
B

Fig. 10. Early land grant maps, such as these maps from ca. 1840, show the Laguna as a series of perennial ponds or lakes. The lower map labels it "Laguna de Livantuligüeni"; Livantuligüeni (there are numerous spelling variants, including Livantolomi and Livancacayomi) refers to an Indian rancheria located just west of the Laguna (Merriam 1966, Vallejo et al. 2000). (A: USDC ca. 1840a; B: USDC ca. 1840b; both courtesy of The Bancroft Library, UC Berkeley)

Moraga's description is echoed in later accounts that describe the Laguna in this area as "a series of lakes" (Thompson 1877a) and "a series of ponds and wide marshes" (Watson et al. 1917). Several early land grant maps likewise depict the Laguna as a string of ponds (Fig. 10).

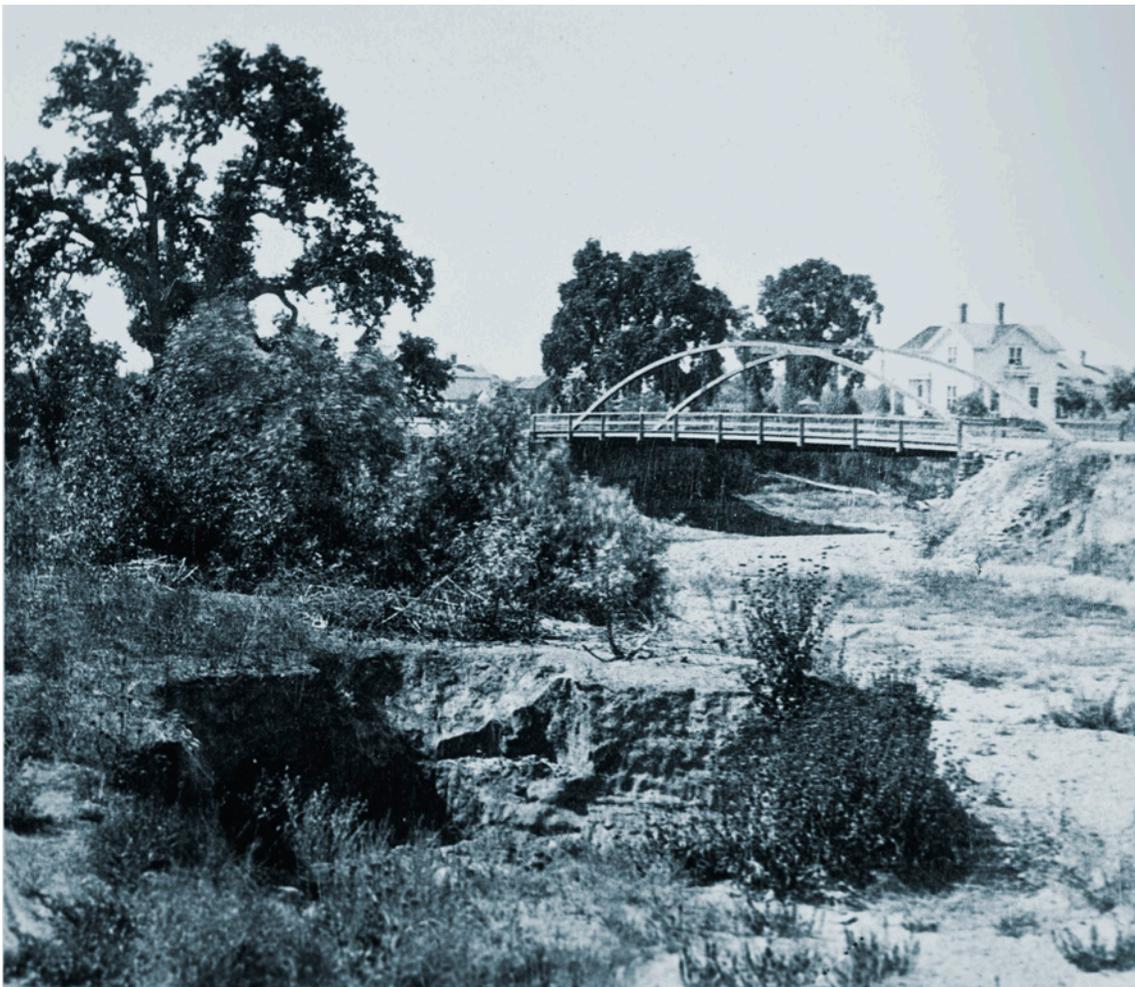
Fig. 11. Surface flows in Santa Rosa Creek, the largest tributary to the Laguna, did not extend to the Laguna confluence during the dry season. This 1879 photograph, looking towards Main Street Bridge in Santa Rosa (upstream of the study area), shows the dry bed of Santa Rosa Creek. (Annex Photo 546, courtesy of Sonoma County Library)

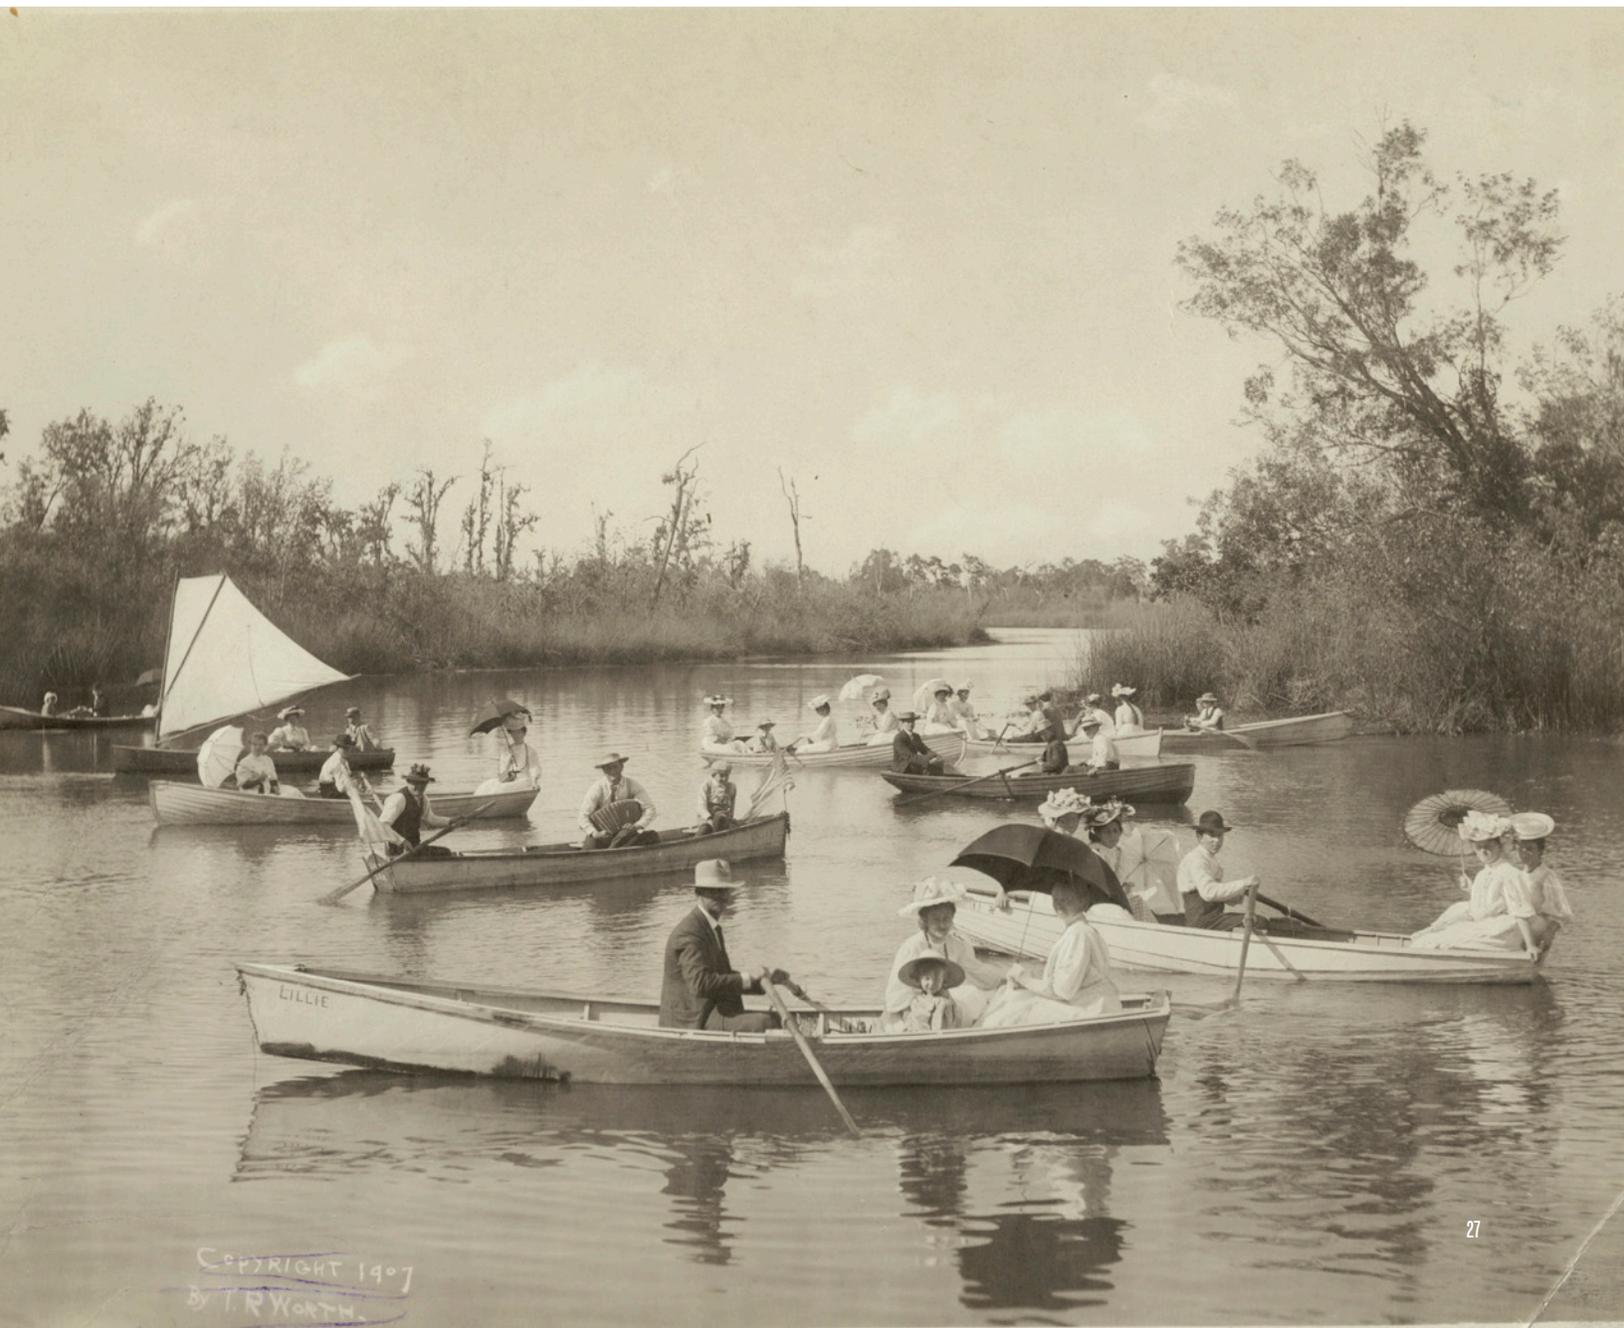
Fig. 17. Boating on Lake Jonive, ca. 1907. The lake was a popular swimming and boating destination during the late 19th and early 20th centuries. (CHS-45682, courtesy of USC Libraries, California Historical Society Collection)

One of the central features within the study area was a deep, perennial freshwater lake known as Lake Jonive. Located east of present-day Sebastopol, this elongate lake extended from just north of present-day Highway 12 to present-day Occidental Road, approximately 3 km (2 mi) north. The lake was a popular boating and swimming destination during the late 19th and early 20th centuries, as documented in numerous landscape photographs from the period (Fig. 17).

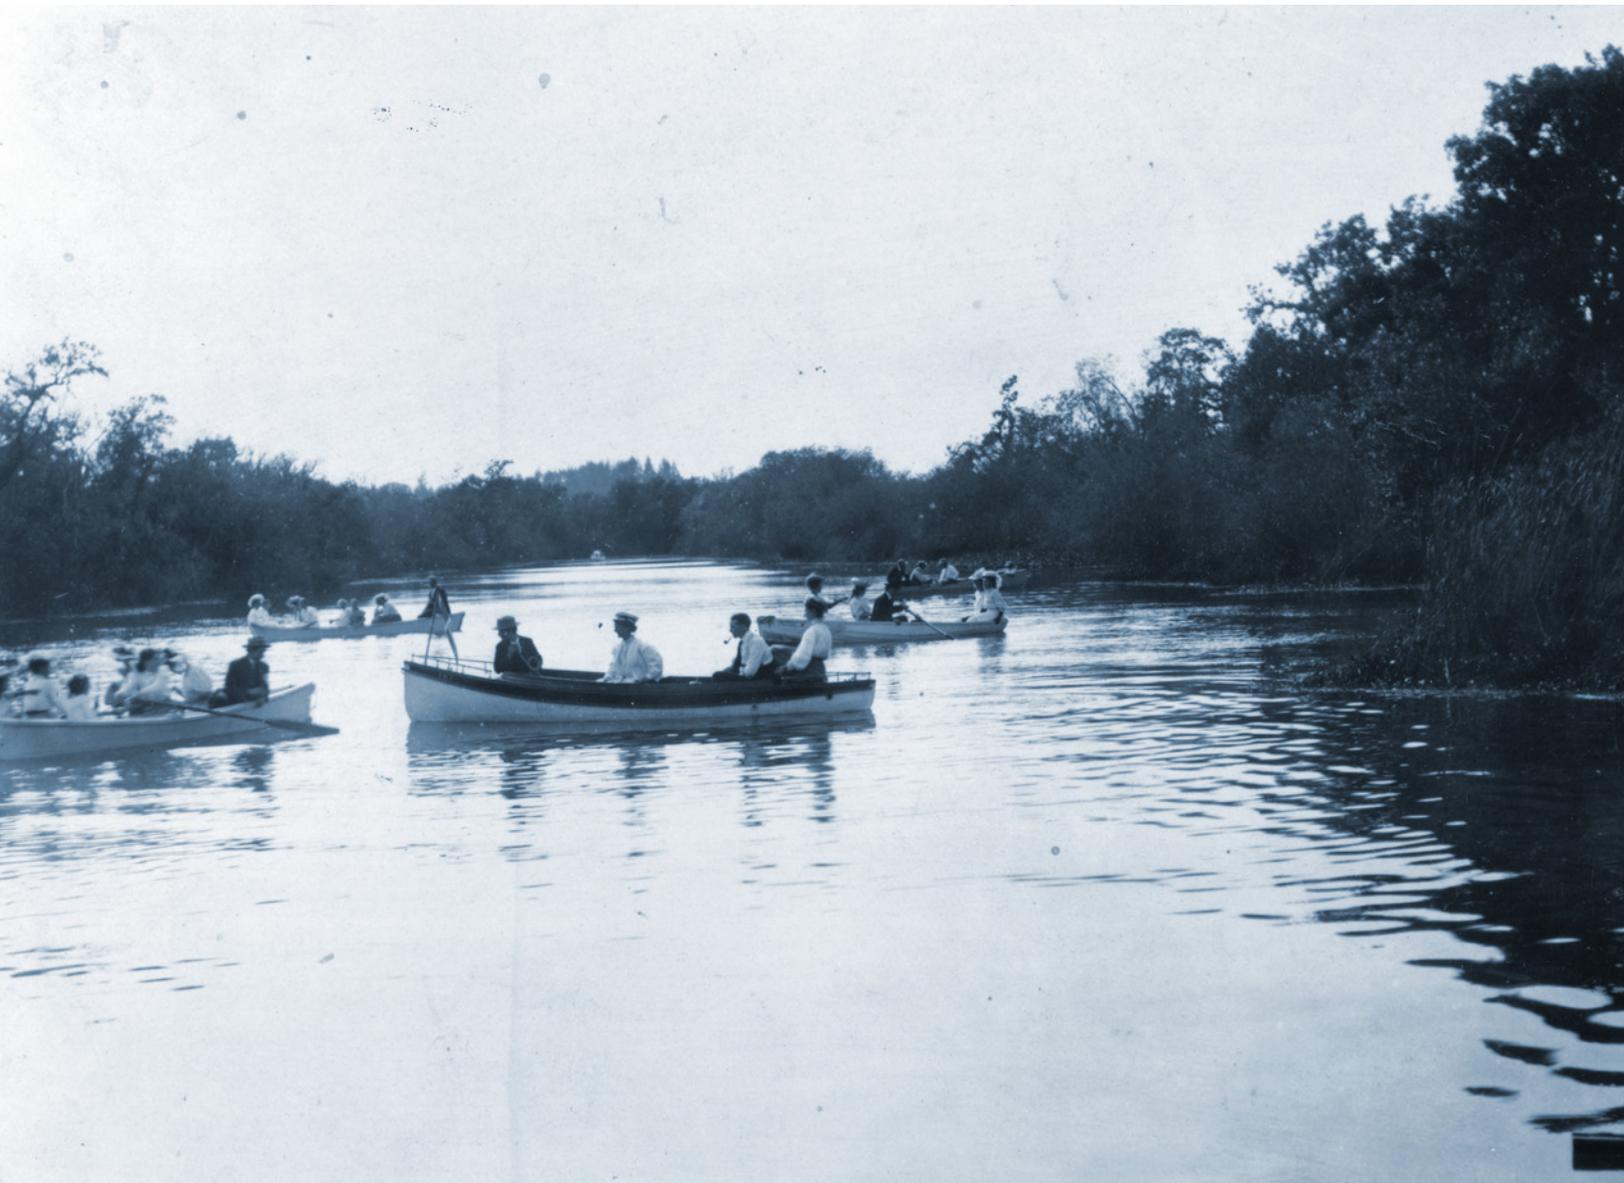
Fig. 18. Though relatively narrow, Lake Jonive extended along the valley for approximately 3 km (2 mi) and reached a maximum depth of just over 7 m (23 ft). As shown in these early 20th-century photographs, the lake was bordered by tules and a mixed riparian forest dominated by oaks and willows. (Above: Photo #2027, courtesy of Western Sonoma County Historical Society; Opposite, top: Photo #1376, courtesy of Laguna de Santa Rosa Foundation; Opposite, bottom: Photo #2028, courtesy of Western Sonoma County Historical Society)

Lake Jonive was bordered by a mixed riparian forest dominated by oaks and willows (see page 30). Landscape photographs from the late 19th and early 20th centuries also appear to show a narrow band of tules around the margins of the lake (not mapped separately; Fig. 18).
