Historical Ecology and Landscape Change
IN THE CENTRAL
LAGUNA DE SANTA ROSA

Historical Ecology
and Landscape Change
in the Central
**LAGUNA
DE
SANTA ROSA**

MARCH 2017

SFEI-ASC PUBLICATION #820

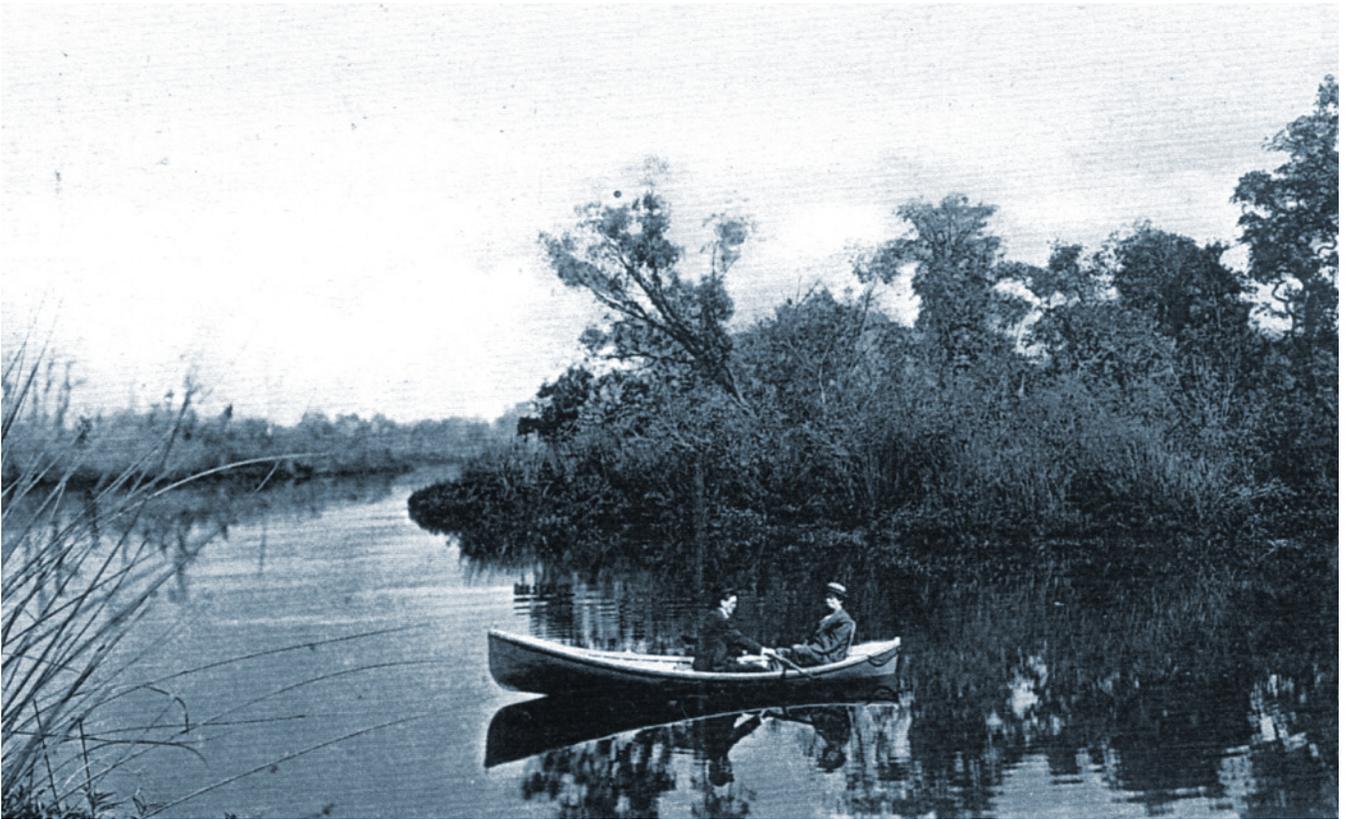
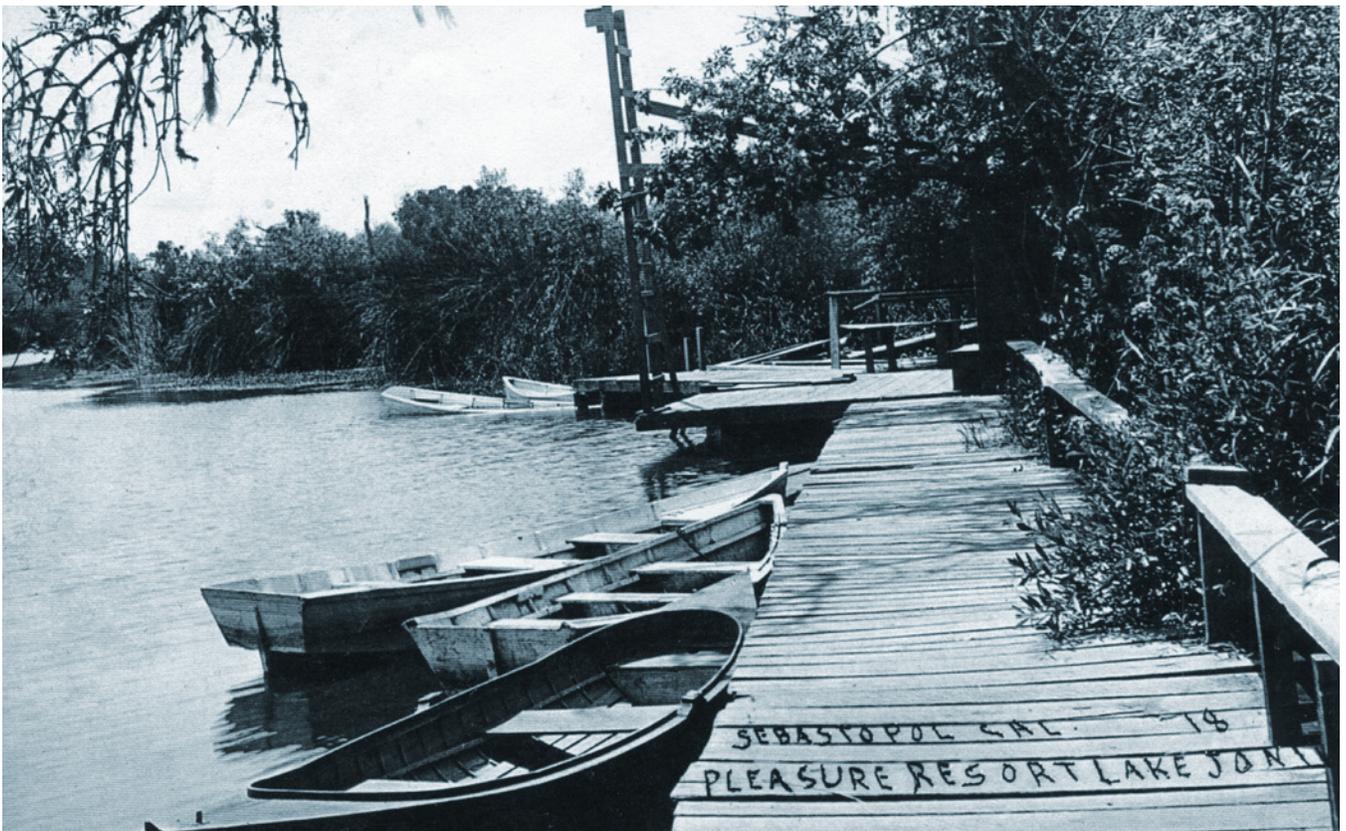
Fig. 18. Though relatively narrow, Lake Jonive extended along the valley for approximately 3 km (2 mi) and reached a maximum depth of just over 7 m (23 ft). As shown in these early 20th-century photographs, the lake was bordered by tules and a mixed riparian forest dominated by oaks and willows. (Above: Photo #2027, courtesy of Western Sonoma County Historical Society; Opposite, top: Photo #1376, courtesy of Laguna de Santa Rosa Foundation; Opposite, bottom: Photo #2028, courtesy of Western Sonoma County Historical Society)

Lake Jonive was bordered by a mixed riparian forest dominated by oaks and willows (see page 30). Landscape photographs from the late 19th and early 20th centuries also appear to show a narrow band of tules around the margins of the lake (not mapped separately; Fig. 18).

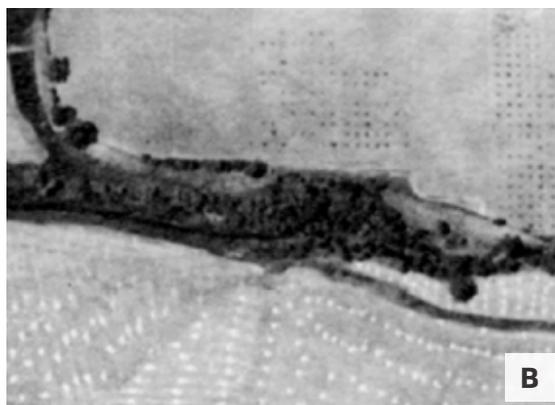
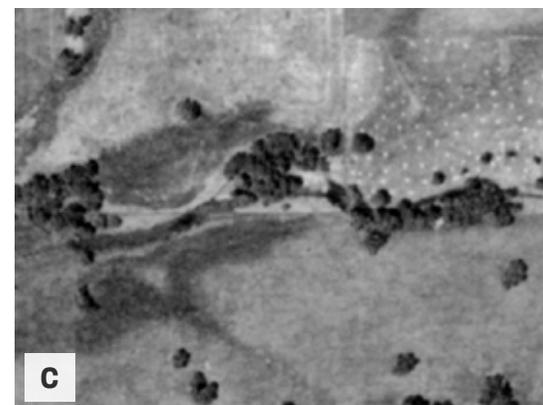
Fig. 20. (below) Details from 1942 aerial photomosaic showing patches of riparian forest along Lake Jonive (A) and tributaries (B,C). Lake Jonive supported a broad (10–350 m wide) riparian forest, while tributaries such as Santa Rosa Creek and Irwin Creek appear to have supported small patches or narrow corridors of forest. (USDA 1942)

Mixed riparian forest, dominated by oaks and willows, occupied 70 ha (180 ac) within the study area. This habitat type occurred primarily along the margins of Lake Jonive, where it covered approximately 60 ha (150 ac) and varied in width from less than 10 m to over 350 m (30–1,150 ft; Fig. 19). Turn-of-the-century newspaper articles described the lake as “bordered by a heavy growth of oak” and as “bordered with oaks, willows, etc” (*The Sebastopol Times* 1903a, 1903b; see also Fig. 18 on pages 28–29). Oregon ash and boxelder were also likely present within these riparian areas (Figueroa 1834, Millington 1865, Shelton 1911, Howell 1951, Waaland 1989). By the time the earliest aerial photos were taken in 1942, portions of the forest had already been cleared, but remnants are still visible (USDA 1942; Fig. 20A).

Conclusive historical evidence for extensive riparian forests along tributaries within the study area was not found, though tributaries like Santa Rosa Creek and Irwin Creek appear to have supported small patches or narrow corridors of mixed riparian forest (Fig. 20B,C). For example, the 1942 aerial photos show narrow bands of trees bordering the Santa Rosa Creek channels, though much of the surrounding area was under cultivation by that time and it is possible that substantial numbers of riparian trees had already been removed. Most parts of the riparian corridor along Santa Rosa Creek visible in the 1942 aerial photos are between 10–30 m (30–100 ft) in width, though a corridor up to 60 m (200 ft) wide is visible just upstream of the confluence with the Laguna, perhaps representing a remnant of a more extensive

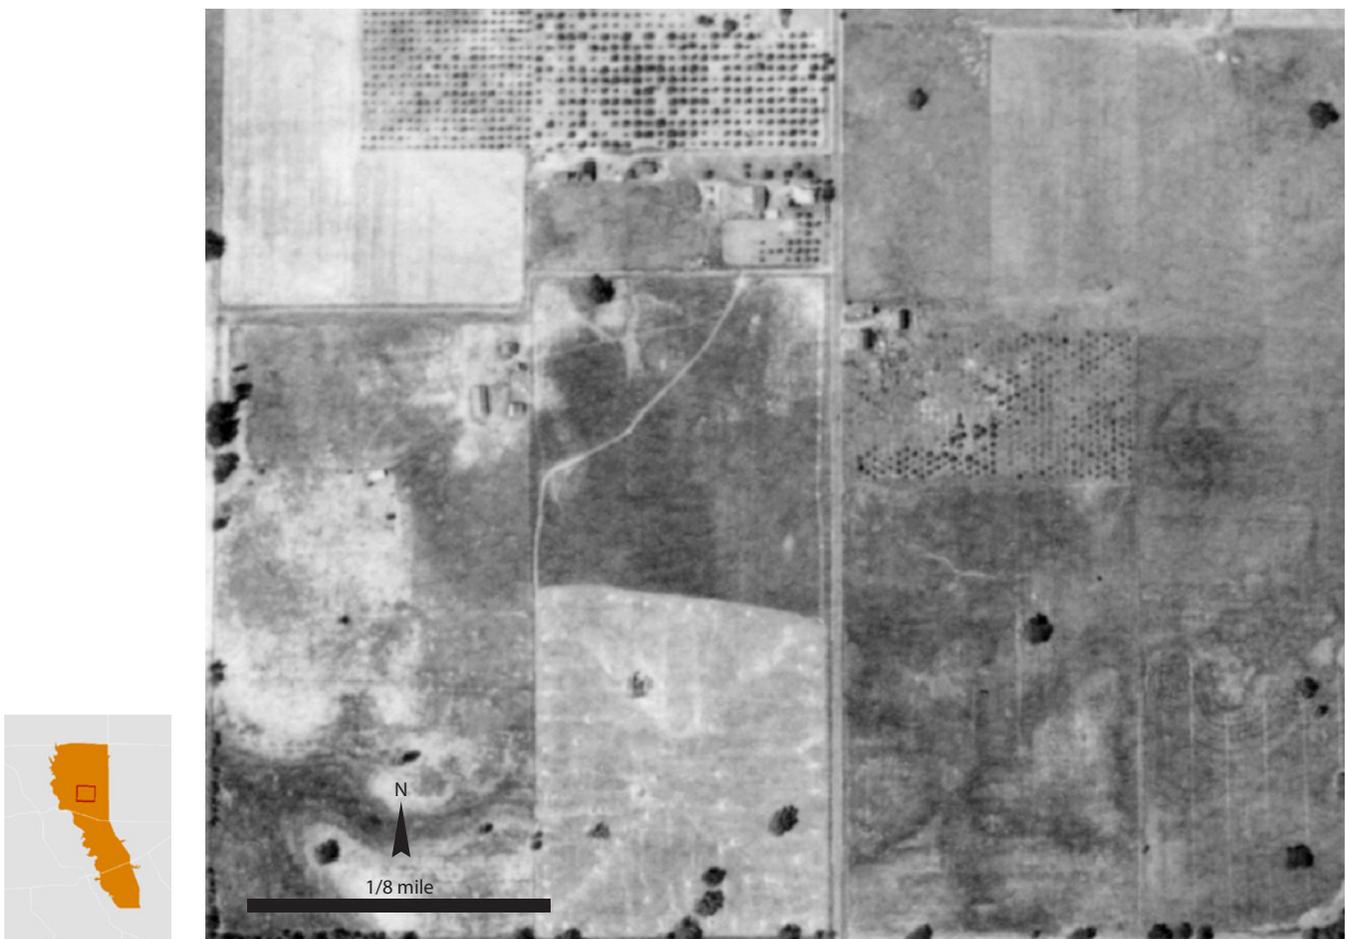
Fig. 23. Wet meadow, 1942. This detail from the historical aerial photomosaic east of the Laguna (just north of Irwin Creek) shows the dark patches often characteristic of wetter conditions and poor drainage. (USDA 1942)

Early maps and textual accounts often do not document or describe seasonal wetlands like wet meadow, likely as a result of their variable and somewhat ephemeral nature. As a result, the evidence for wet meadows within the Laguna wetland complex is much more limited than for other wetland types. Many of the areas mapped as wet meadow correspond approximately to areas mapped as Dublin Clay Adobe by the 1915 soil survey (Watson et al. 1915; see Fig. 12 on page 24). Dublin Clay Adobe is described as having "incomplete" drainage (Watson et al. 1917). There is also evidence for wet meadows from the 1942 aerials in the form of darker patches in areas with herbaceous cover, which are often a signature of wetter conditions and poor drainage (Fig. 23).

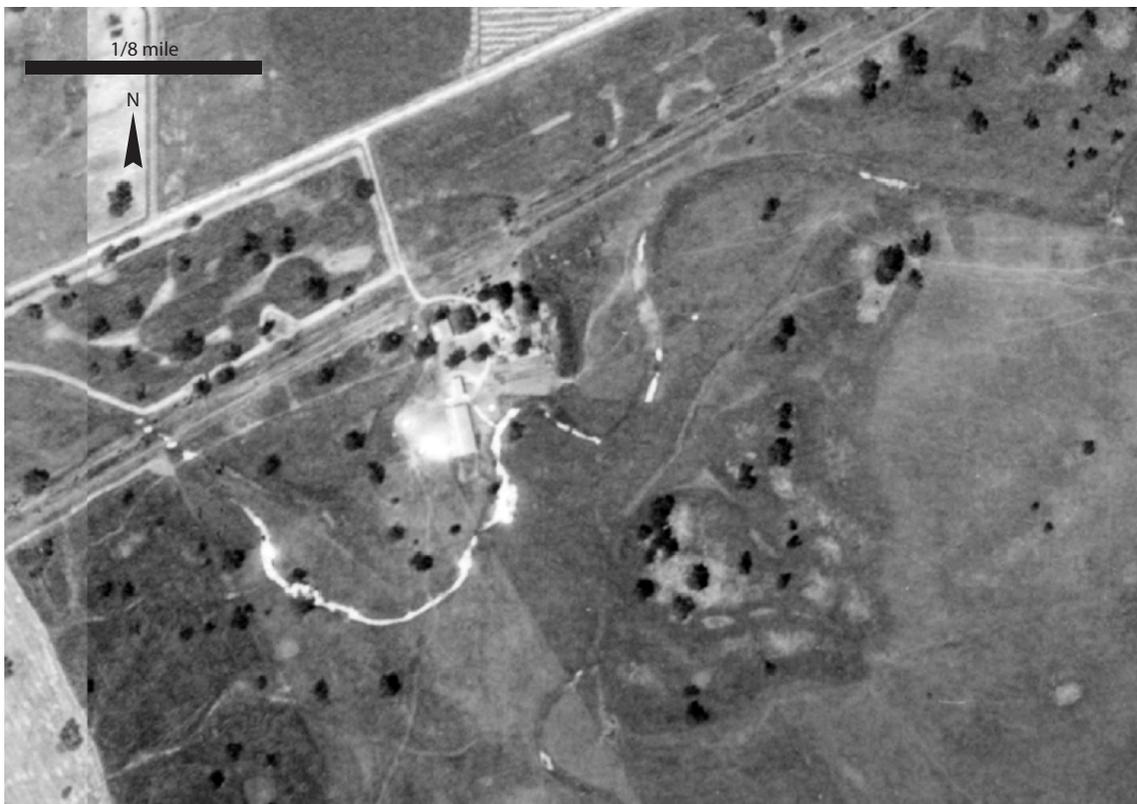
Fig. 24. Scattered oaks and vernal pools near Gravenstein Creek, 1942. (USDA 1942)

Slightly higher-elevation areas surrounding the wet meadow supported oak savanna/vernal pool complex (Fig. 24). This habitat type was dominated by a sparse cover of oak trees (mostly valley oak) intermixed with an array of vernal pools within a grassland matrix. Previous analyses (e.g., Waaland 1989, Waaland 1990, Butkus 2011b), along with evidence from historical soil surveys, aerial photos (Fig. 25), and other archival sources, suggest that oak savanna/vernal pool complex historically occupied large areas of the Santa Rosa Plain east of (and contiguous with) the study area. The mapped area thus represents a small fraction of a much more extensive oak savanna/vernal pool complex within the region historically.

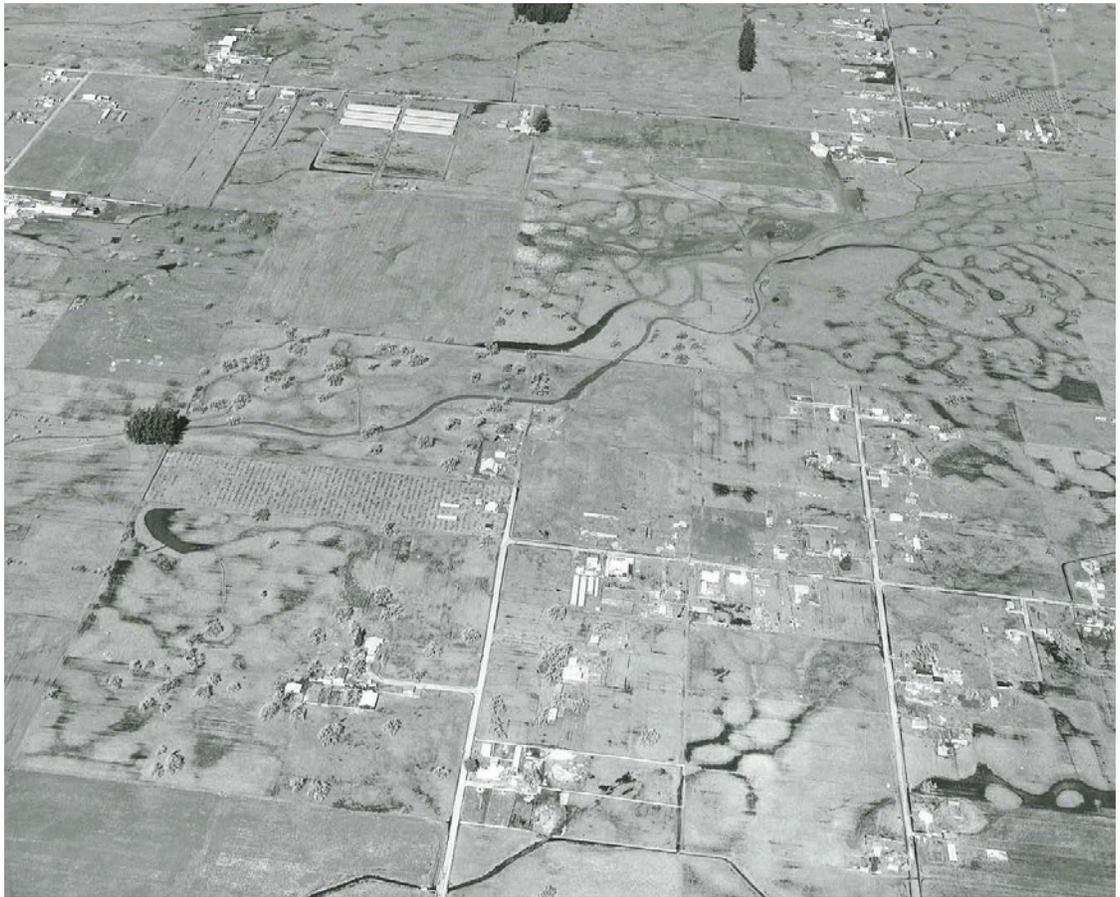
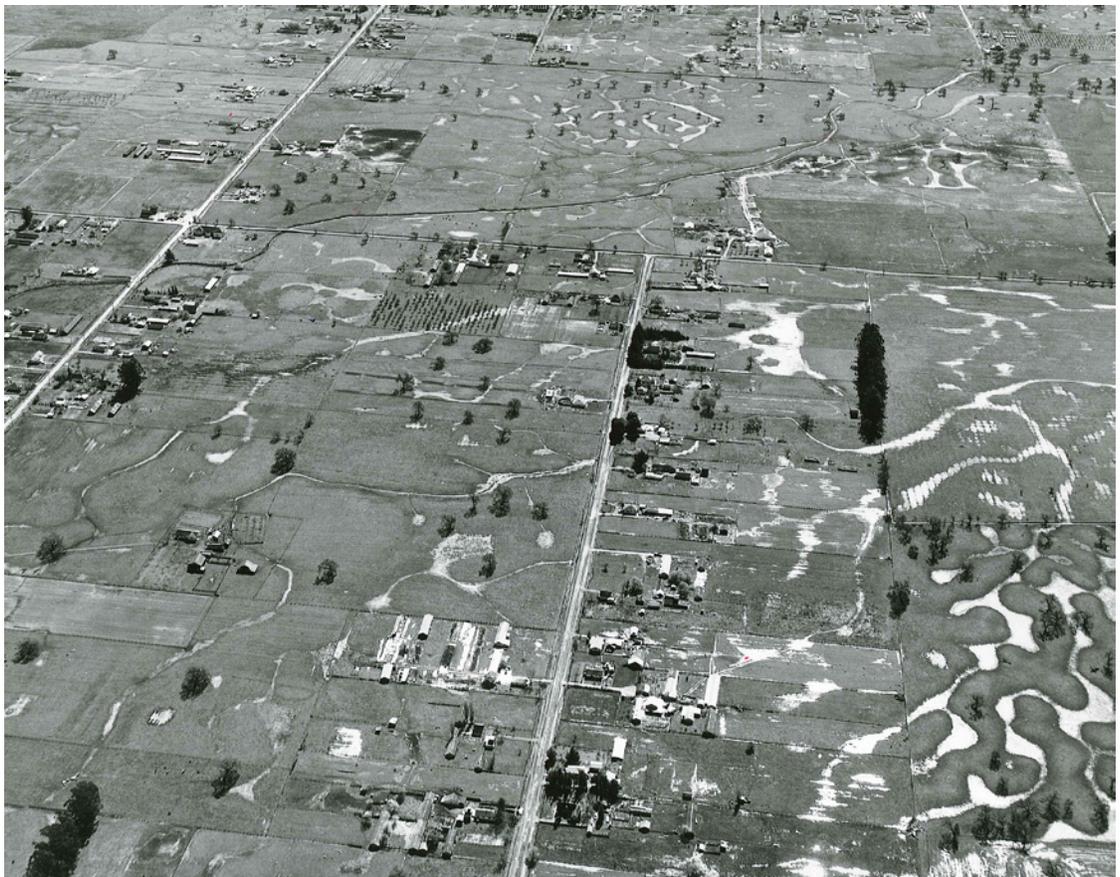
Fig. 25. Vernal pool/swale complexes on the Santa Rosa Plain. Scattered oak trees are also visible. **(top)** Near Arlington Avenue and Scenic Avenue, February 26, 1966. **(bottom)** Near Ludwig Avenue and Stony Point Road, February 26, 1966. (Top: Negative #321-23; Bottom: Negative #321-20; both courtesy of Sonoma County Water Agency)

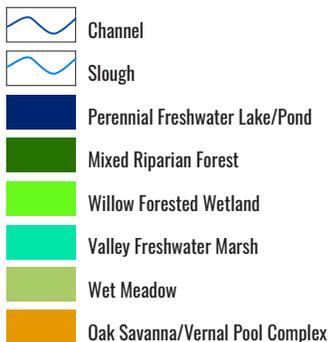
Fig. 26. Summary of county and General Land Office survey evidence for oak lands in the study area. The surveys, conducted between 1853 and 1865, describe valley oaks and black oaks on the plain east of the Laguna.

Numerous surveyors recorded the presence of “white oaks” (valley oaks), black oaks, and “scattering oak timber” on the eastern side of the study area (Fig. 26; Whitacre 1853, Gray 1857, Millington 1865). In contrast, vernal pool complexes, like wet meadow and other seasonal wetland types, were generally not mentioned in early surveys.

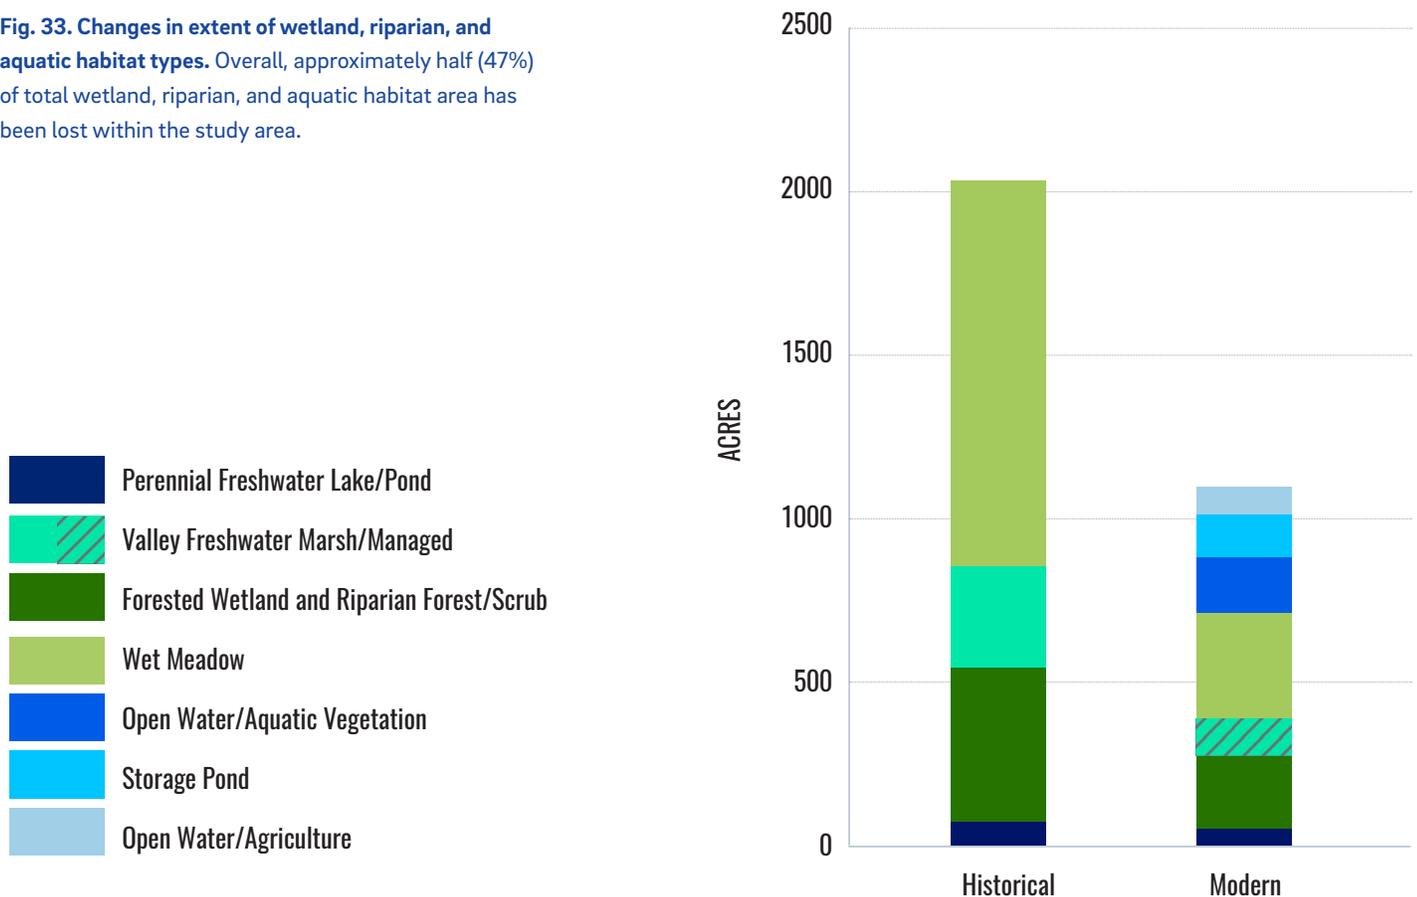
Fig. 33. Changes in extent of wetland, riparian, and aquatic habitat types. Overall, approximately half (47%) of total wetland, riparian, and aquatic habitat area has been lost within the study area.

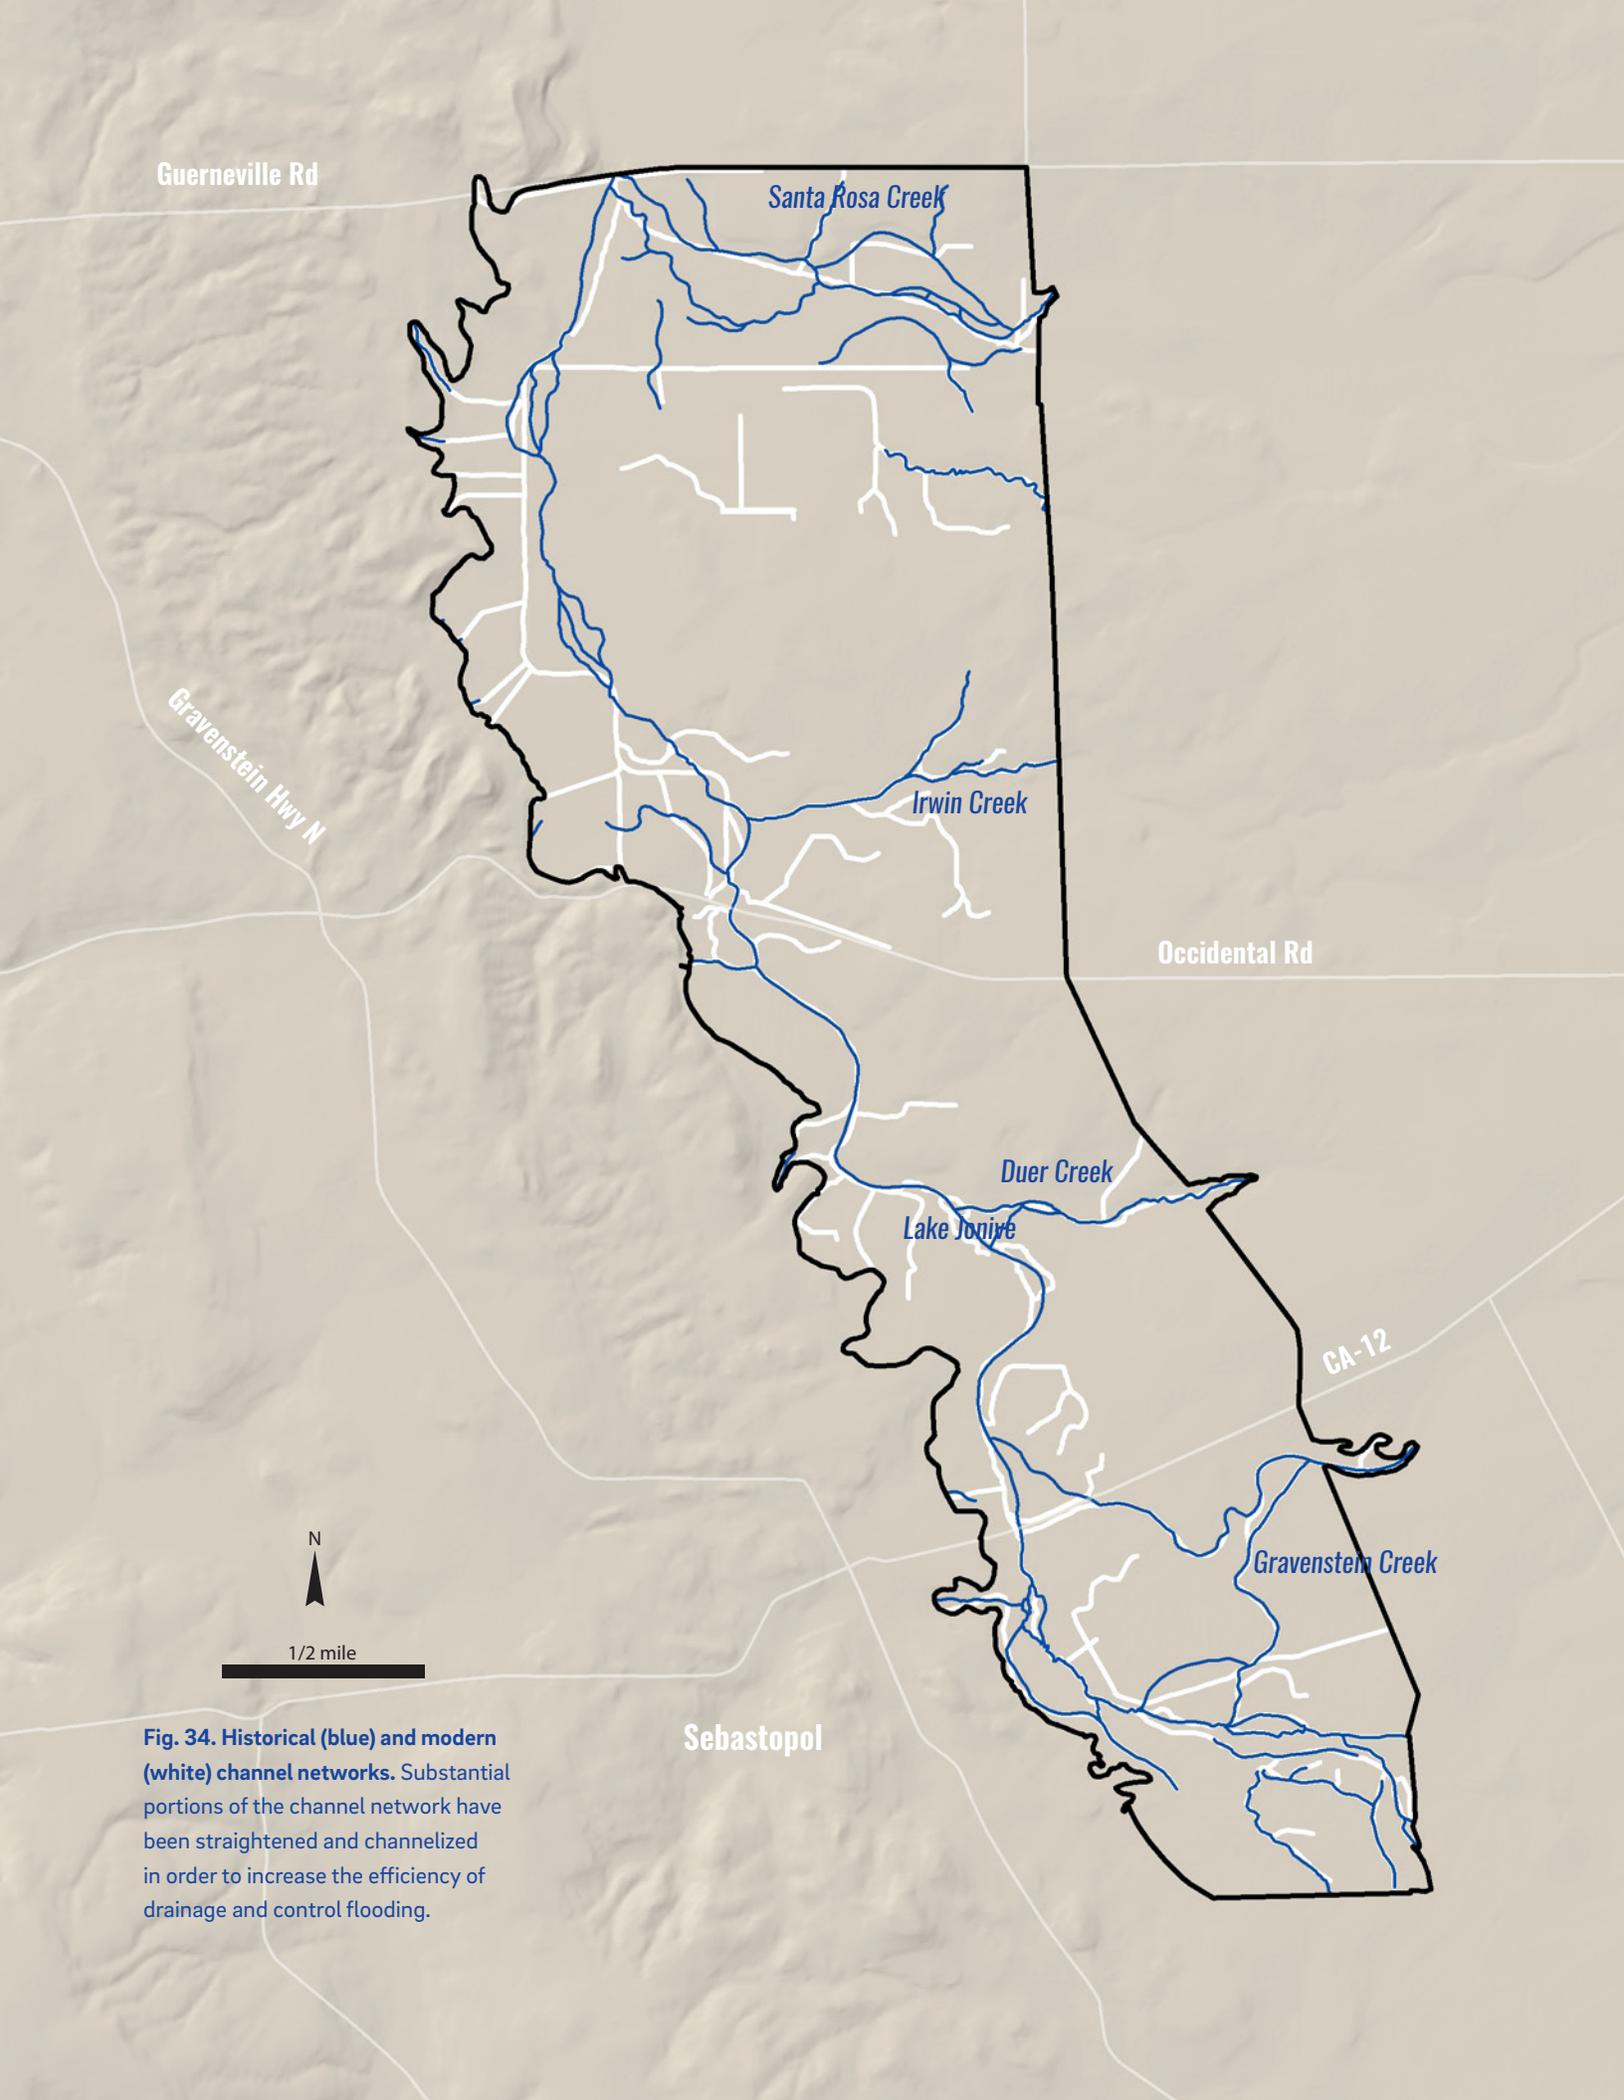
Fig. 34. Historical (blue) and modern (white) channel networks. Substantial portions of the channel network have been straightened and channelized in order to increase the efficiency of drainage and control flooding.

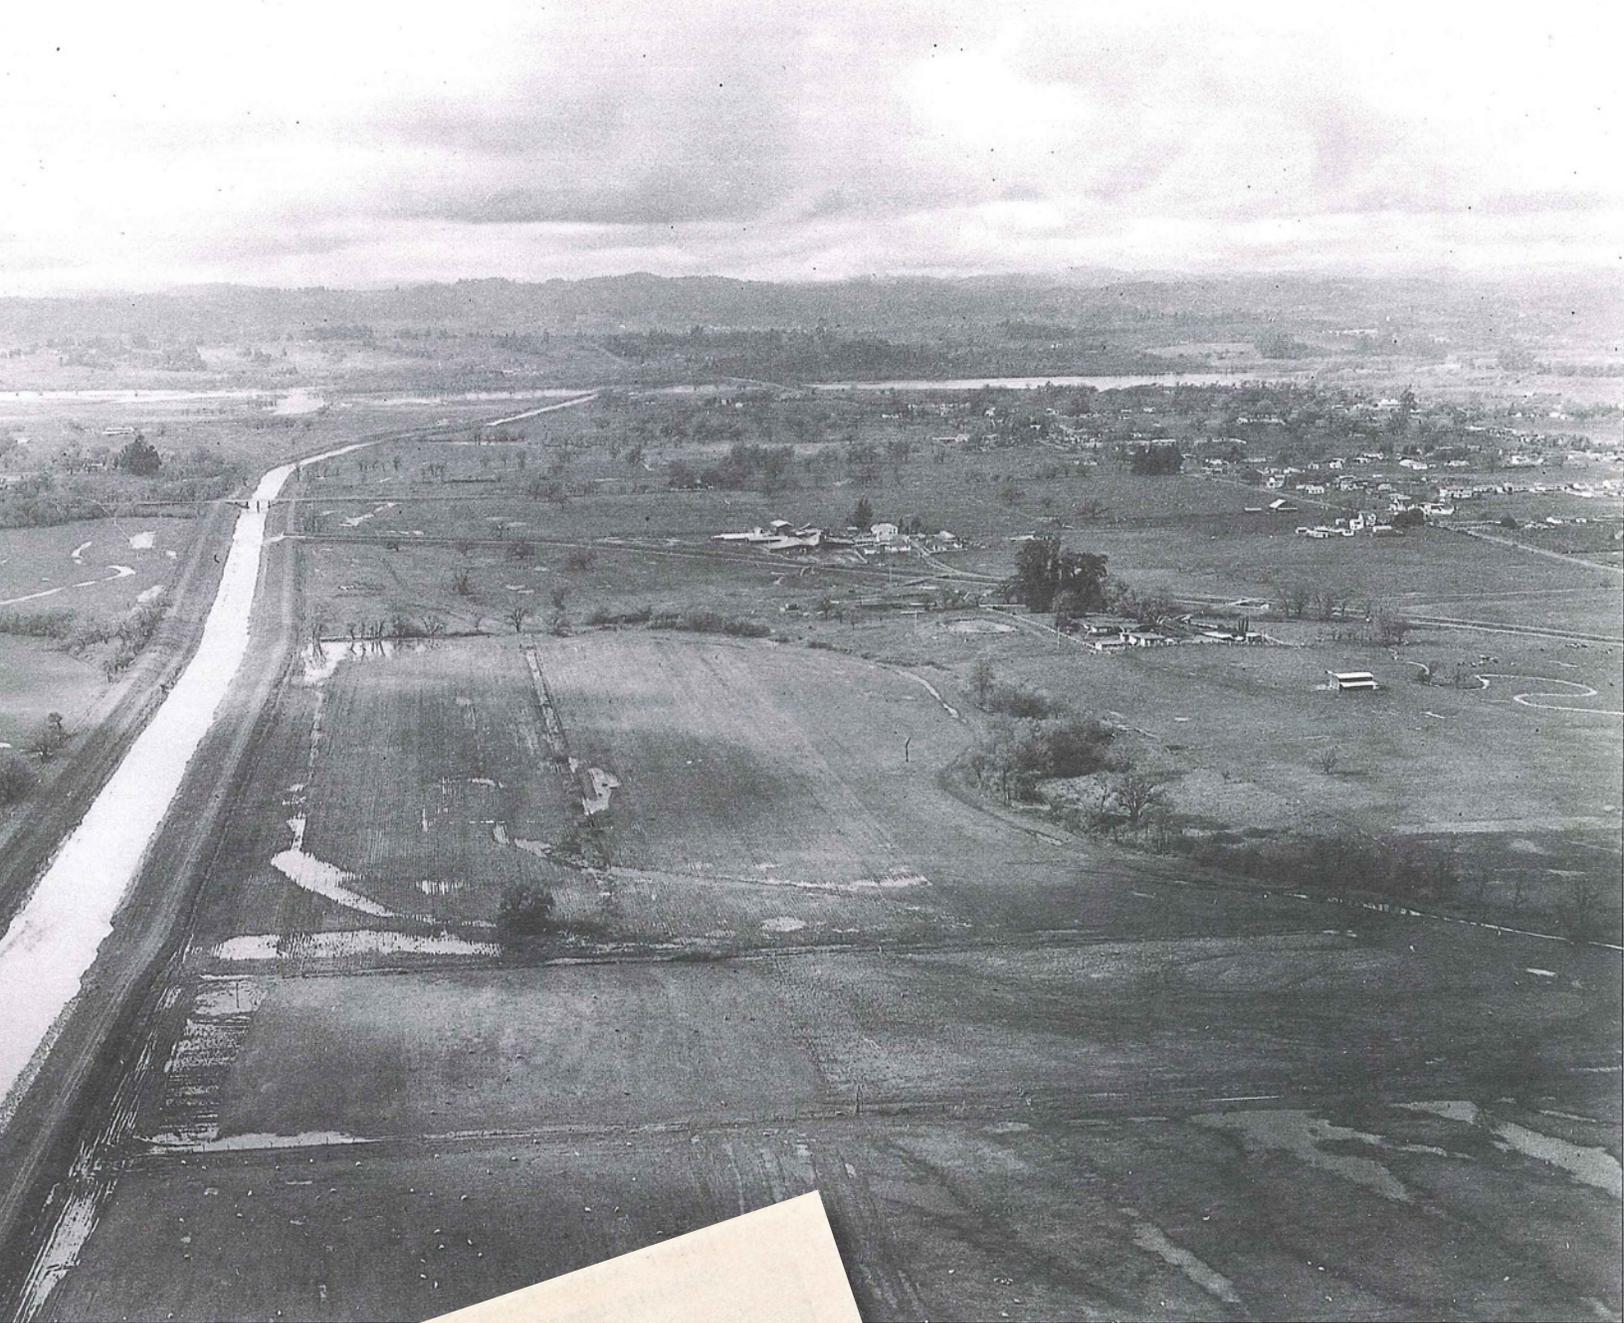
Fig. 35. Construction of the Santa Rosa Creek Flood Control Channel (bottom) in 1964, and completed channel (top) in 1967 looking west towards Laguna. (Top: Print no. 0-3, Location = "Wendell Prop"; Bottom: Photo #999, "Unit No. 2 Santa Rosa Creek Channel Lower Channel 3 construction"; both courtesy of Sonoma County Water Agency)

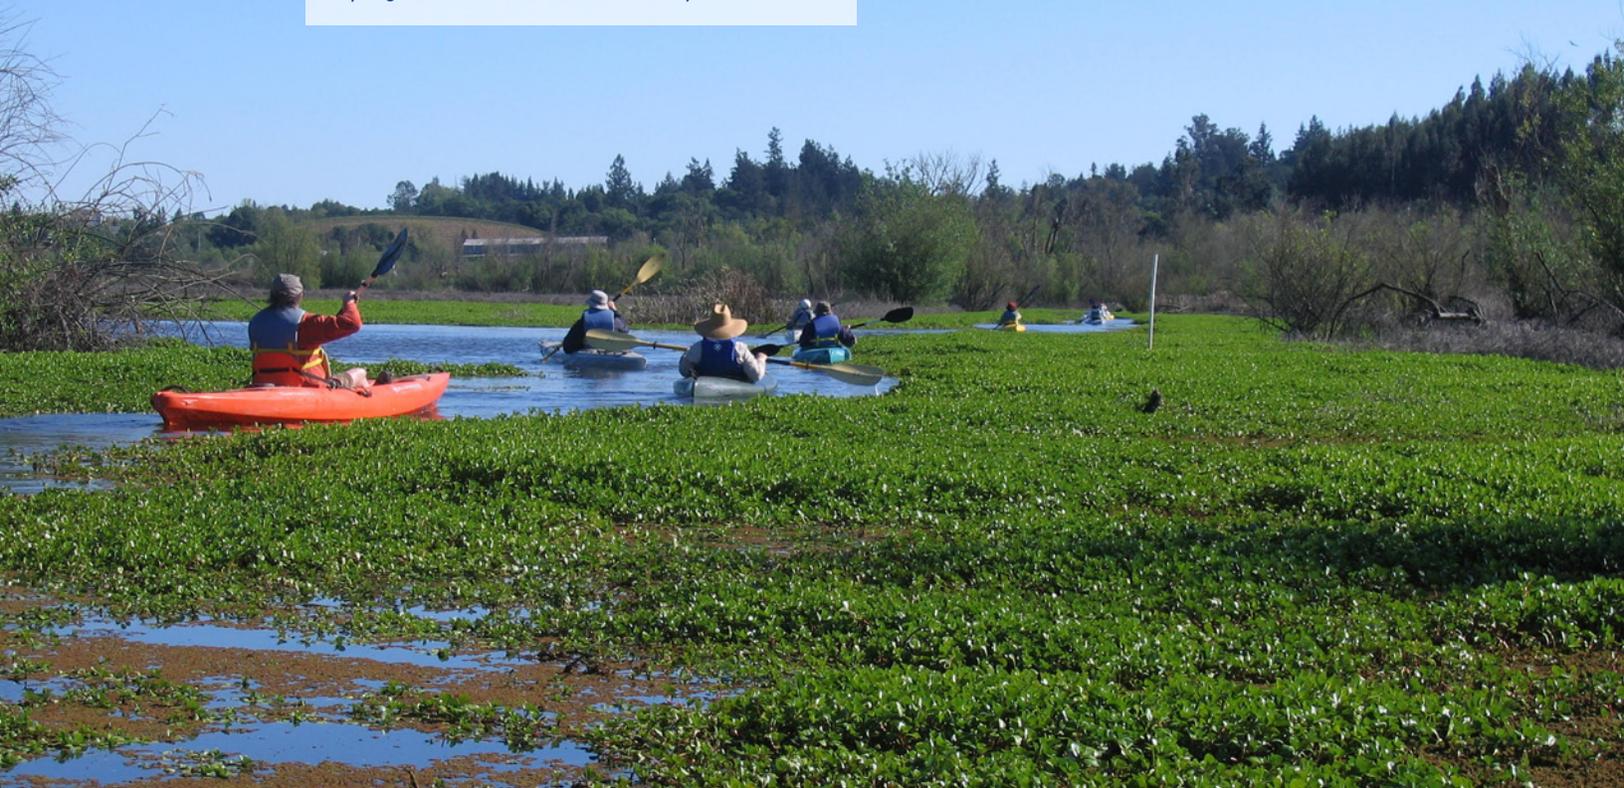
Fig. 37. The spread of invasive *Ludwigia* over large areas of the Laguna has been driven in part by increased nutrient loads, along with changes in hydrology and sediment dynamics (TetraTech 2015a). *Ludwigia* is visible in the Laguna between Occidental Road and Guerneville Road in this 2006 photograph. (Photo by Julian Meisler, 2006, courtesy of Laguna de Santa Rosa Foundation)

Historical changes to the drainage network, along with changes in wetland extent and distribution, have cumulatively had major implications for water quality in the Laguna. This is particularly true given the broader land use changes that have occurred within the watershed, such as the establishment of dairies and other agricultural enterprises and the discharge of treated wastewater, which have increased external nutrient loading rates to the Laguna (Morris 1995).¹ Butkus (2013) estimates that nitrogen and phosphorus inputs to the Laguna are 4–6 times higher today than they were during the pre-settlement era. Increased nutrient loading has significantly impacted habitat quality, and, along with hydrologic changes, the increased nutrient availability (and in particular, the elevated levels of phosphorus) is likely a primary factor driving the invasion by *Ludwigia* (Fig. 37) and other non-native aquatic plants (Baye 2008, Fitzgerald 2013, TetraTech 2015a).
