MONTECITO STREAMS VICINITY OF MONTECITO SANTA BARBARA COUNTY, CALIFORNIA

PREPARED FOR
SANTA BARBARA COUNTY FLOOD CONTROL AND WATER CONSERVATION DISTRICT
BY THE
DEPARTMENT OF THE ARMY, LOS ANGELES DISTRICT, CORPS OF ENGINEERS
LOS ANGELES, CALIFORNIA

JUNE 1974

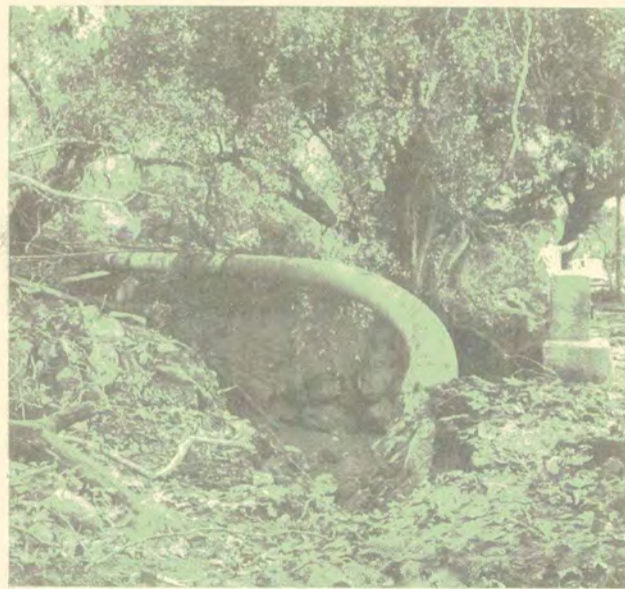
High pressure gasoline near Mountain Drive bent by the force of the 1964 floodflows from San Ysidro Creek.

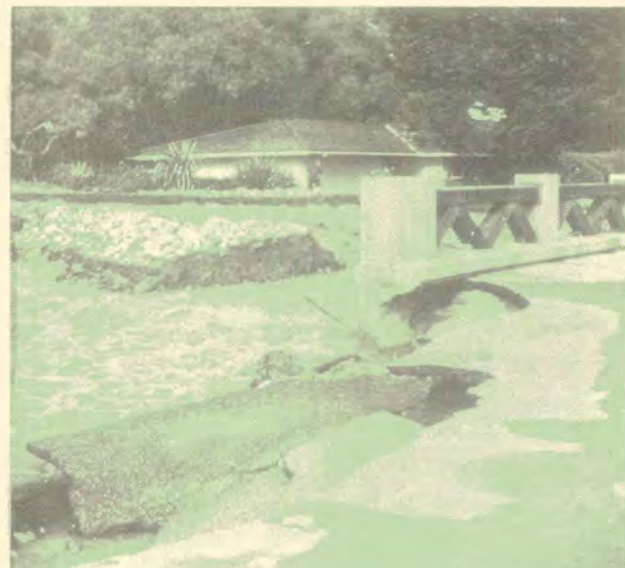
Channel filled with debris during 1969 flood forcing flow from San Ysidro Creek out of the banks.

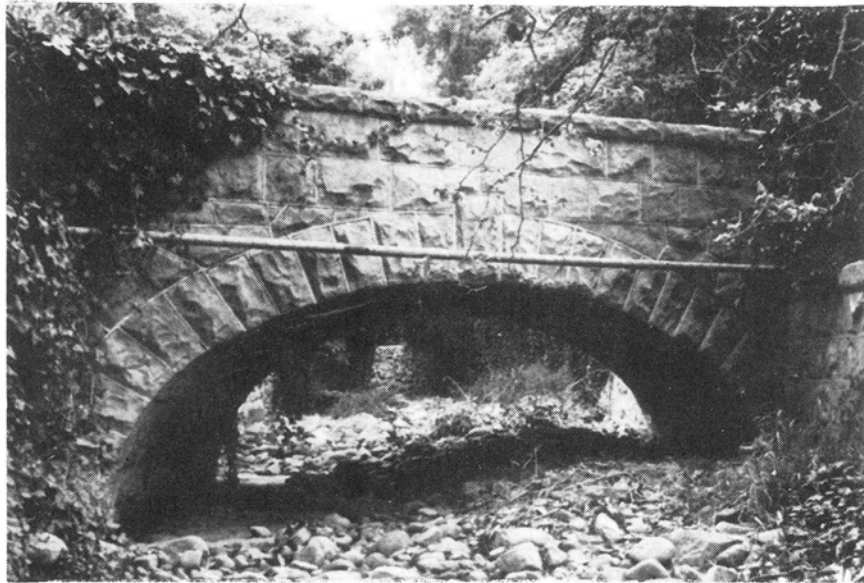
Figure 2 — Romona Lane bridge over Oak Creek (looking upstream at river mile 0.54).

In general, obstructions restrict floodflows and result in overbank flows and unpredictable areas of flooding, destruction of or damage to bridges and culverts, and increased velocity of flow immediately downstream. Debris-laden flows from steep areas may deposit their load in the channel as they reach milder slopes and flood adjacent areas that otherwise would not have been flooded. The major obstructions to floodflows in the study area are listed in table 3 and a few major representative structures are shown in figures 1 through 8.

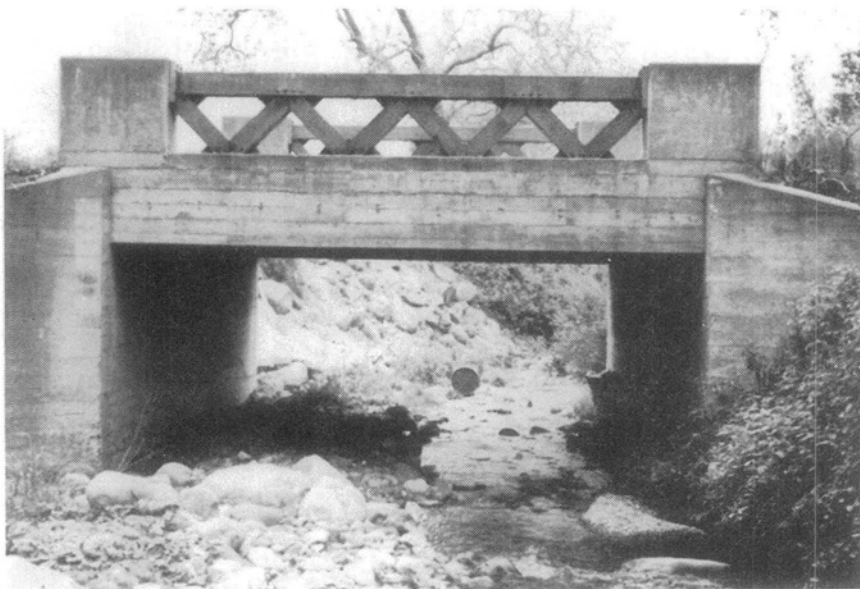
Figure 3 — Sheffield Drive bridge over Romero Canyon Creek (looking downstream at river mile 0.74).

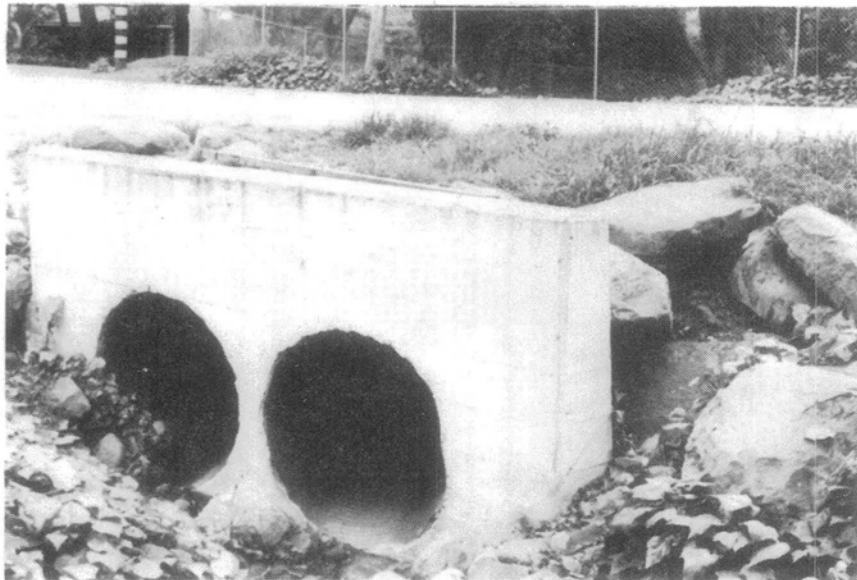
Figure 4 — East Branch Buena Vista Creek culvert at Veloz Drive (looking downstream at river mile 1.33).

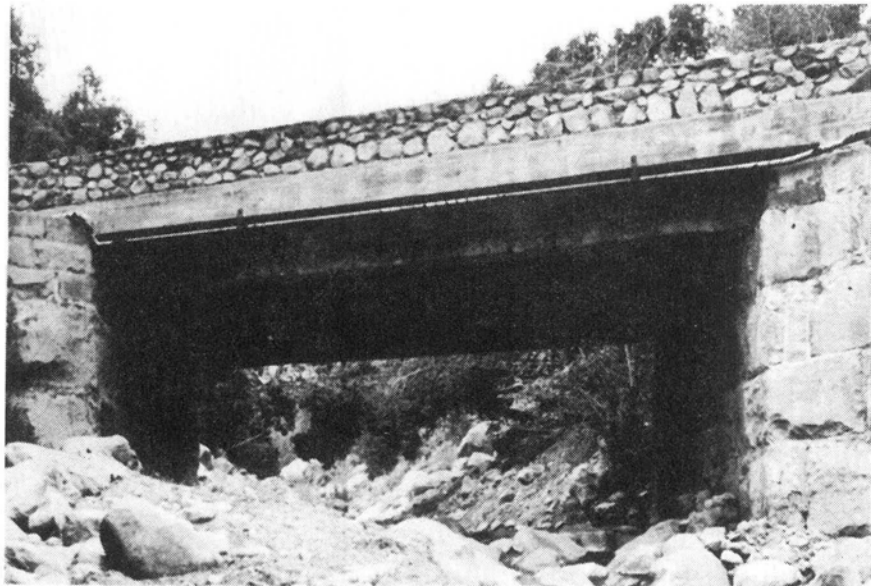
Figure 6 — East Valley Road bridge over West Branch Toro Canyon Creek (looking upstream at river mile 1.85).

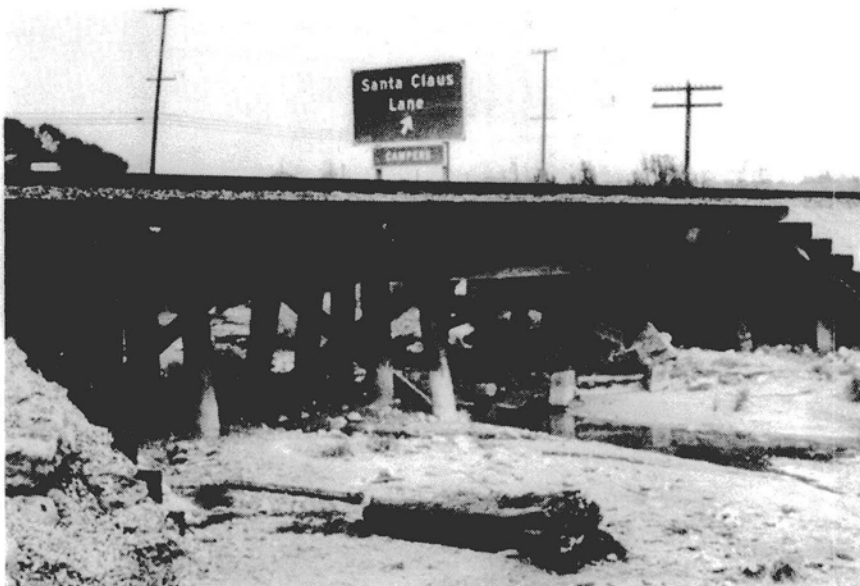
Figure 7 — Southern Pacific Railroad bridge over Arroyo Paredon (looking upstream at river mile 0.10).

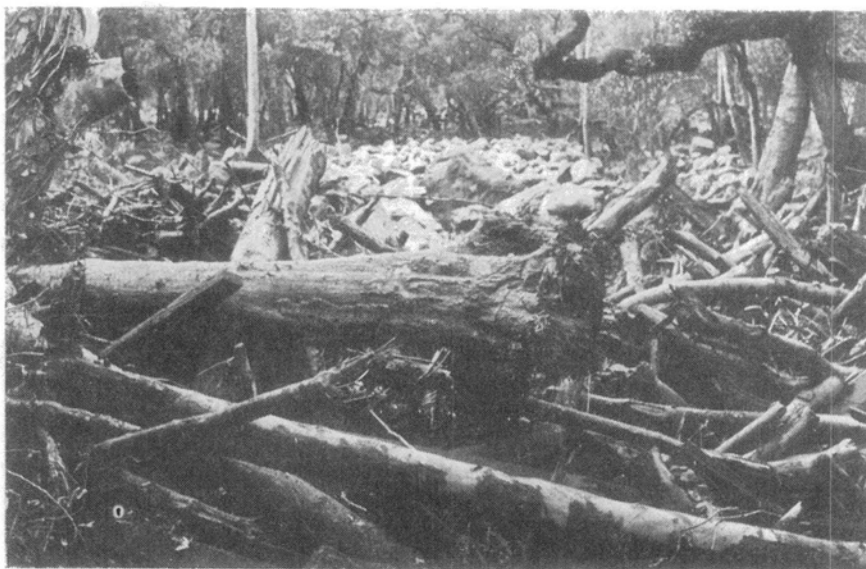
Figure 9 — Cold Springs Creek, above Ashley Road, after November 1964 flood in which debris completely filled channel.

Clogging of Hot Springs Creek by the bridge at Mountain Drive sent water, silt and debris across the road and cascading into the beautiful home community of Riven Rock Estates. The Ashley Road bridge over Cold Spring Creek, above its confluence with Hot Springs, also was clogged, contributing to the flood conditions in Riven Rock Estates.

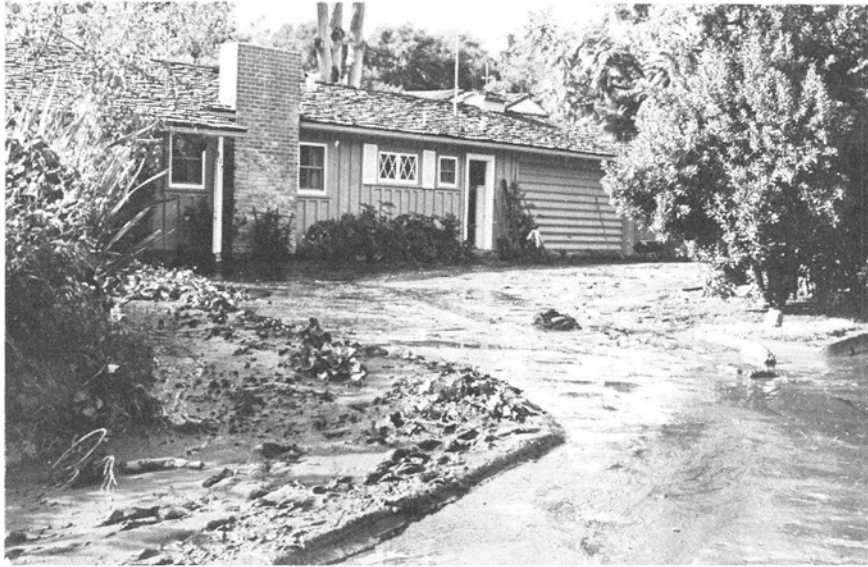
Figure 10 -- Overflow from Hot Springs Creek along Olive Mill Road during November 1964 flood.

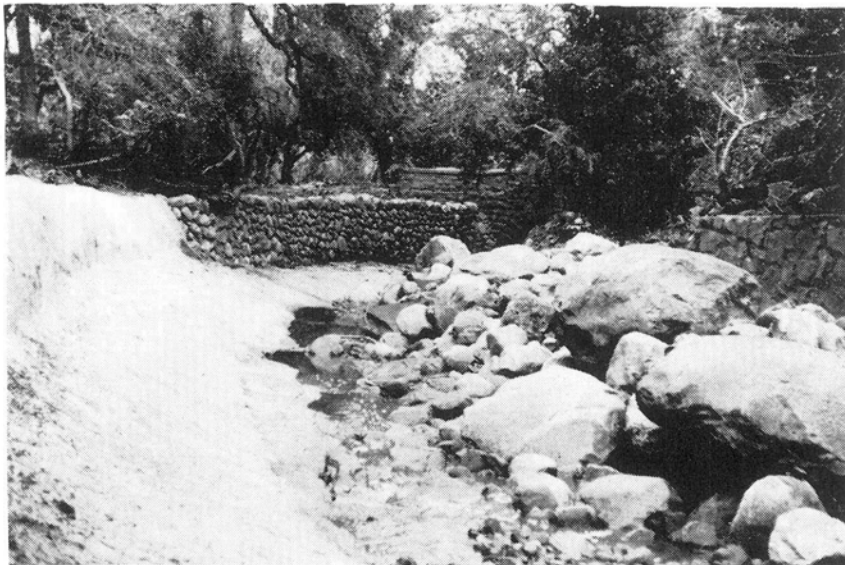
Figure 11 -- Montecito Creek, near Hot Springs Road, after November 1964 flood. Large boulders carried by the flow were deposited upstream from the bridge.

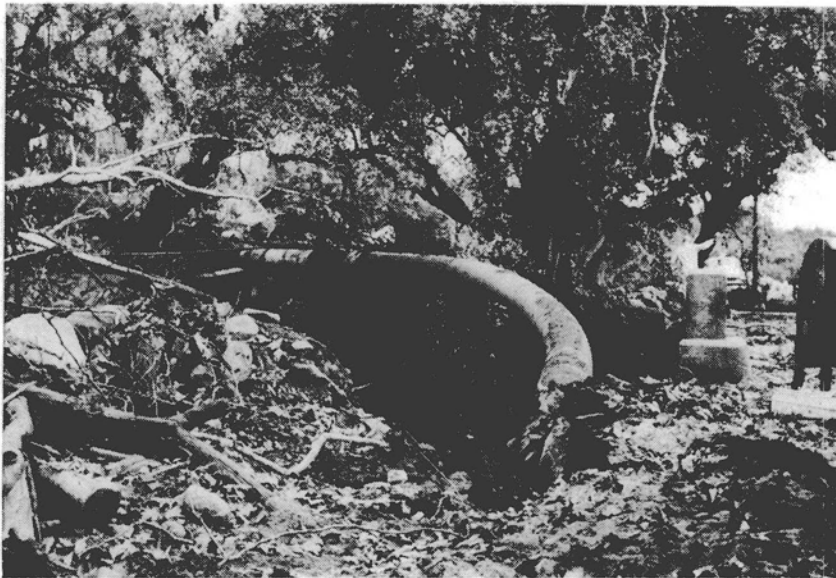
Figure 12 — San Ysidro Creek, near Mountain Drive, after November 1964 flood where a 20-inch high pressure gasline was bent by the force of the flow. Debris were carried over the bridge deck shown on the extreme right of the picture.

Gas Main Bent

A high pressure gas main was bent near San Ysidro Creek and Mountain Drive. It did not break, but officials as a safety measure turned it off.

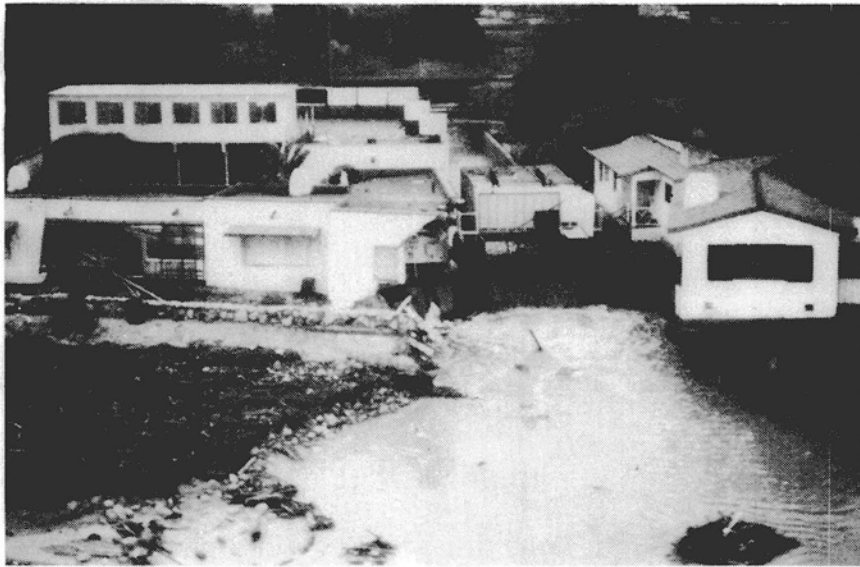
Figure 14 — Oak Creek, at the ocean, eroded its banks and undercut existing structures during January 1969 flood.

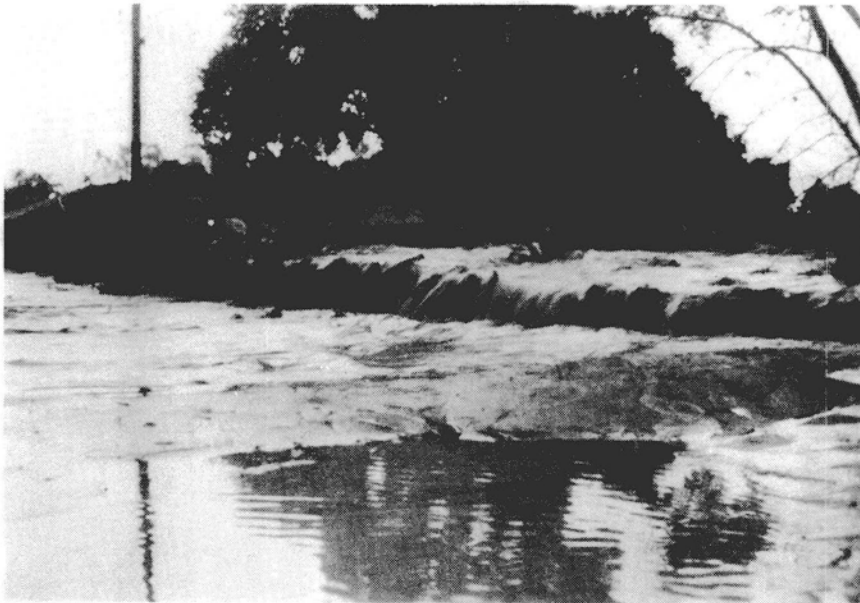
Figure 15 — San Ysidro Creek during January 1969 flood. The channel was filled with debris, forcing floodwaters out and onto La Vuelta Road where many houses were flooded.

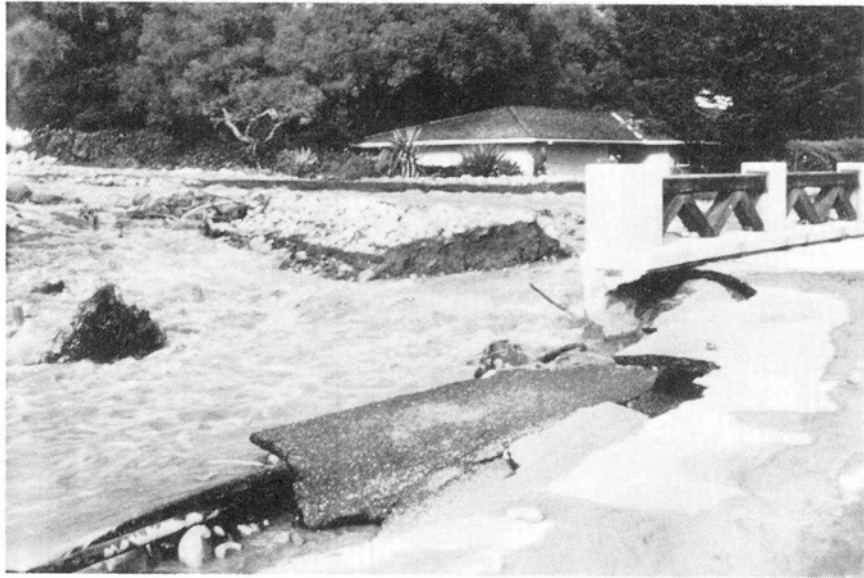
Figure 16 -- San Ysidro Creek, at East Valley Road, during January 1969 flood. The channel was filled with rocks and debris forcing flow out of the banks.

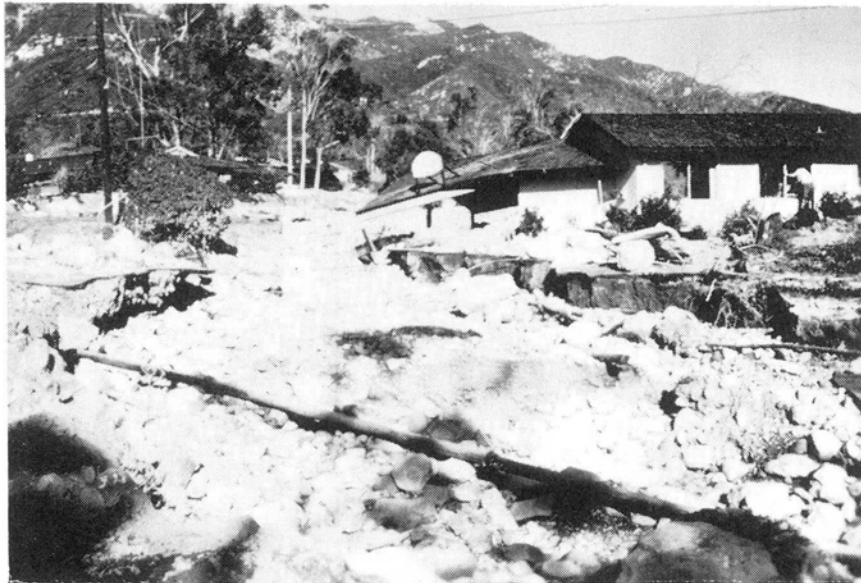
Figure 17 -- Romero Canyon Creek, near Featherhill Road, after January 1969 flood. Boulders, carried by the flow, crashed through this home and others.

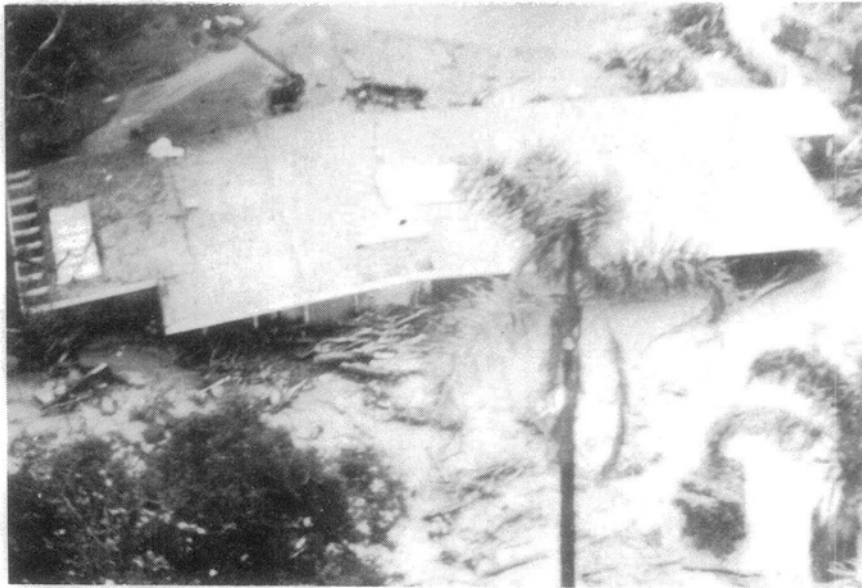
Figure 18 — Overflow from San Ysidro Creek, in the Glen Oaks area, during January 1969 flood.

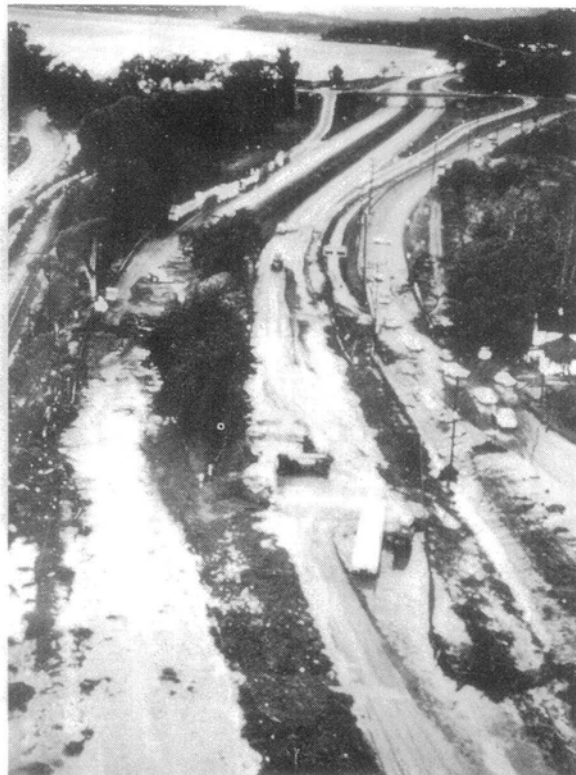
Figure 19 — View of Highway 101 and Southern Pacific Railroad flooded by overflow from Toro Canyon Creek during December 1971. (Note trucks jack-knifed on highway.) Both railroad and the highway were out of service for many hours.

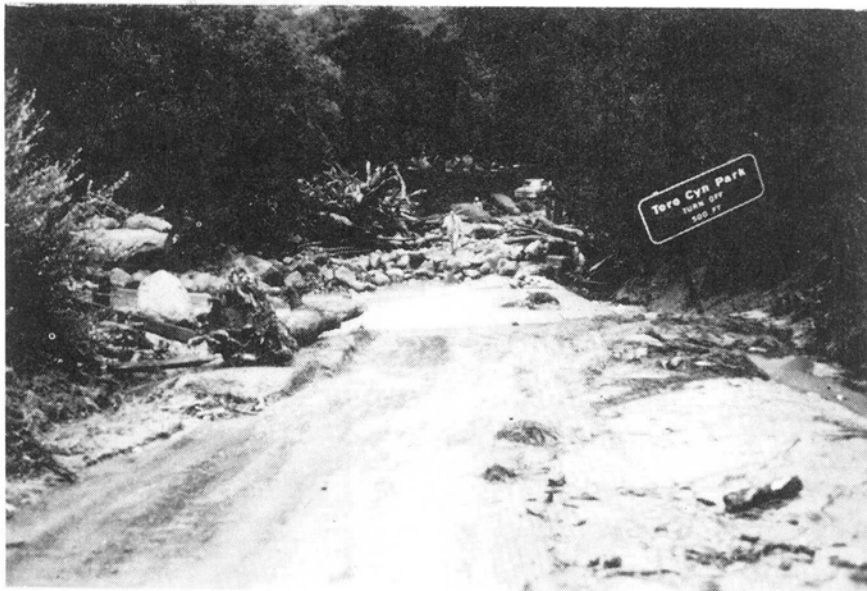
Figure 20 — Garrapata Creek, at Toro Canyon Road, after December 1971 flood.
