Department of
Water Resources

California High Water 1979-80

Bulletin 69-80
November 1981

Bulletin 69-80, the fourteenth in a series of reports on high-water in California, presents information on storms, flooded areas, and damage during the 1979-80 water year (October 1, 1979 through September 30, 1980). Included are weir overflow graphs, and hydrographs of selected stream gages and reservoir operations.

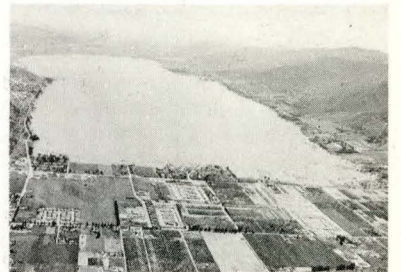
ON THE COVER: Lake Elsinore in Riverside County as it appeared in March 1980 after 80 days of heavy inflow swelled the lake to 1.75 metres (5.7 feet) above flood stage, causing some 2,000 lakefront residents to flee to higher ground.

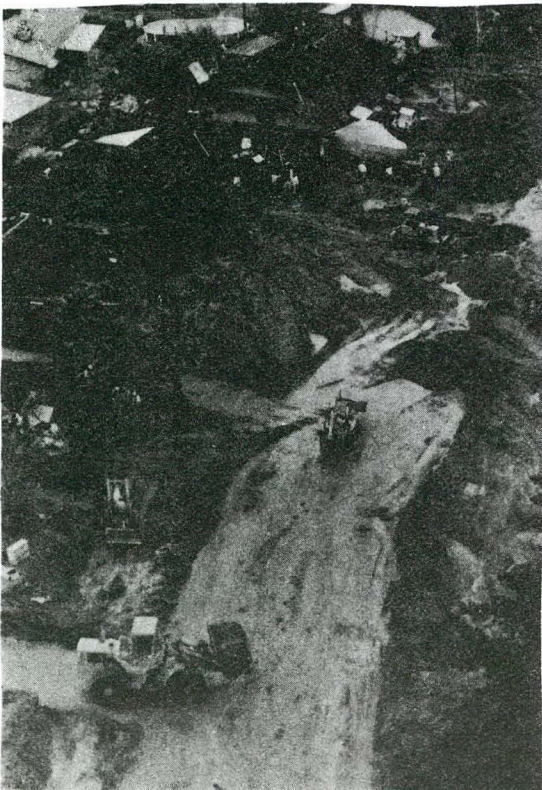
This is Hampshire Avenue as seen from a helicopter

Just above the Hampshire Avenue area is Harrison Canyon. Last summer, fires in the small, steep canyon burned the vegetation with such intense heat that even the roots of the vegetation were destroyed. Then, on January 9, before the vegetative growth could recover, a rainstorm struck the canyon. Thousands of tons of earth and debris were eroded from the denuded canyon walls, completely filling the small Harrison Canyon debris basin above the Hampshire Avenue area. Again, on January 14, before the debris basin could be cleared, intense rains brought another avalanche of mud and debris, causing the debris basin to overflow. The mud flowed onto Hampshire Avenue and damaged 28 homes. As much as 1.2 metres (4 feet) of mud filled some houses.

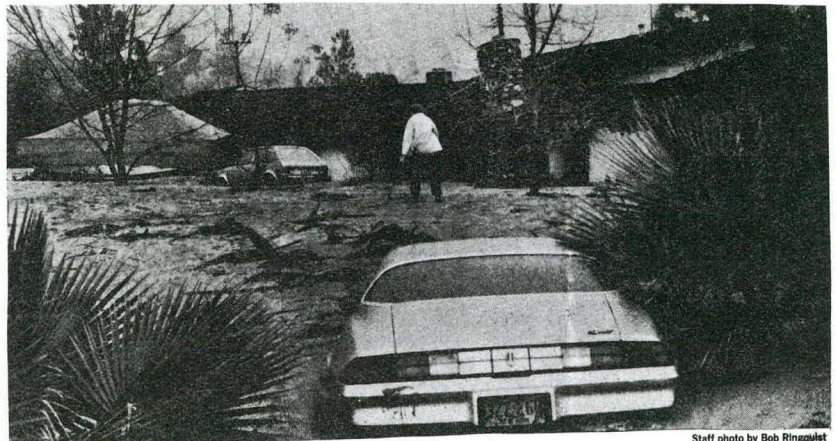
A San Bernardino police officer walks toward a house on Hampshire Road, where mud filled the street and several houses.

Once again a massive cleanup effort was launched, but on February 16, heavy rains struck the canyon and unleashed a fourth torrent of mud and water into the Hampshire Avenue area. This time, a total of 40 homes were damaged. The damage from the fourth slide was much more severe than on previous occasions, because the mud came with enough force to buckle both interior and exterior walls of the homes, to break windows and to rip doors off their hinges. Residents and volunteers were reluctant to begin cleanup efforts again.

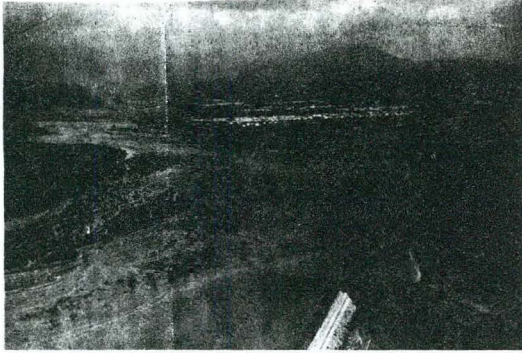
BREAKING POINT — An 1,800-foot hole tore through the San Jacinto River levee at the east end of Commonwealth avenue near Mountain avenue. Riverside Flood Control District blamed the failure on shifting sandbars, which directed the full force of the river straight into the levee. Crews are now attempting to build a rock dike around the break. (Hemet News photo)

At approximately 7 a.m., February 21, a section of levee on the San Jacinto River failed, and muddy water as deep as 1.2 metres (4-feet) flooded the town of San Jacinto. Police with loudspeakers sounded the alarm, and local emergency agencies and volunteers searched for stranded residents and pets. Helicopters hovered above the inundated areas and rescued people from rooftops. National Guard personnel assisted in the rescue work and took steps to prevent looting.

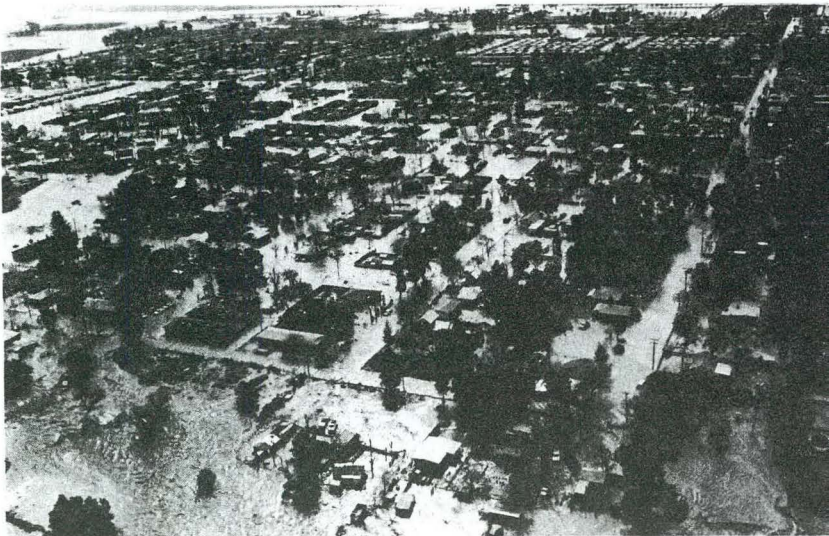
The city of San Jacinto was flooded yesterday when a levee on the San Jacinto River broke. Thousands of residents fled their homes.

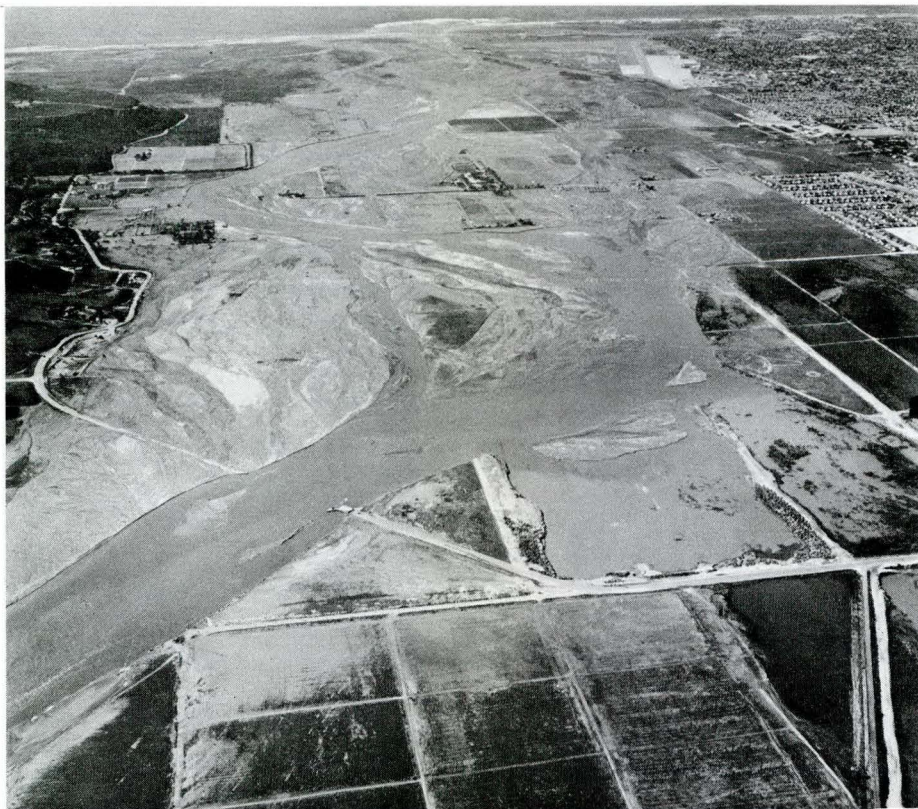
THE TIJUANA RIVER WINDS ITS WAY TO THE PACIFIC ALONG A NEW PATH AFTER JANUARY AND FEBRUARY 1980 FLOWS EXCEEDING $850 \text{ m}^3/\text{sec}$ (30,000 cfs) FORCED IT FROM ITS BANKS.

In February, flood flows occurred again, peaking on February 21 at $937 \text{ m}^3/\text{sec}$. (33,100 cfs) at the Mexican border, crossing into California. Damage estimates in California, for the January and February 1980 flooding, were \$300,000 for agricultural improvements, \$200,000 for livestock, \$300,000 for homes, \$1.1 million for roads and bridges, and \$2.4 million for farm land erosion, totaling \$4.3 million.
