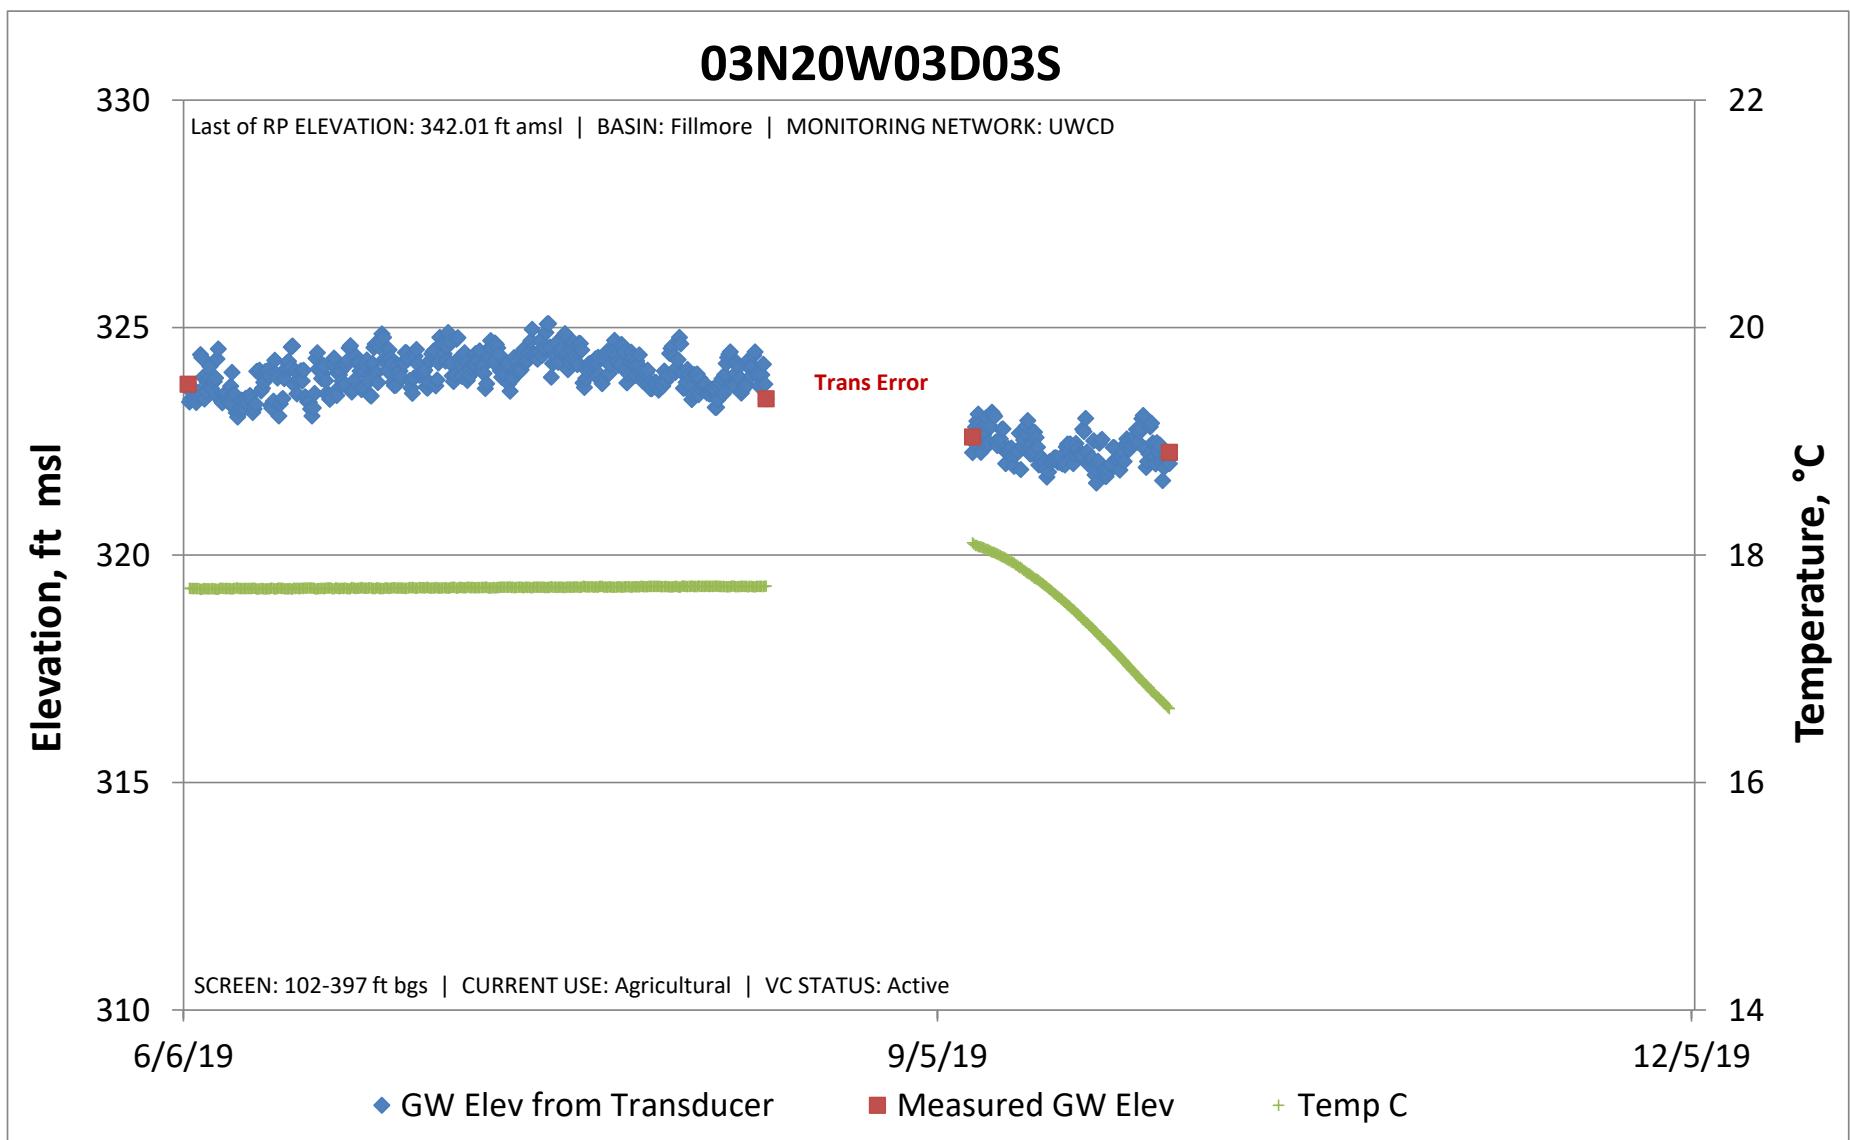
03N20W03D03S

High-Frequency Data from
Recording Pressure
Transducers

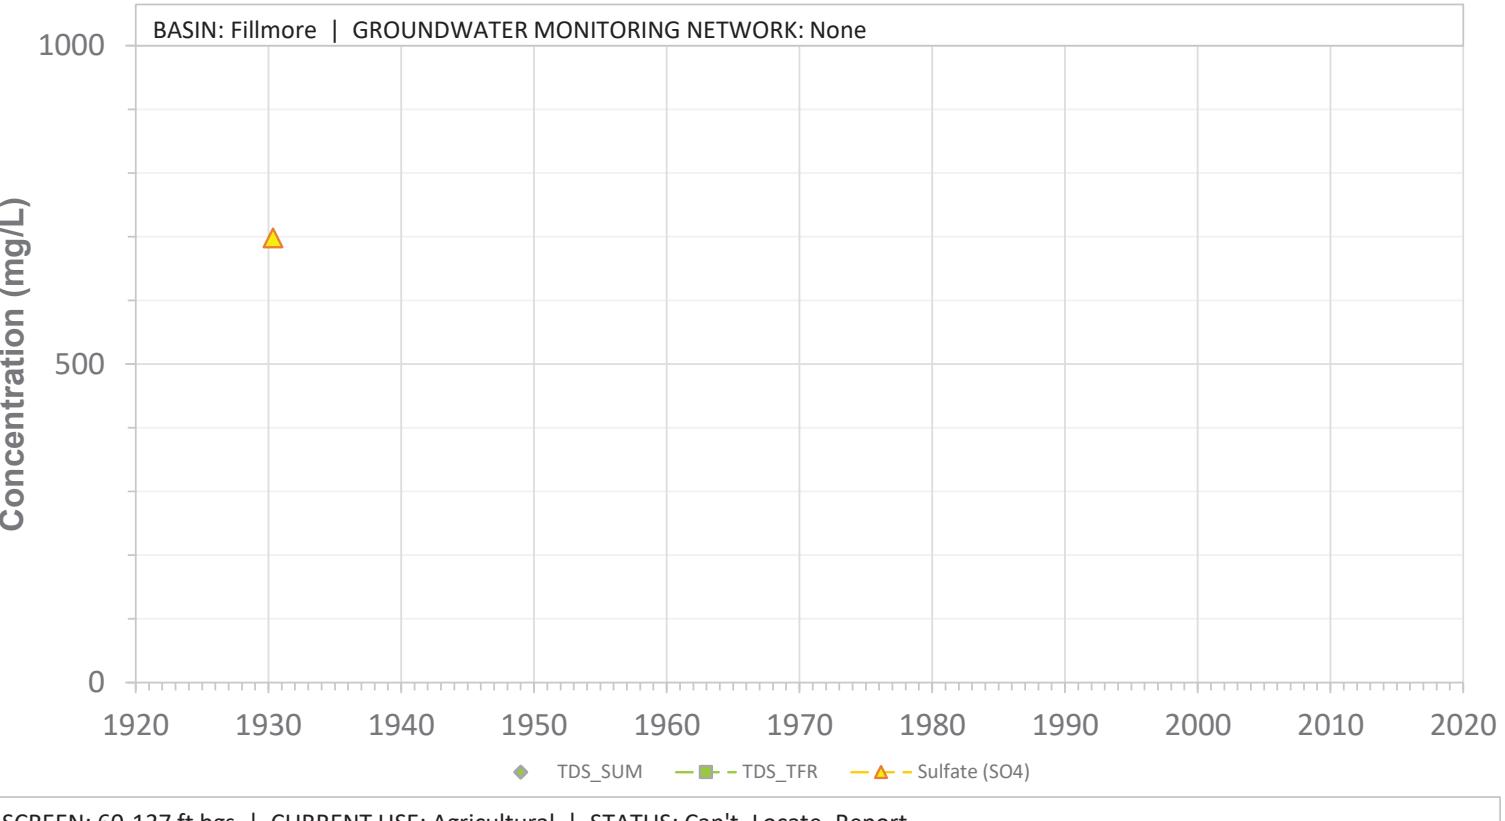
03N19W05D01S

Groundwater Quality Time-Series Graphs
