State of California
California Natural Resources Agency
DEPARTMENT OF WATER RESOURCES
Division of Engineering

CALIFORNIA AQUEDUCT SUBSIDENCE STUDY

San Luis Field Division
San Joaquin Field Division

June 2017

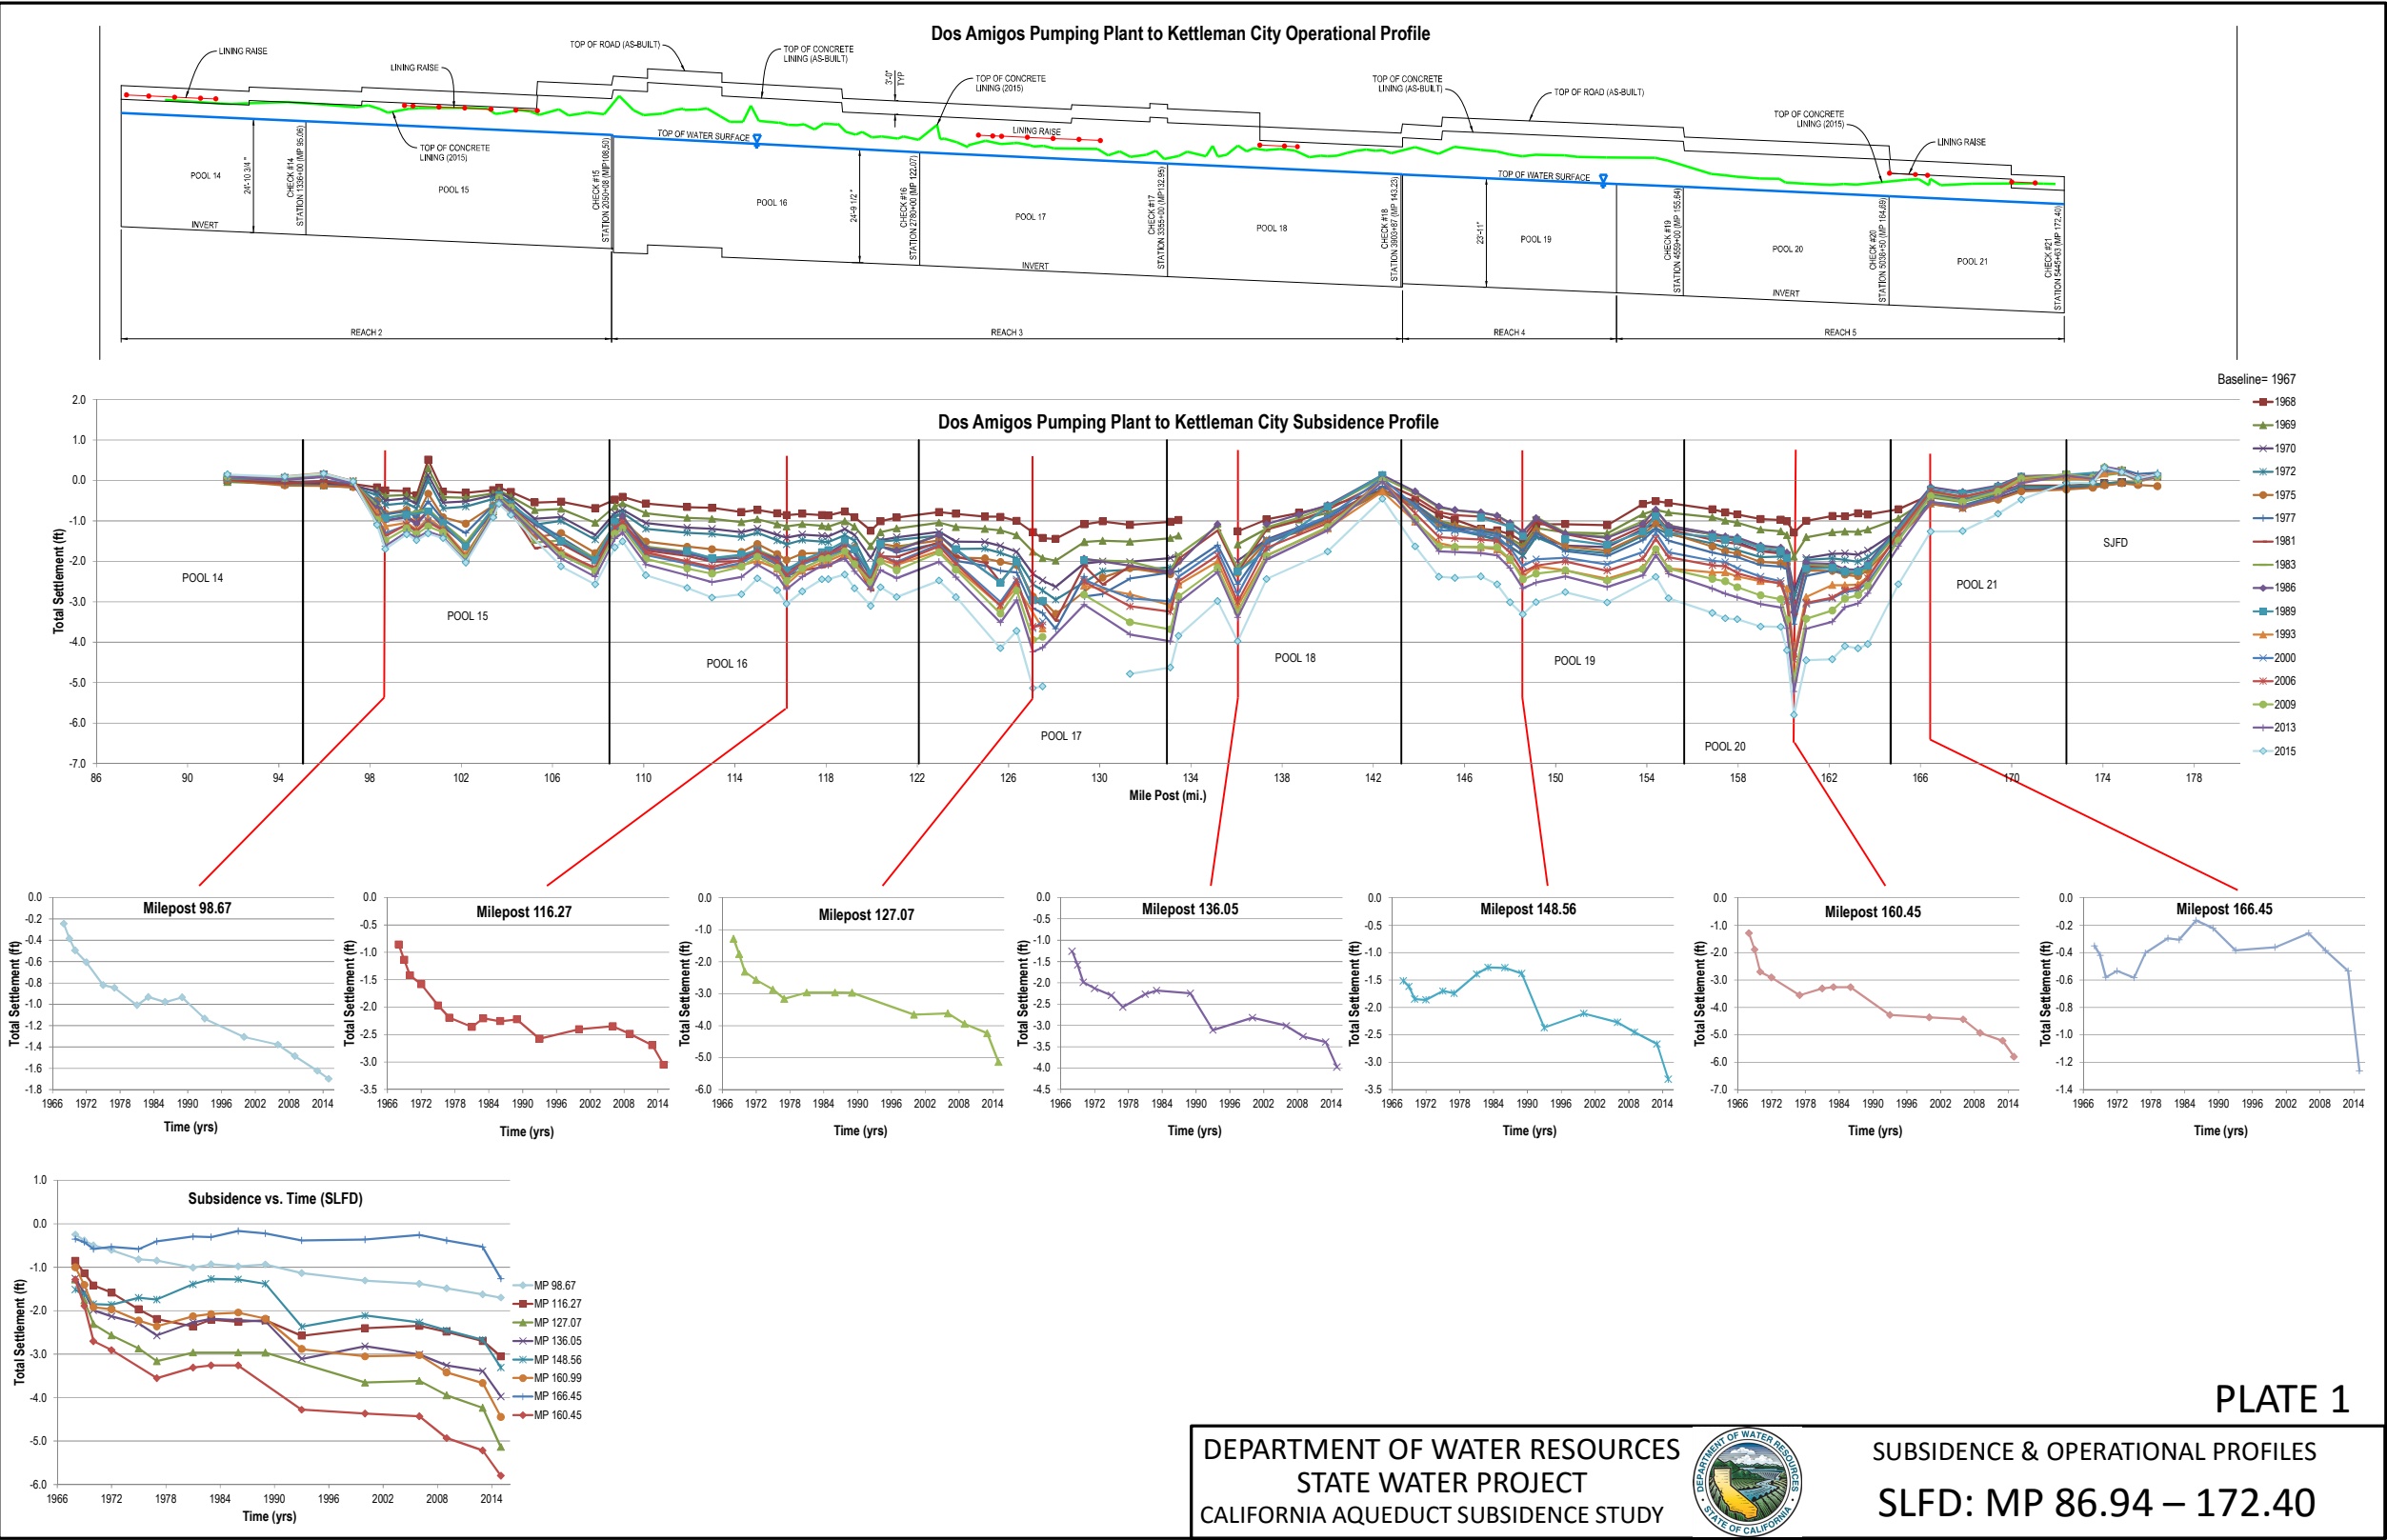
Figure 6-1 Subsidence and Operational Profiles - San Luis Field Division - Plate 1

1. A data set of 90 benchmarks, located on structures and top of the lining, was selected based on historic regional data benchmarks that were used in past subsidence studies. The yearly data of these benchmarks, identified by their milepost location, were plotted, milepost versus total subsidence in a given year, to show the progression of subsidence from 1967 to 2015. That change was calculated by subtracting a recorded elevation for a particular benchmark, at each year, from the baseline value recorded in 1967. The process was repeated for all of the benchmarks and the difference in elevation was plotted out on the y-axis, for a given milepost (x-axis). The leveling data from these benchmarks are summarized in Section 6.3 and are profiled in the subsidence profile graphs on Plates 1 through 9. Plate 1 is a plot of the SLFD. Plates 2 through 9 are plots of Aqueduct Pools 14 through 21.

2. A data set of 136 benchmarks, located on the top of the lining, was also extracted from the 940 benchmarks that were surveyed along the San Luis Canal in 2015. Their elevations were plotted on the operational profile graphs on Plates 1 through 9. They show the total subsidence that has occurred on the lining up to 2015.

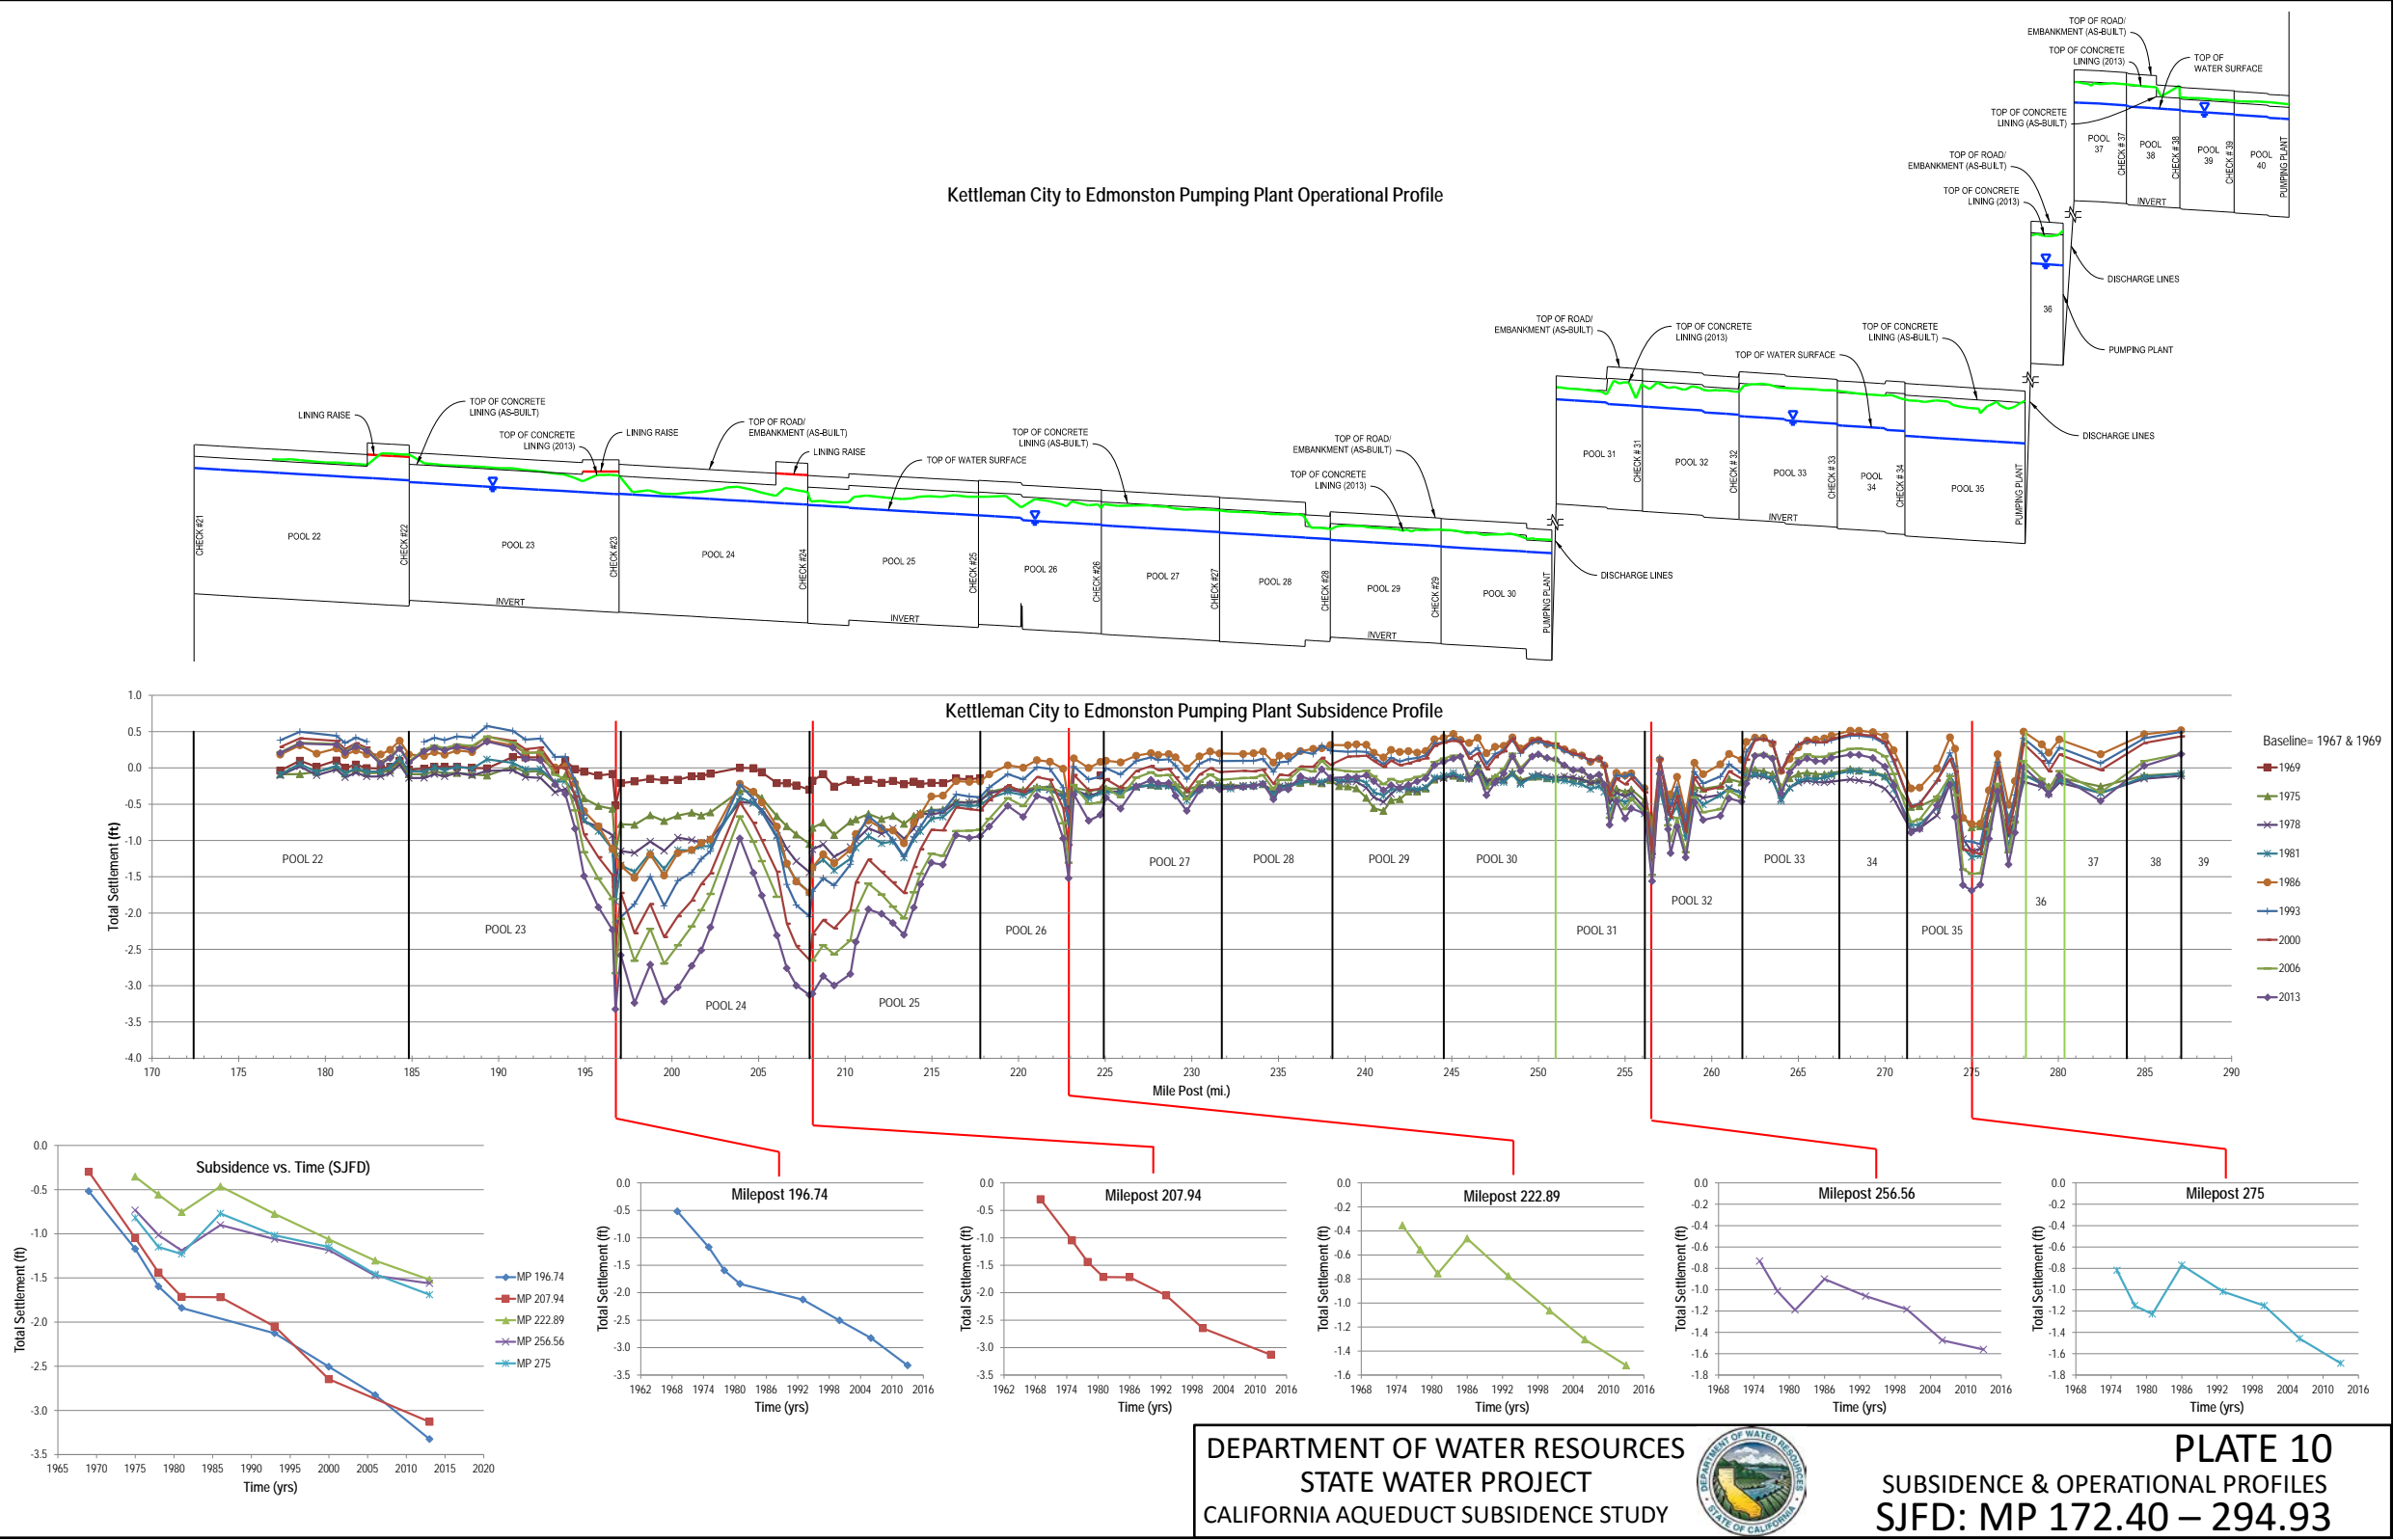
Figure 6-2 Subsidence and Operational Profiles - San Joaquin Field Division - Plate 10

1. A data set of 173 benchmarks located on structures and top of the lining, was selected based on historic regional data benchmarks that were previously used in subsidence studies. The yearly data of those benchmarks, identified by their milepost location, were plotted, milepost versus total subsidence in a given year, to show the progression of subsidence from 1967 to 2013. This change was calculated by subtracting a recorded elevation for a particular benchmark, at each year, from the baseline value recorded in 1967. This process was repeated for all of the benchmarks and the difference in elevation was plotted out on the y-axis, for a given milepost (x-axis). The leveling data from these benchmarks are summarized in Section 6.3 and as profiles on subsidence profile graphs in Plates 10 through 27. Plate 10 is a plot of the SJFD. Plates 11 through 27 are plots of Aqueduct Pools 22 through 38.

2. A data set of 249 benchmarks located on the top of the lining, was also extracted from the 1,009 benchmarks that were surveyed in the SJFD during 2013. Their elevations were plotted on the operational profile graphs on Plates 10 through 27. They show the total subsidence that has occurred on the lining up until 2013.

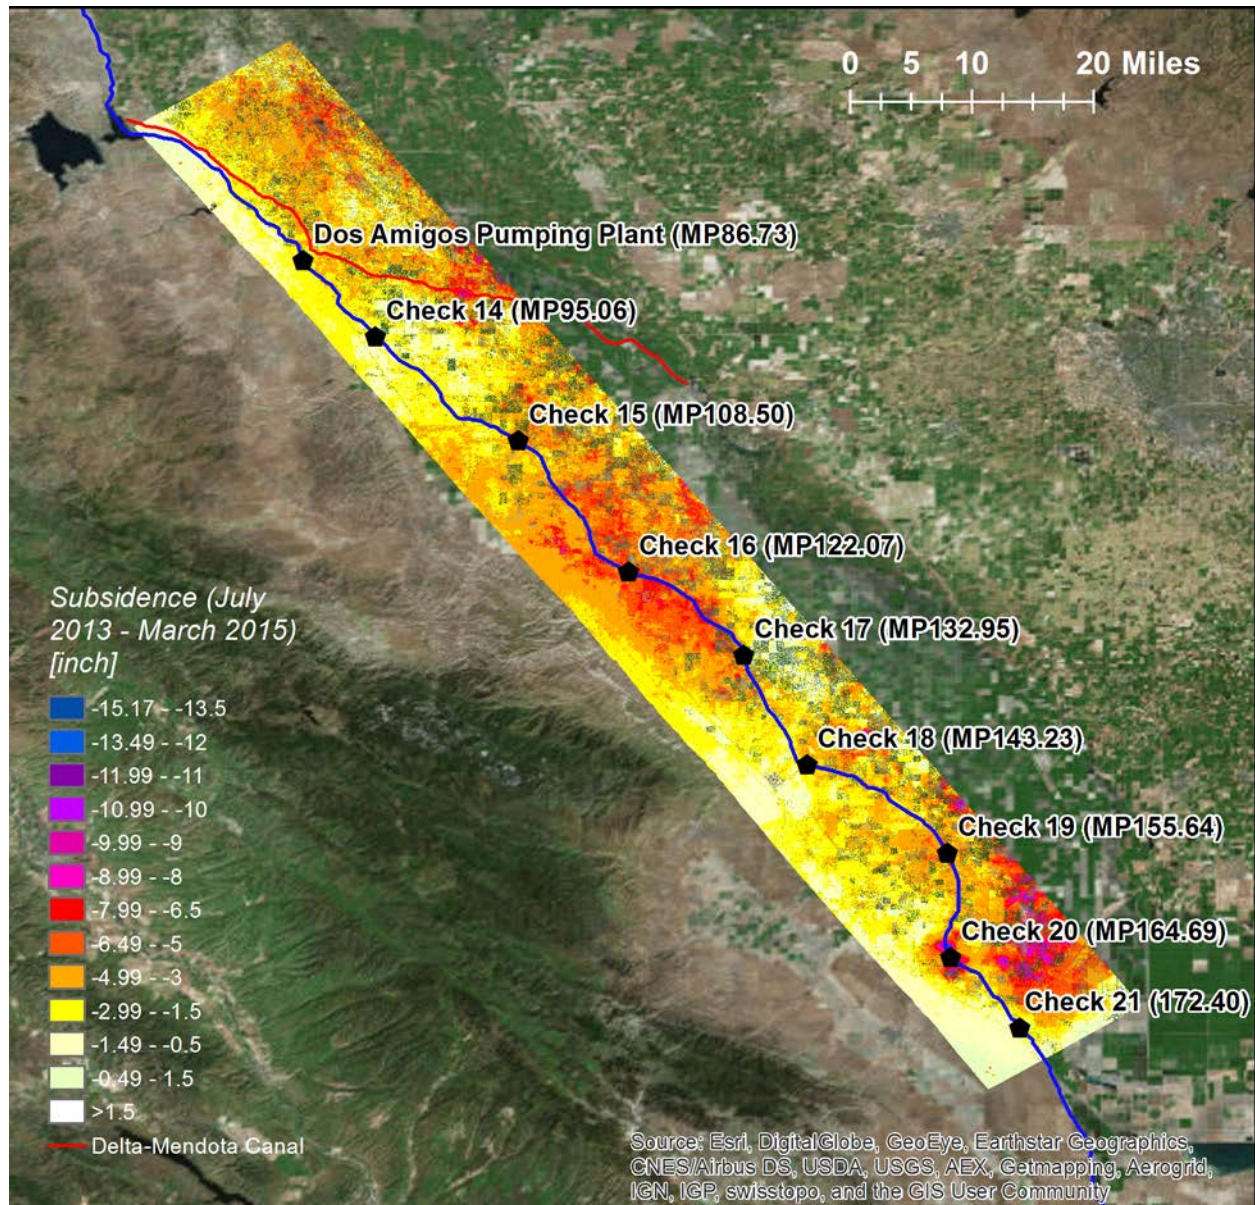
Figure 6-7 Subsidence in San Luis Field Division between July 2013 and March 2015, from UAVSAR (NASA 2015)

There were 11 flights along the SLFD flight line from July 2013 to March 2015 which produced 10 sets of interferograms showing the progression of subsidence. Figure 6-7 shows the estimated subsidence between July 2013 and March 2015, from O'Neill Forebay to Kettleman City, in yellows (-1.5 inches to -3.0 inches), oranges (-3.0 inches to -5.0 inches) and reds (-5.0 inches to -8.0 inches). There were seven flights along the SJFD flight line between April 2014 and January 2015, which produced six sets of interferograms. The SJFD flight line covers the area approximately between Mileposts 215 and 292. Figure 6-8 shows the estimated subsidence between April 2014 and January 2015, which show areas of green (-3 inches to -4 inches) and light blue (-4 inches to -5 inches); but, those areas are in the Buena Vista Lakebed area. All 16 interferograms produced for the NASA study have been transferred to DWR in raster format for use in this study and future studies.

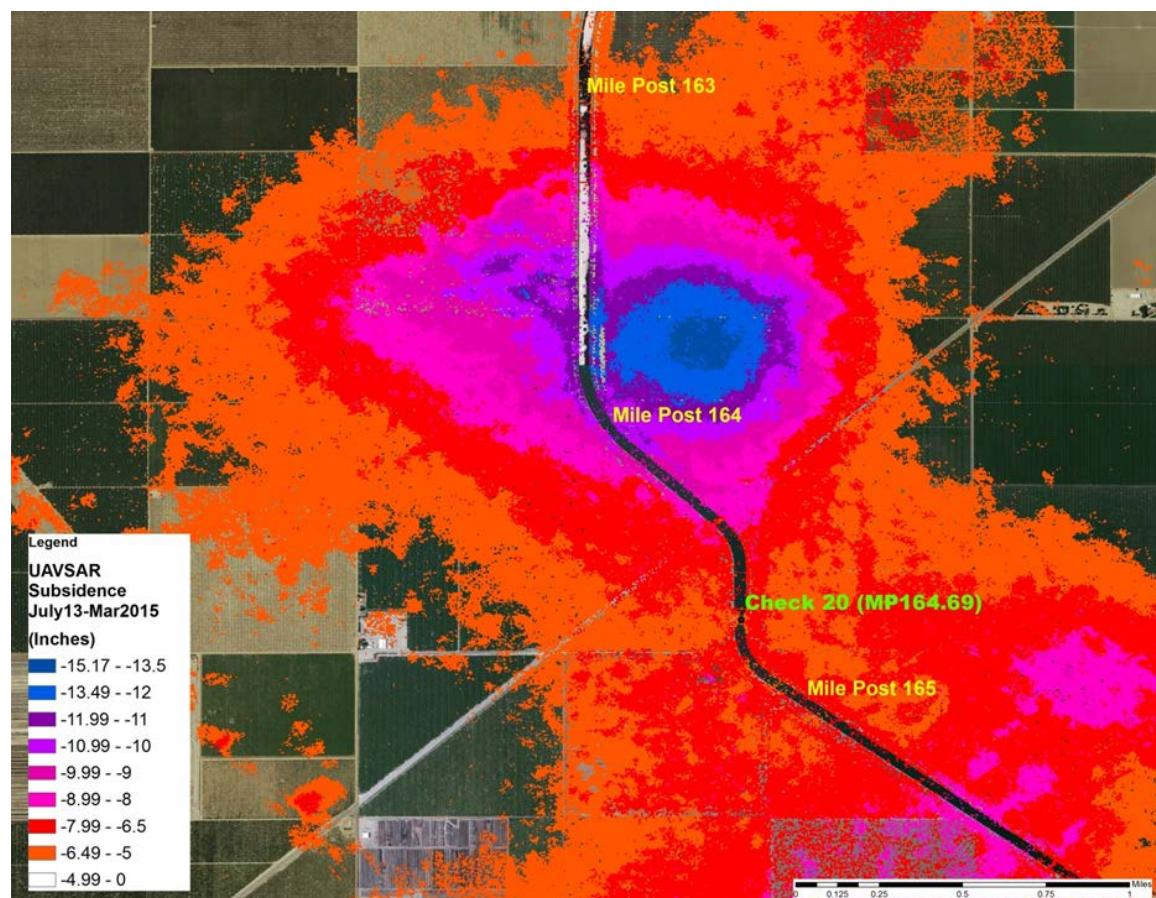
Figure 6-9 Avenal Cutoff Subsidence Hotspot – Plan

After the creation of the first few sets of UAVSAR interferograms in the SLFD, an area was noticed near Avenal Cutoff Road, Milepost 163.69, which had significantly more subsidence than the surrounding area. It was a distinct “hotspot” bowl of subsidence centered approximately 1,500 feet east of the Aqueduct.

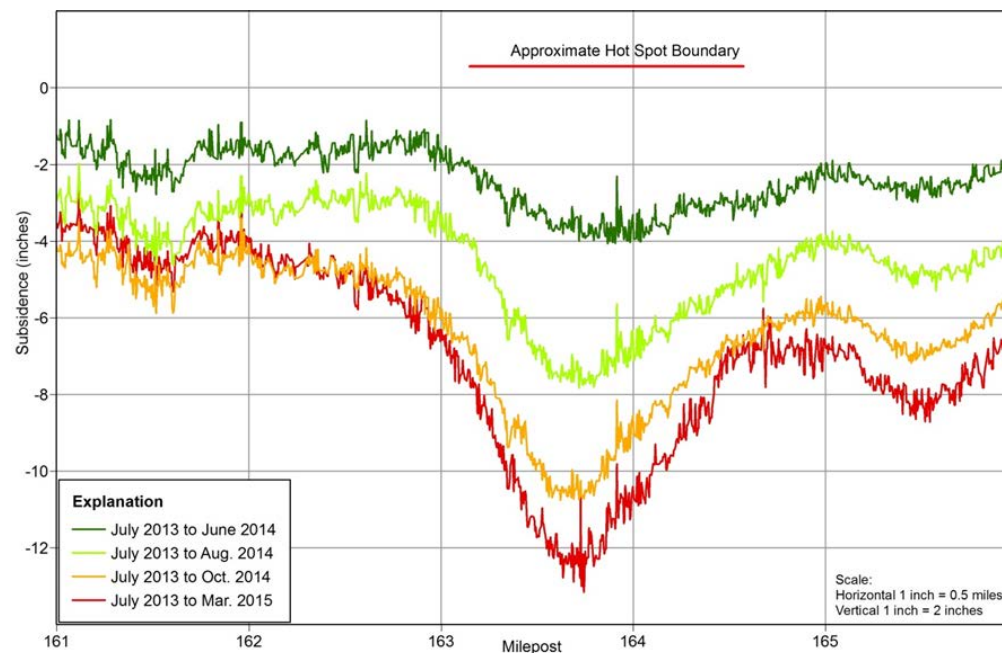
Figure 6-10 Aqueduct Subsidence Profile at Avenal Cutoff Hotspot

To illustrate the increase in subsidence over time, a profile was created along the eastern side of the Aqueduct for each interferogram. They were combined in Figure 6-10 to show the progression of the cumulative subsidence. When the times between datasets are taken into account, the most subsidence occurred from June 2014 to August 2014 (the space between the dark green line and the light green line).

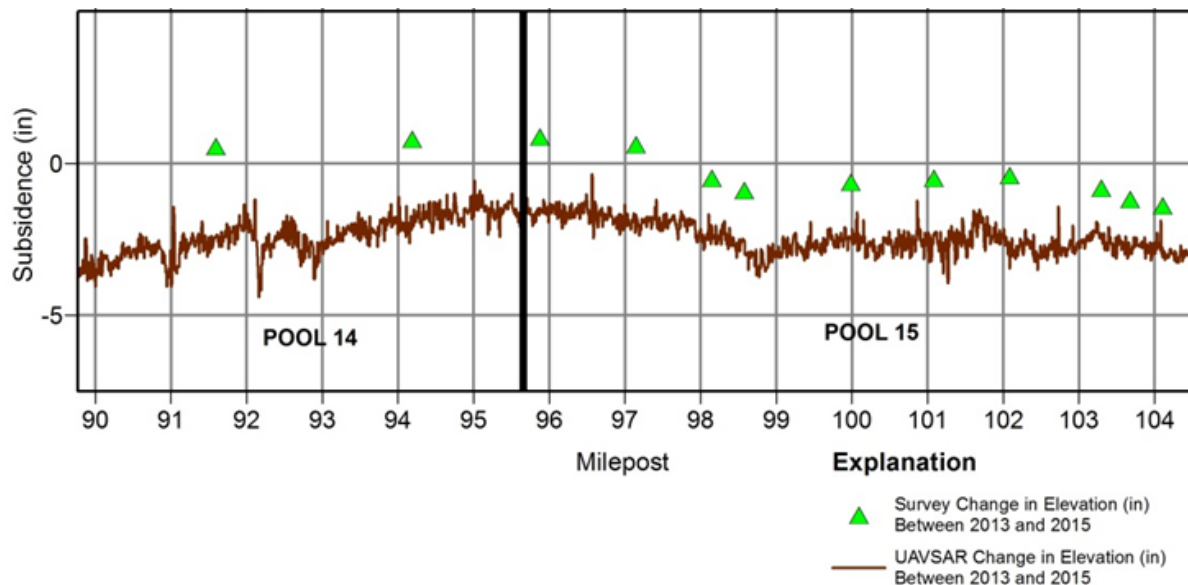
Figure 6-11 Comparison of UAVSAR and Survey Data Subsidence in Pools 14 and 15 (from Plate 30)

- The differences between the data seem to be a constant percentage between the two sets of data.
- The UAVSAR data between the survey data points show, for the most part, linear trends. There are no spikes or troughs between the data points. That indicates that a linear interpolation between the survey points is a reasonable assumption.

The reasons for the differences between the survey data and UAVSAR data may be because of numerous factors:

- The cell size of the UAVSAR data averages all the elevation points in the cell. In that case the Aqueduct embankment, field, and water-elevation data may be averaged.
- The lack of UAVSAR data at some points because of data gaps or no change in the elevation because water surface elevations remained relatively constant.
- The uncertainty of the UAVSAR data ranges between 0.13 inch and 0.80 inch, which is a factor of processing and conditions during acquisition.

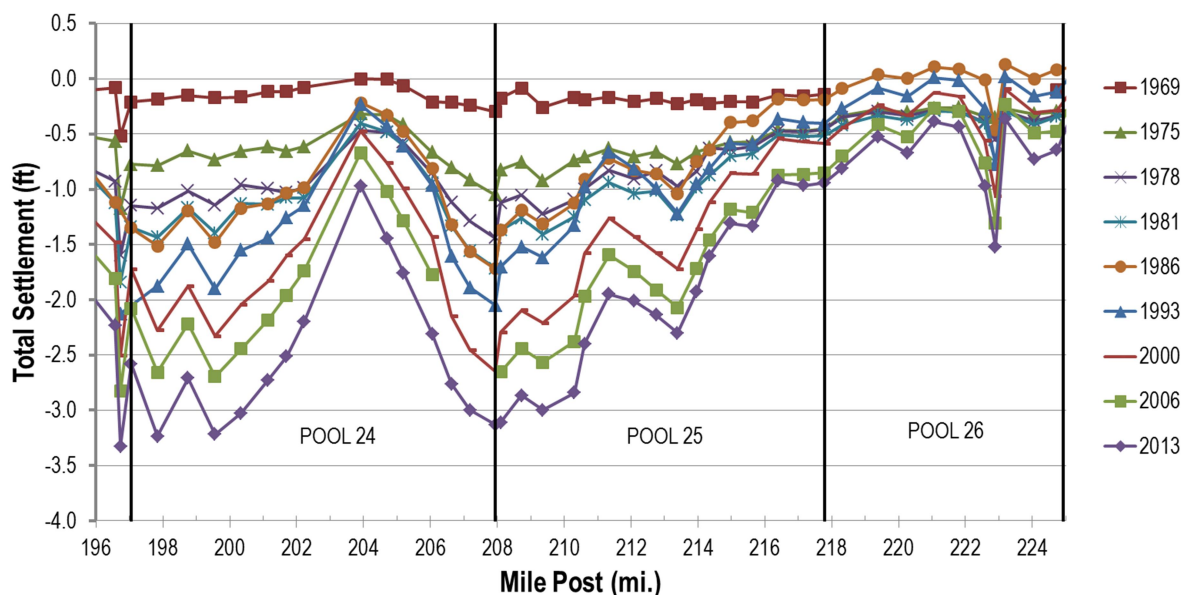
Figure 7-2 Subsidence Profile (Pools 24 to 26)

Figure 7-2 shows the magnitude of subsidence in Pools 24 through 26 in the SJFD, by year. Figure 7-2 shows that in 2013, the subsidence at Check 24 (between Pools 24 and 25) was approximately 3.1 feet, while Check 25 subsided 0.94 foot. As of 2013, the upstream side of Pool 25 subsided 2.2 feet more than the downstream end, where the controlling level sensors are located.

The magnitude of the subsidence shown in Figure 7-2 in Pool 25 compares well with the difference between the top of concrete lining (as built), and the top of concrete lining (2013) as shown in Figure 7-1. The subsidence (or difference) is greater on the upstream end of Pool 25, and decreases as it goes downstream to the end of the pool.

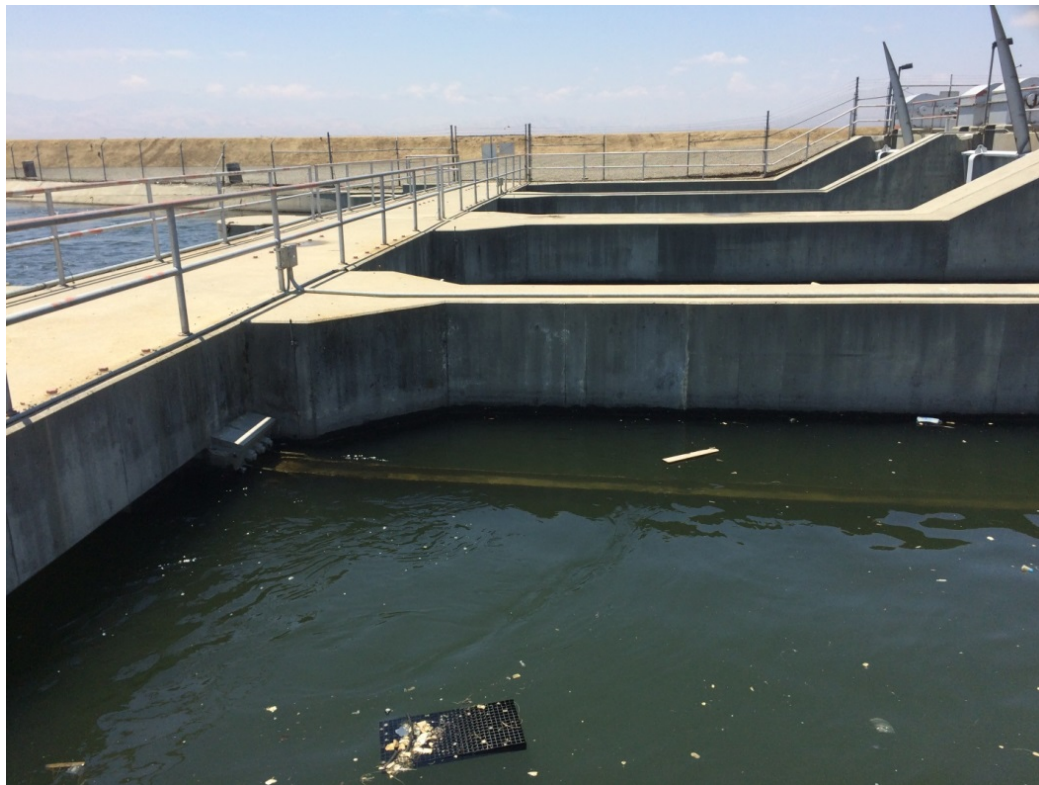
Figure 7-5 Check 20, Trunnions in the Water

While visiting Checks 17 and 24, it became apparent that both of the trunnions are very close to the water surface and their gates are always operated out of the water. Figure 7-5 provides a look at Check 20 and its submerged trunnions. Figure 7-6 provides a view of Check 24 with its gates out of the water.

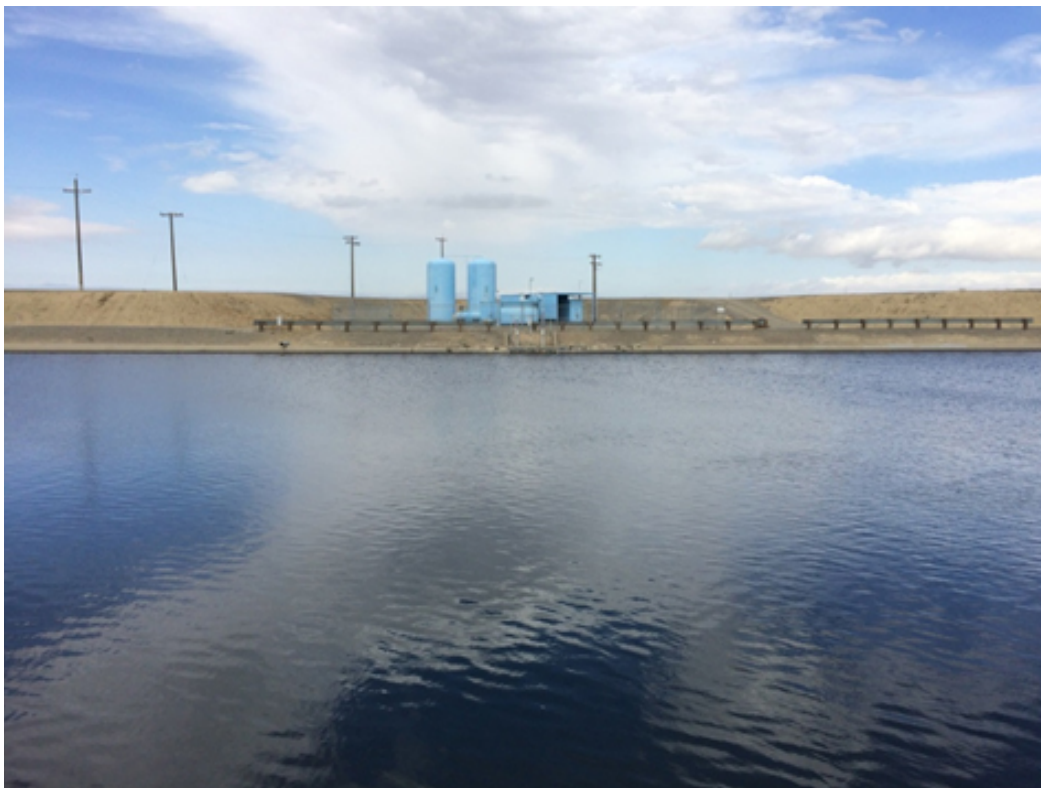
Figure 7-7 Turnout at Milepost 160.45

While driving from Check 20 toward Milepost 160, it became apparent that the distance between the WSE and the top of the liner was getting smaller. Normally (at design flows), the WSE and the top of the liner should be equidistant. At 1,000 cfs (flow during site visit), the distance between the WSE and the top of the liner should get larger, not smaller. This observation was consistent with the Precise Survey unit's data that showed a large drop (about 6 feet of subsidence) at Milepost 160.45. Figure 7-7 provides a view of Milepost 160.45 (right side). It shows the height of the WSE while flowing 1,000 cfs (maximum design flow in this pool is 8,350 cfs). Very little freeboard is visible between the WSE and the top of liner.

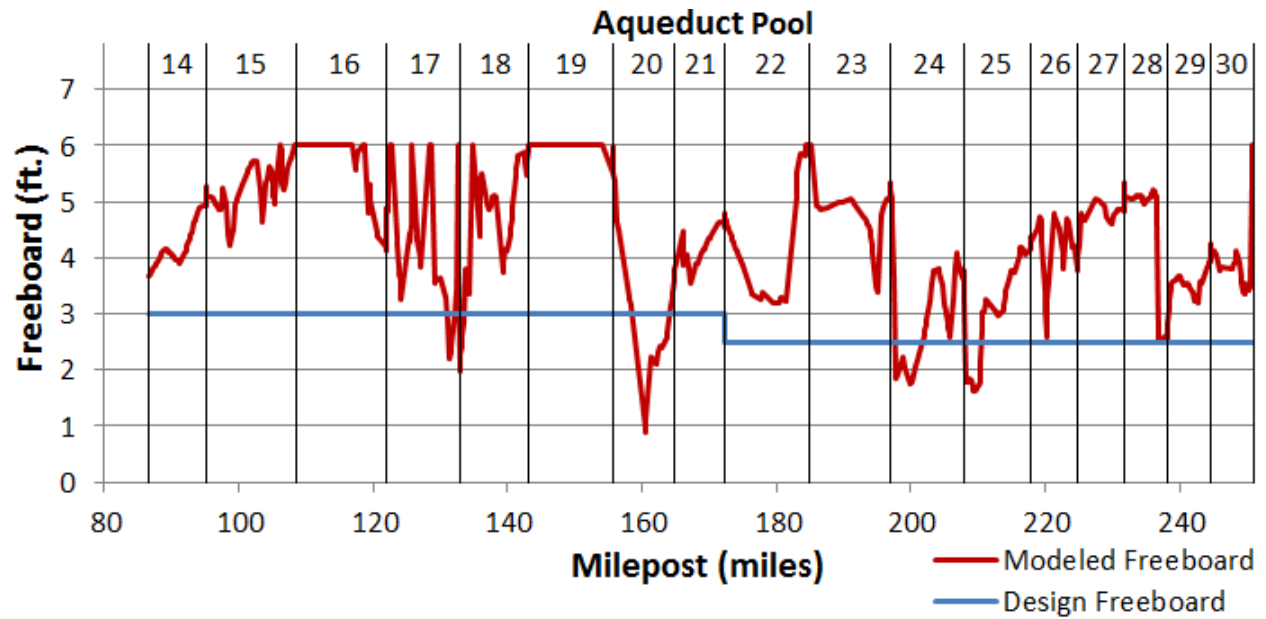
Figure 8-1 Lined Freeboard with Original n-value (0.0160) and Design Flow Capacity

Figure 8-1 shows the modeled freeboard along the Aqueduct alignment under the assumption that the channel roughness, n, equals the original design value of 0.016, and each pool is carrying the design flow. The geometry used in the model corresponds to the subsided geometry of the Aqueduct. It is seen that at multiple pools, the lined freeboard (red line) is lower than the designed minimum freeboard (blue line). Table 8-2 shows the design freeboard of the Aqueduct has been reduced for a length of about 12.7 miles. The lowest freeboard is 0.9 foot in Pool 20, and near Milepost 160.45, extending about 750 feet in length.

Given the decades of canal operation with accumulation of sediments and debris in the canal bed, along with movement of panels and accumulation of algae, the channel roughness, or the Manning's coefficient, has likely increased. An increase in the channel roughness decreases the canal conveyance capacity. The results, as shown in Figure 8-1, represent the upper limit of the conveyance capacity.

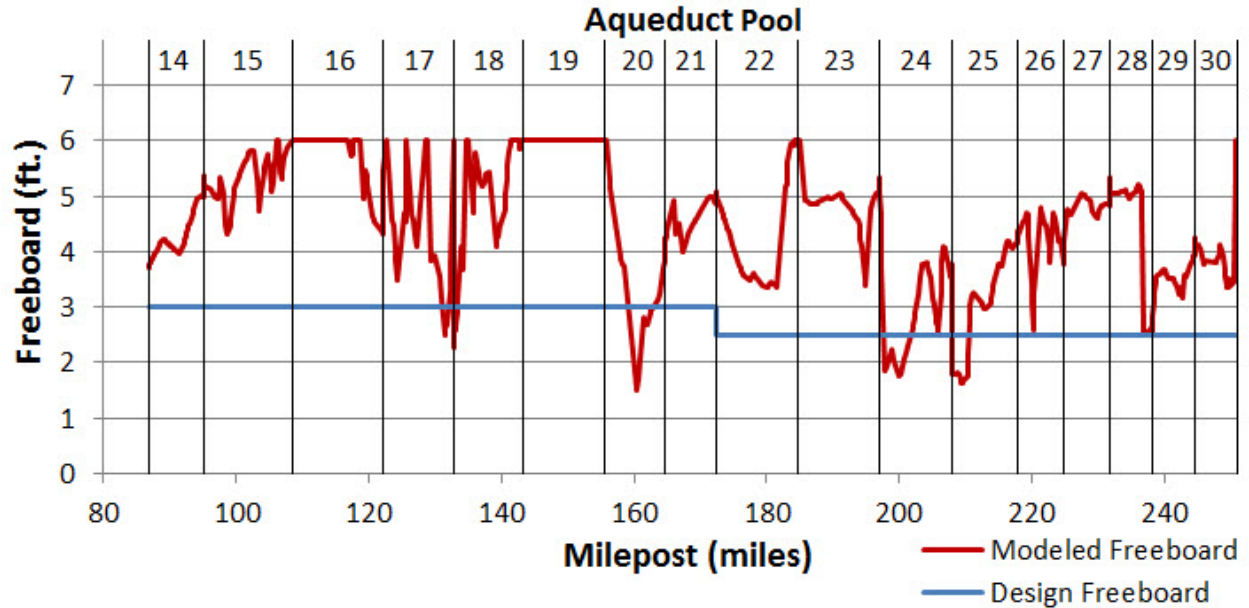
**Figure 8-2 Lined Freeboard with Original n-value (0.016) and Reduced Flow Capacity**

In the second run, and in order to assess the impacts of subsidence on freeboard, the HEC-RAS model was rerun with a revised freeboard requirement. The HEC-RAS model was run multiple times by changing the inflow into a pool so that the freeboard at any point within a pool is at least 1.5 feet. For all trial runs, and in order to maximize the flow, the check structures gates were kept open. The modeled freeboards along the Aqueduct profile are shown in Figure 8-2. Pools 17, 18, 20, 24, and 25 are some of the pools with reduced freeboard. The original and modeled capacities of the pools are shown in Figure 8-3. In order to maintain a minimum freeboard of 1.5 feet, the maximum flow at Pool 20 had to be limited to approximately 7,600 cfs. This relates to about a 9 percent reduction from the original capacity of 8,350 cfs. As shown in Table 5-1, the original design capacities of Pools 21 and 22 were 8,350 cfs and 8,100 cfs, respectively. The reduction in the Pool 20 flow capacity also reduces the capacities of Pools 21 and 22. As a result, Pool 20 acts like a choke point for pools downstream.

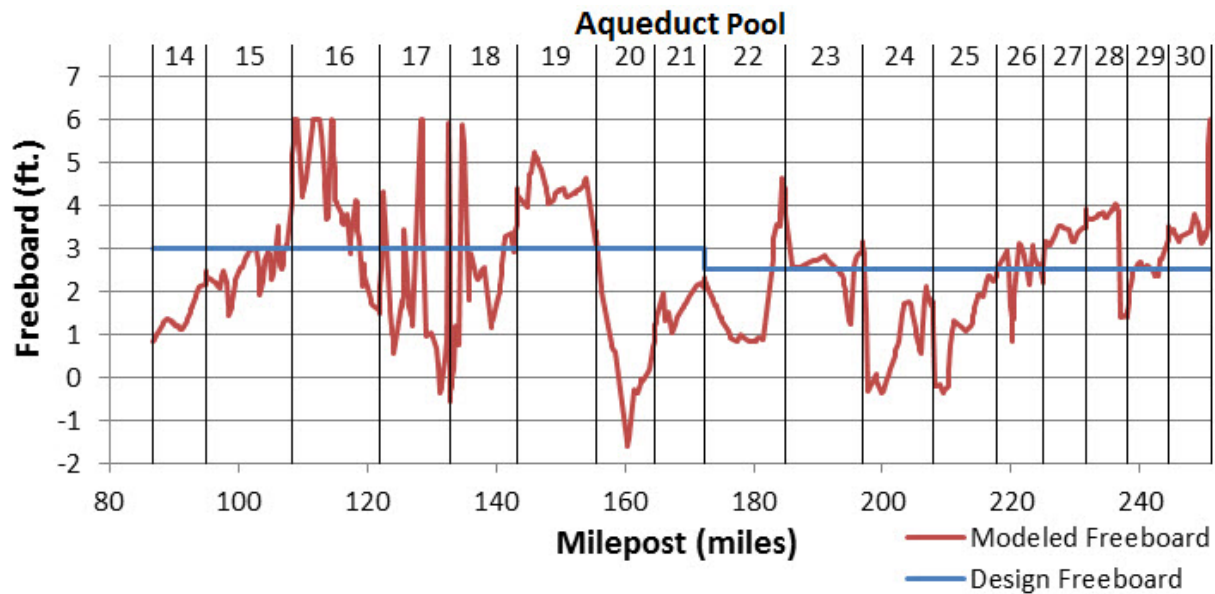
Figure 8-4 Lined Freeboard with Current n-value (0.020) and Design Flow Capacity

To model the current conditions, the HEC-RAS model was modified by setting the Manning's n-value to 0.020. The upstream boundary condition corresponds to the design flow capacity and the downstream boundary condition is the minimum WSE at BVPP forebay pool. The lined freeboard along the Aqueduct profile is shown in Figure 8-4. Model results show that, with the increased bed roughness, the liner is overtopped at multiple locations. As shown in Table 8-2, out of the 164.2 mile long Aqueduct section that was considered in the model, the freeboard has been reduced below designed minimum of 3 feet for about 96 miles. In total, the liner is overtopped for about a 9.5 mile stretch of Aqueduct. At Pool 20 and near Milepost 160.45, which experienced the greatest subsidence, the liner is over topped by 1.6 feet. The liner is also overtopped at Pools 17, 18, 20, 24, and 25. Table 8-2 shows the length of Aqueduct that has less than the design freeboard height, for both ideal conditions (n=0.016) and the estimated current conditions (n=0.020).

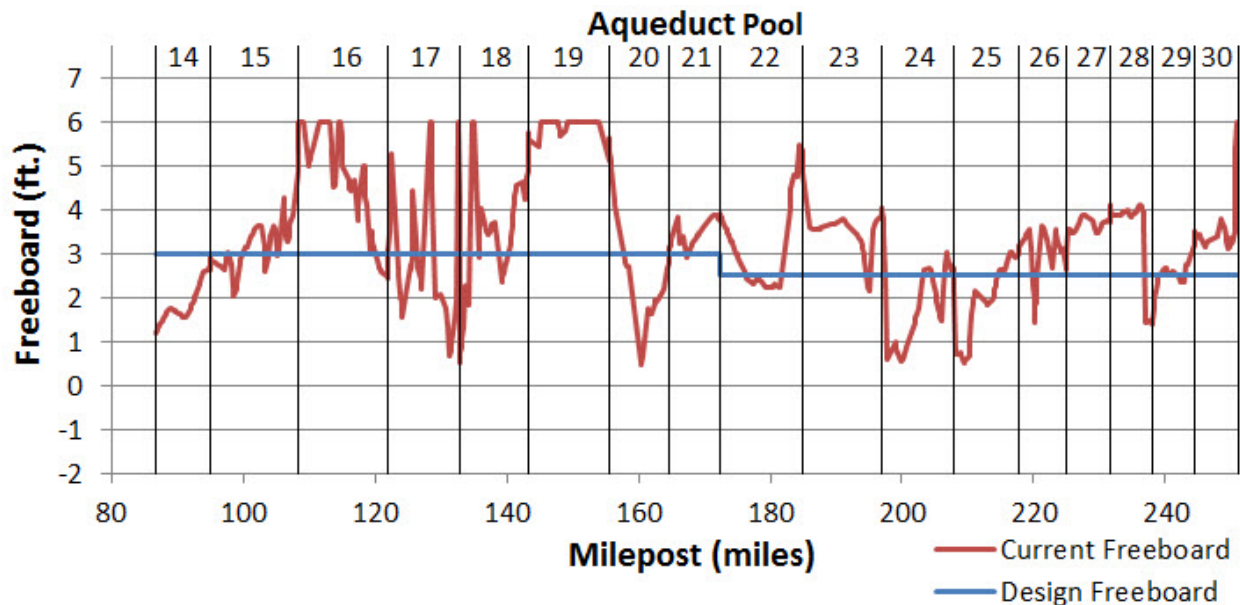
Figure 8-5 Lined Freeboard with Current n-value (0.020) and Reduced Flow Capacity

any point within a pool is about 0.5 foot. In the run, the flow rate within a pool was kept constant. Figure 8-5 shows the freeboard along the aqueduct section. The minimum freeboard is seen near Mile Post 160.42 (Pool 20), which has experienced the greatest subsidence. At multiple locations in Pools 17, 18, 24, and 25, the freeboard is less than 1 foot. Figure 8-6 shows the design flow rate and the maximum flow rate that result in 0.5 foot freeboard. The figure allows a comparison to see the reduction flow rate caused by subsidence in each pool. As shown in Figure 8-7, the flow capacity has been reduced at multiple pools. For Pool 20, which has the most subsidence, the maximum capacity is 6,650 cfs, a reduction of 1,700 cfs, or about 20 percent from the original capacity.

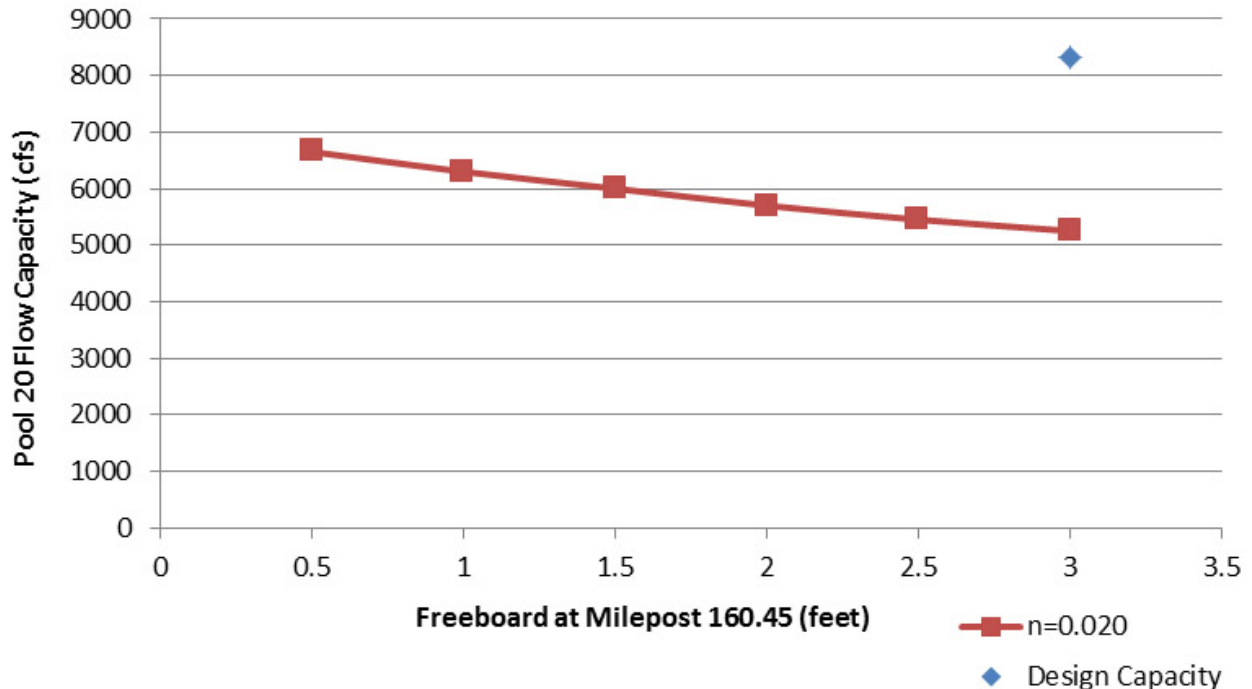
Figure 8-8 Reductions in Pool 20 Flow Capacity with Increase in Freeboard for $n=0.020$

The maximum flow passing through Pool 20 as a function of freeboard is shown in Figure 8-8. The modeling results show that for a freeboard of 0.5 foot the flow capacity is 6,650 cfs, and for a freeboard of 3.0 feet the flow capacity is 5,250 cfs. The figure also shows flow capacity of Pool 20 decreases linearly with subsidence. This suggests additional subsidence will further reduce the capacity of Pool 20.

Note: At 2.6 feet of freeboard, Pool 20 would be lower than minimum elevation; turnouts may be inoperable.

As part of the hydraulic modeling, the flowrate in Pool 20 was varied to create a relationship between flowrate and the minimum freeboard, which is at Milepost 160.45. Figure 8-8 was created to show that relationship. The relationship is the same as that between future subsidence and flowrate capacity, except for one small difference. The geometry of models created for a future subsidence and flowrate capacity would each need to be modified to account for the incremental subsidence. The slight change in the geometry would only slightly change the hydraulic results in the models.

The capacity of Pool 20 is currently 6,650 cfs, with 0.5 foot of freeboard (Figure 8-8). From the figure, at 1.5 feet of freeboard the capacity would be 6,000 cfs. That amount of freeboard (1.5 feet) is the same as 0.5 feet of freeboard with an additional 1 foot of subsidence. As a result, if an additional foot of subsidence occurs, the capacity would fall to 6,000 cfs. If an additional 2 feet of subsidence occurs, the capacity would fall to 5,450 cfs. At that point some of the turnouts would start becoming inoperable, because of low water levels in the pools.
