State of California
The California Natural Resources Agency
Department of Water Resources
FloodSAFE Environmental Stewardship and Statewide Resources Office

Technologies for Passing Fish at Large Dams

June 2013

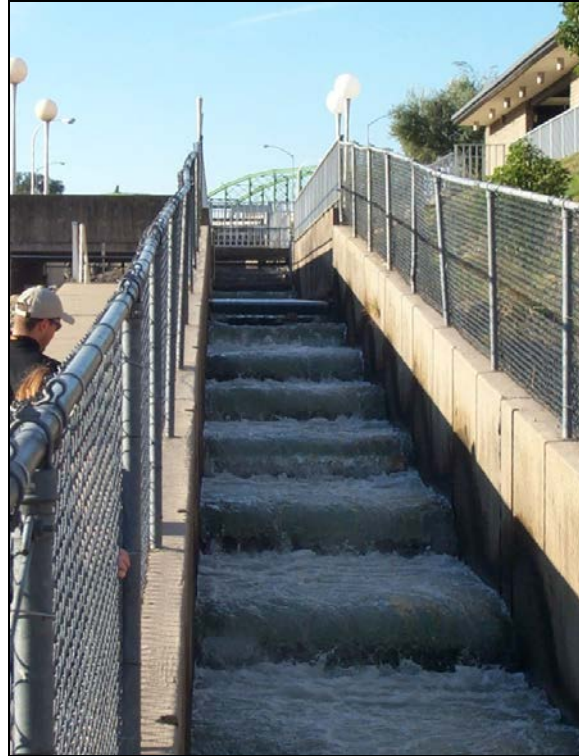
Figure 11: Pool and Weir Fishway at the Feather River Fish Hatchery, California (CA Department of Water Resources)

The entrance configuration and attraction flow are important features of pool-type fishways. Attraction flow mimics the turbulence and water movement of the river and encourages adults to enter and ascend the ladder (Clay 1995). Improper flows can mean that fish cannot find the ladder entrance and migration is delayed. Flows in these types of fishways can vary from around one cfs to several hundred cfs and the slope from less than 5% to more than 20%, most frequently ranging from 10% to 12% (Larinier 2000).

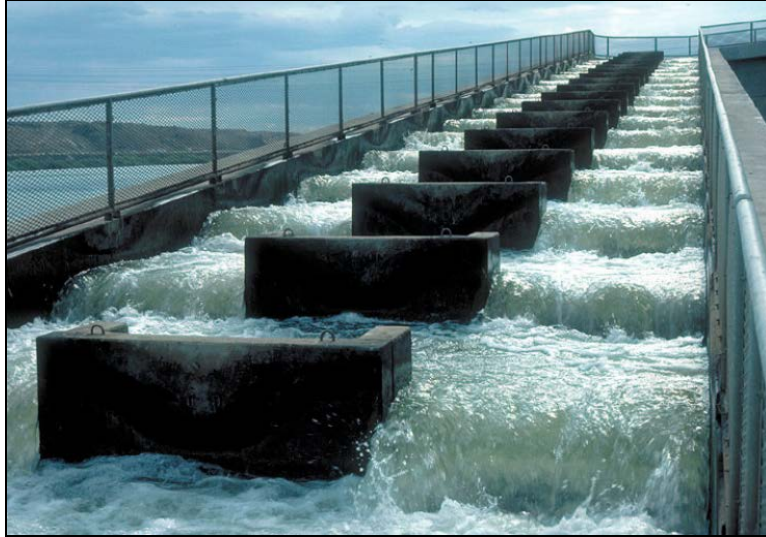
Figure 13: Ice Harbor Fishway (Courtesy of U. S. Army Corps of Engineers)

A specific type of pool and weir fishway is the Ice Harbor fishway (Figure 13). Each weir of the Ice

Harbor fishway has a non-overflow center section with flow stabilizers. The fishway also has orifices, is built on a 10% slope, and is recommended for moderate to large applications with good flow control. For lesser flows, the Ice Harbor fishway can be cut in half along the centerline to produce the Half Ice Harbor fishway (Figure 14). Half Ice Harbor fishways have recently been built at the 85 foot high River Mill Dam on the Clackamas River in Oregon (Bartlett and Cramer 2006) and at the adult collection facility at Cougar Dam on the South Fork McKenzie River.

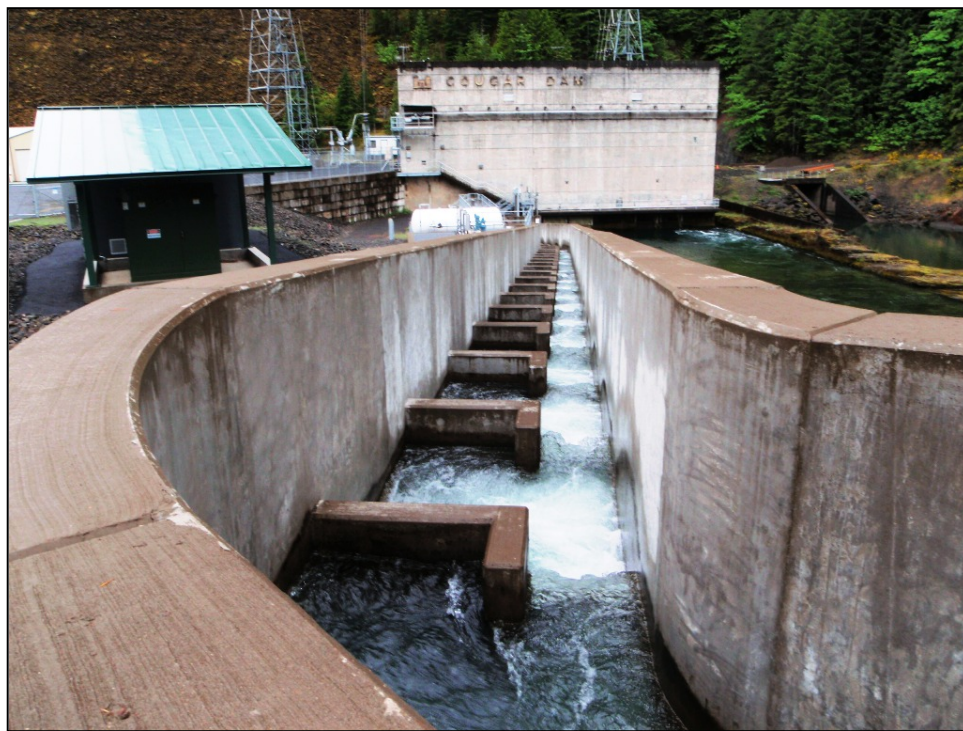
Figure 14: Half Ice Harbor Fishway at Cougar Dam on the South Fork McKenzie River (CA Dept. of Water Resources)

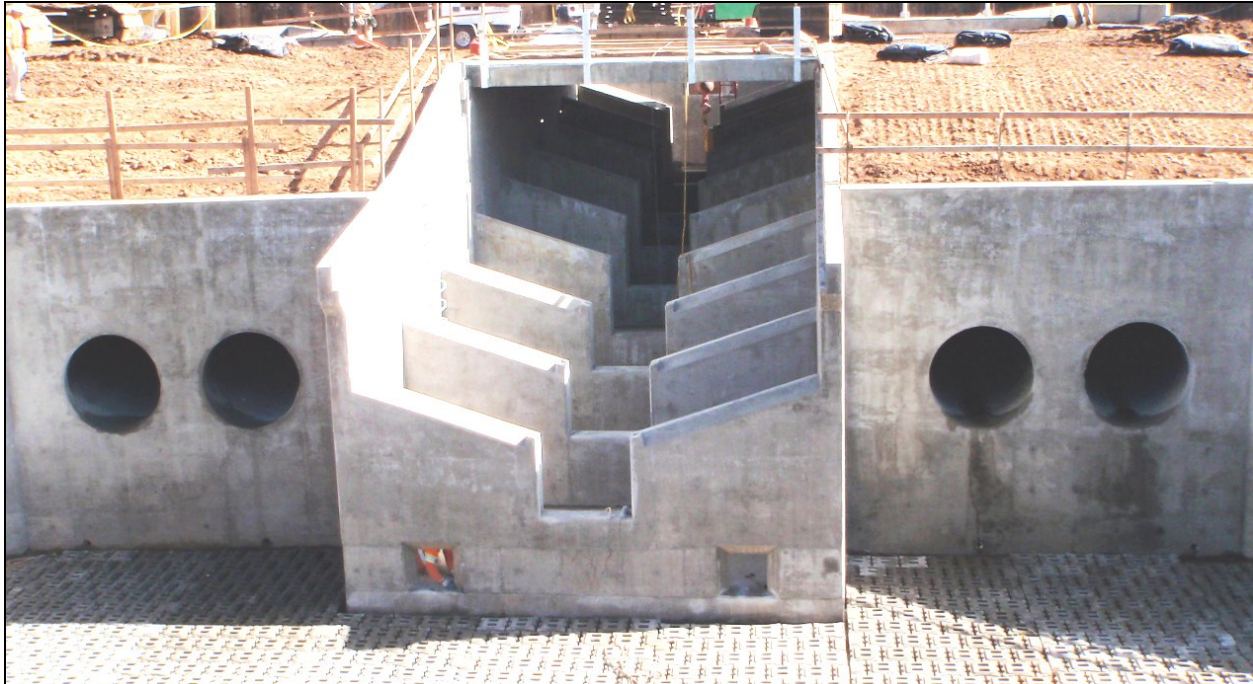
Figure 16: Pool and Chute Fishway at Willow Slough Weir in the Sutter Bypass - Northern California (CA Department of Water Resources)

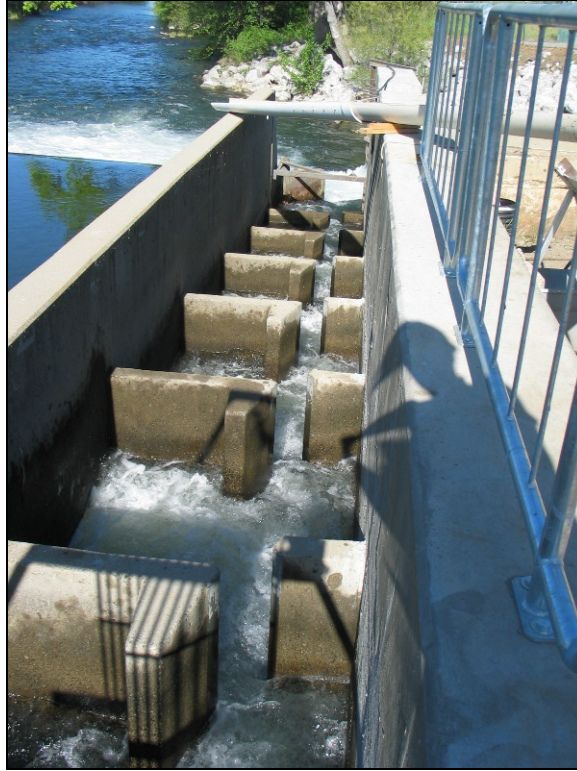
**Figure 17: Vertical Slot Fishway at Coleman National Fish Hatchery
(CA Department of Water Resources)**

Vertical slot fishways do not have overflow weirs as do the previous pool-type fishways. Hydraulic control and fish passage are provided by full-depth slots between the pools (Figure 17).

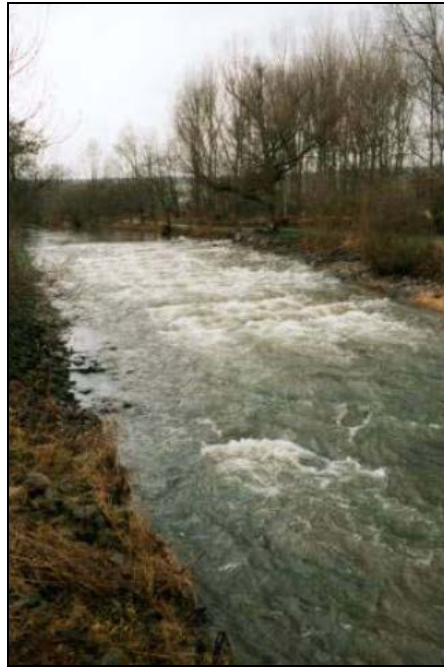
Figure 20: Full width nature-like (rock ramp) fishway (Photo by Uli Dumont in Wildman et al 2002)

designed to recreate pools, riffles, steps, and/or cascades using natural materials. This type of fishway is usually used at low-head barriers and can be a full channel width (Figure 20), partial channel width (Figure 21), or bypass type design (Figure 22). Nature-like fishways are constructed mainly with rock, with the smaller particles, such as sand and gravel, filling the voids between the larger ones (Katopodis et al 2001). In California, the Department of Fish and Game calls these fishways roughened channels, describing them as, “constructed channel reaches stabilized with an immobile framework of large rock mixed with smaller material.”

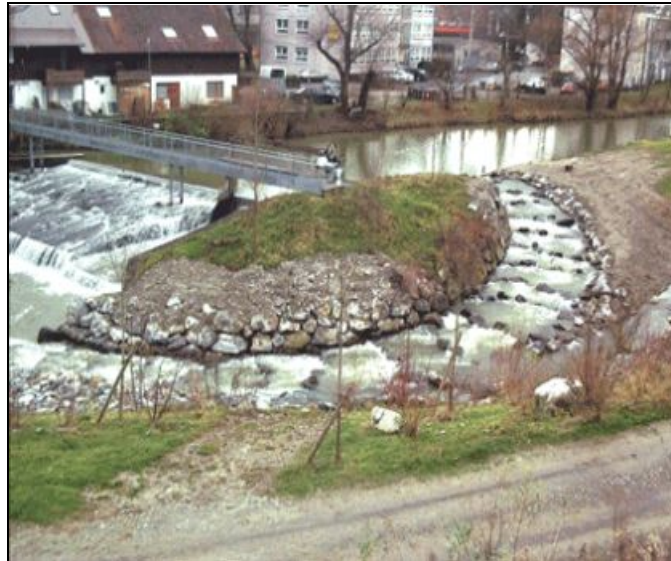
Figure 22: Nature-like bypass channel (Photo courtesy of Rolf-Jurgen Gebler)

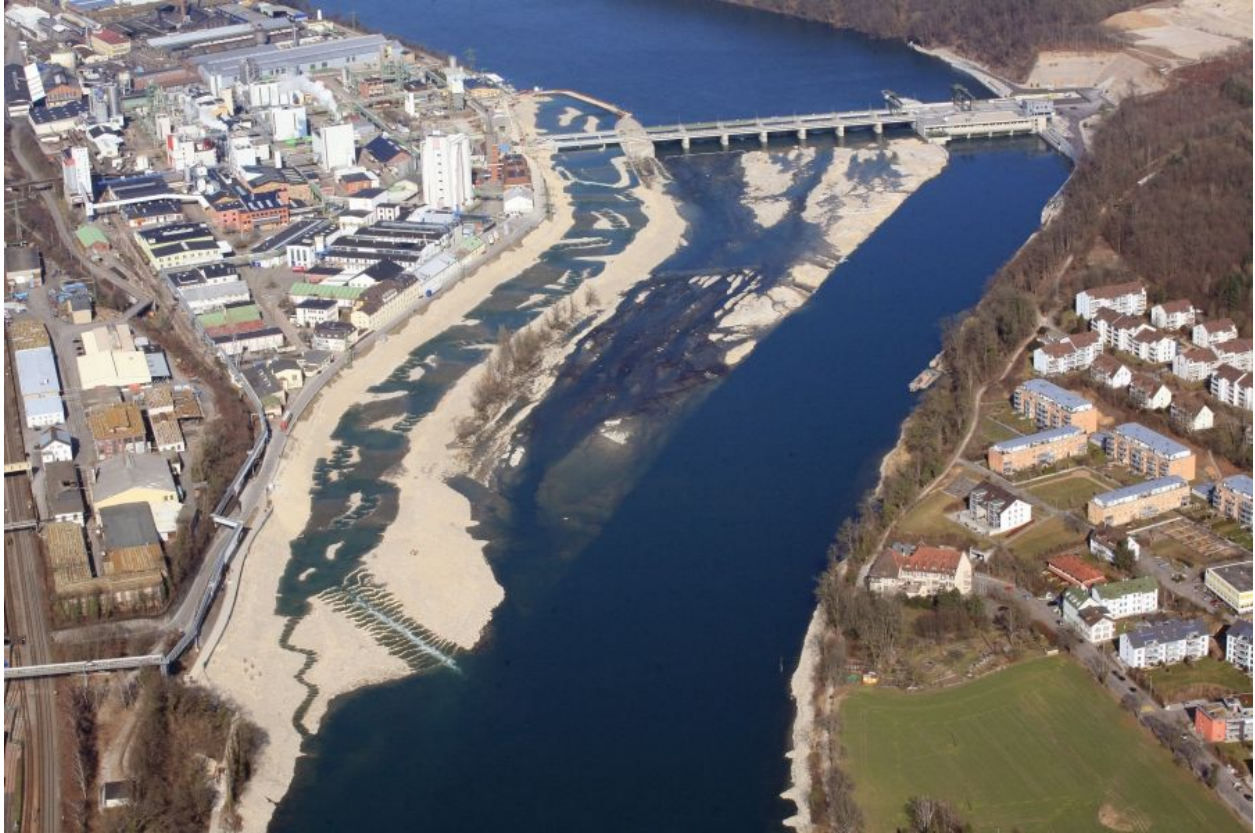
Figure 23: Aerial view of the nature-like bypass channel at the Rheinfelden Power Station on the Rhine River (Courtesy of Rolf-Jurgen Gebler)

and associated dam. Flow in the bypass will be up to 35 cms (1235 cfs) (Gebler 2011).

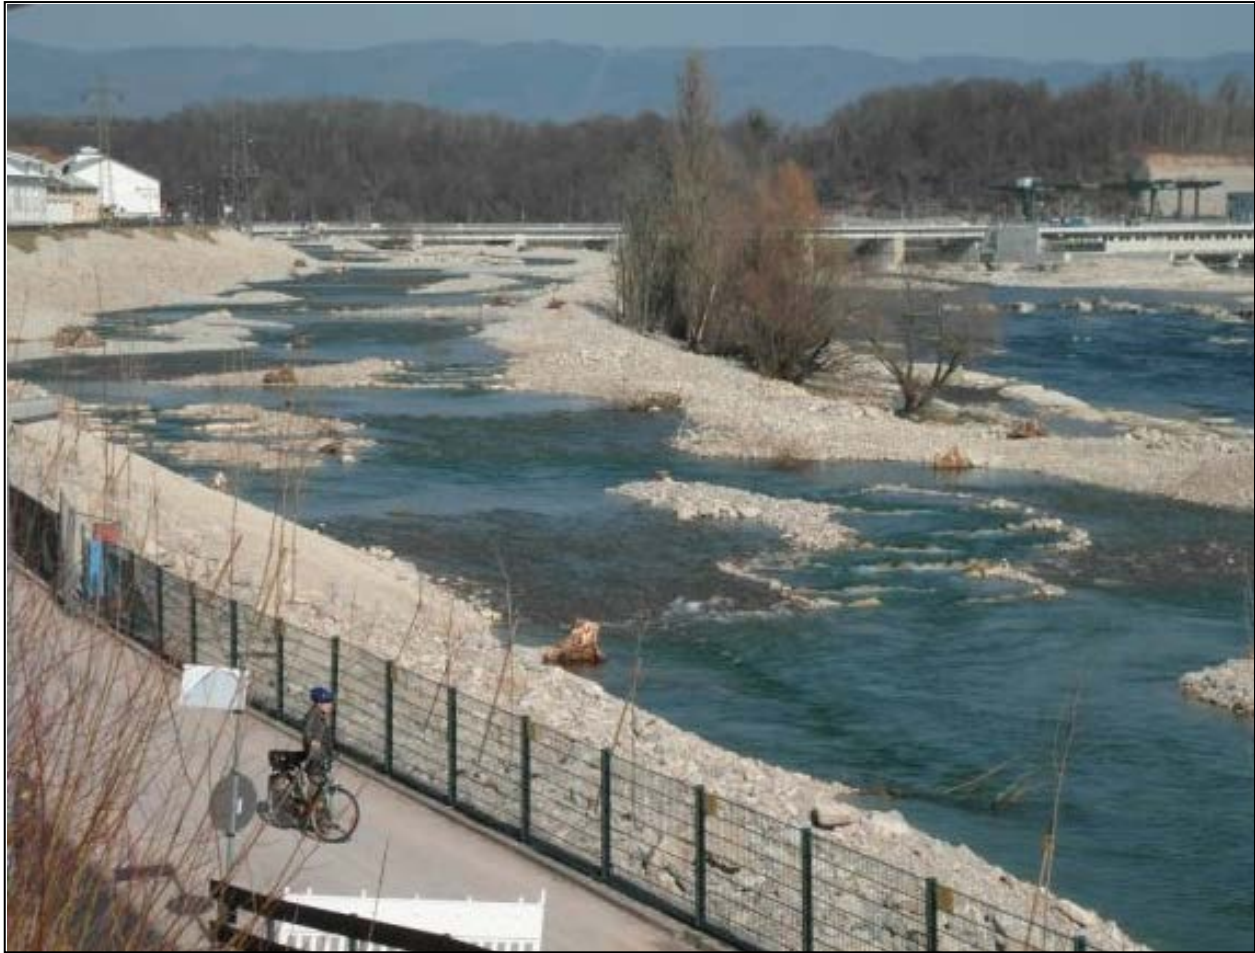
Figure 24: Nature-like bypass channel at the Rheinfelden Power Station on the Rhine River (Courtesy of Rolf-Jurgen Gebler)

As for the applicability of nature-like fishways, Wildman et al (2002) documented many case studies, most of which have hydraulic heads of less than 15 feet. However, some of the bypass channel case studies have greater hydraulic heads, with one passing fish around a 40 foot high dam. One project currently being constructed is a 900 meter long, 50 meter wide (3,000 foot long by 160 foot wide) nature-like bypass channel on the Rhine River in Rheinfelden, Germany (Figures 23 and 24). This bypass overcomes the 9.1 meter (30 foot) hydraulic head created by the Rheinfelden Power Station

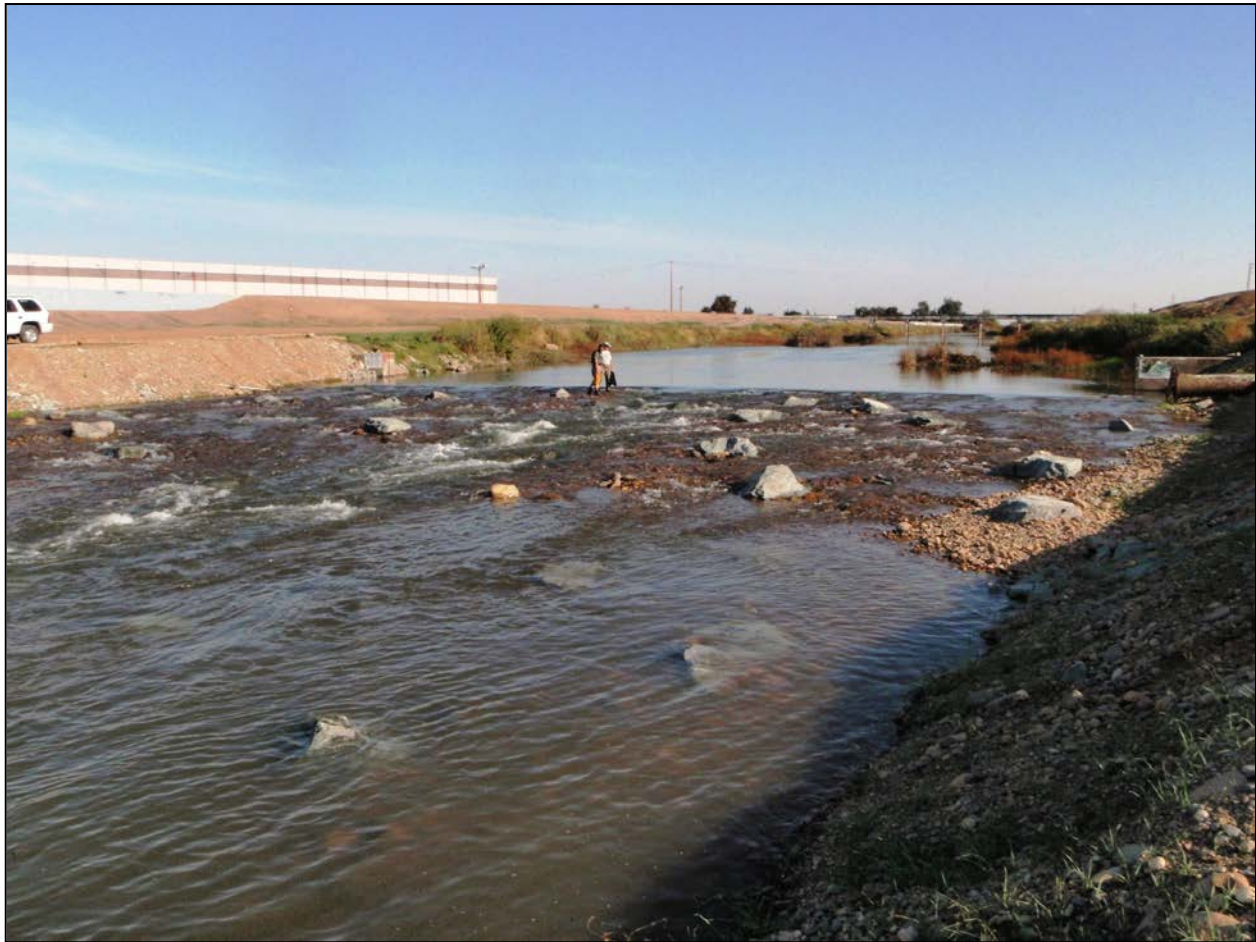
Figure 25: Rock ramp roughened channel at the Budiselich Flashboard Dam site in the Stockton Diverting Canal, Calaveras River System (CA Dept. of Water Resources)

Rock ramps are continuous roughened channels constructed at a constant slope with no large structural bedforms (e.g., steps, pools). Rather, random large rocks in the engineered streambed material create hydraulic roughness and diversity (Figure 25).

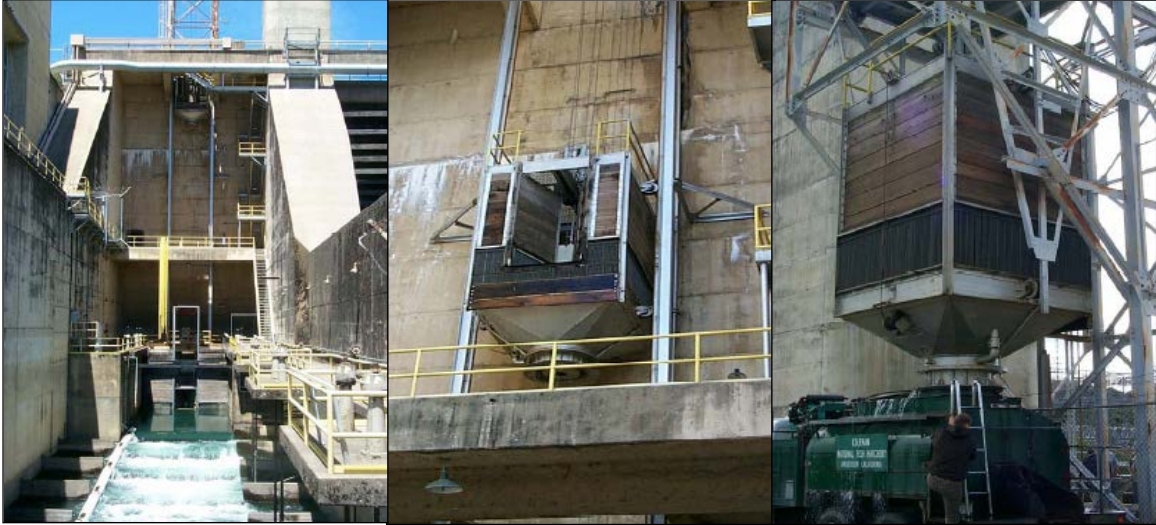
Figure 30: Collection and transport facility at Keswick Dam in California

Several previously mentioned technologies, such as fishways, fish lifts, and fish locks, can be used to raise the fish up to a fish collection facility. At Keswick Dam, fish ascend a fishway to get to a holding pool, and then enter a fish lift that raises them up to the transport area (Figure 30). At the Cowlitz River Project, fish move up a series of fish ladders to get to the Cowlitz Salmon Hatchery. At the hatchery, fish are trapped and sorted by species and destination. As mentioned in the fish lock section, the Baker River Project uses a lock (Figure 31) to raise fish up to a fish facility for processing and loading onto trucks (PSE 2010). At Cougar Dam, fish climb a fish ladder to get to a collection facility for transport to the upper watershed (Figure 32).

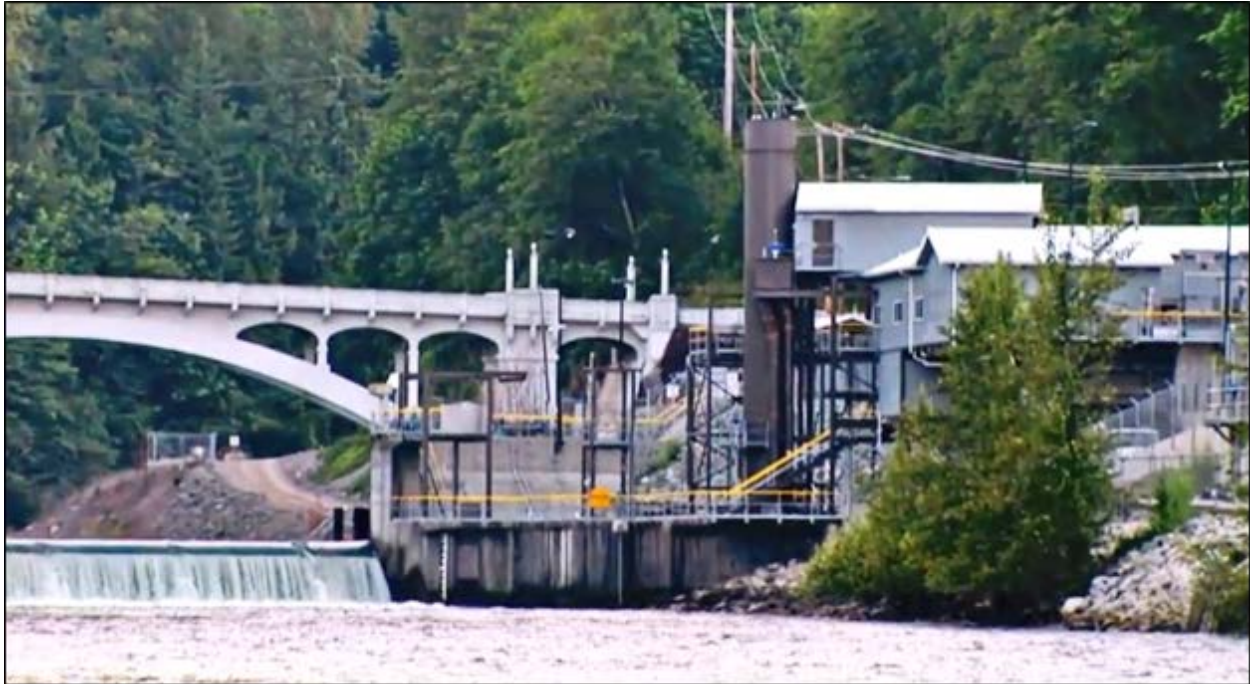
**Figure 31: Adult fish trap and lock on the Baker River, Washington
(Courtesy of Puget Sound Energy)**

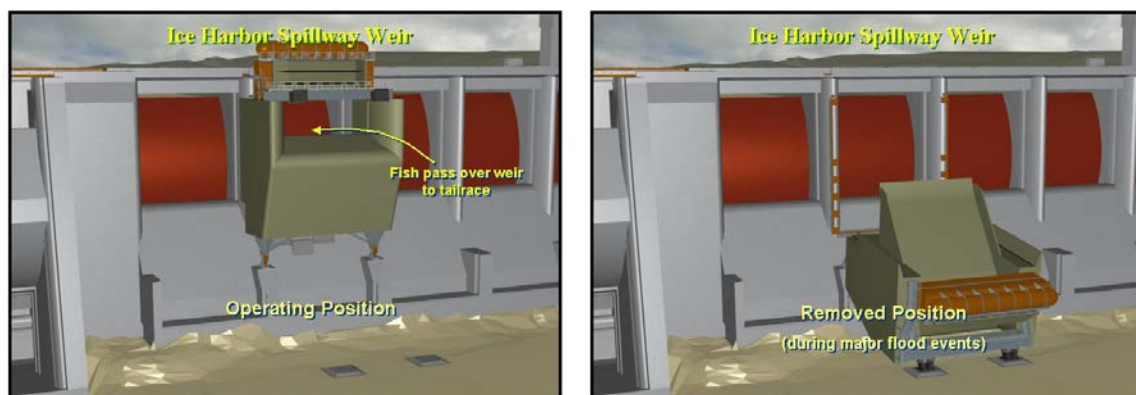
Figure 38: RSW in operating and non-operating positions (USACE 2011)

A removable spillway weir (RSW) is a steel structure that is installed upstream of the existing spillbay (USACE 2002). It has been used on the Columbia and lower Snake Rivers to pass juvenile salmonids over a raised spillway crest (Figures 37 and 38), similar to a waterslide. Since most Columbia River juvenile salmonids tend to stay in the upper 10 to 20 feet of the water column, the RSW reduces migration delays and provides a less stressful dam passage route by allowing them to pass the dam near the water surface at lower water velocities and pressures (USACE 2004).

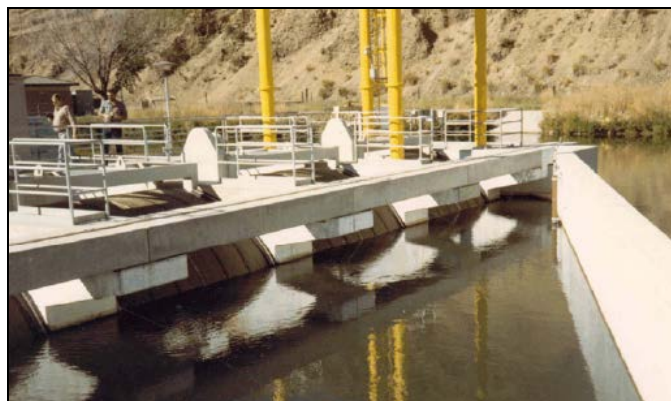
Figure 42: Roza Diversion Dam Drum Screens, Yakima River, WA (USBR)

An example of a rotary drum screen facility is the Roza Diversion Dam on the Yakima River in Washington State (Figure 42).

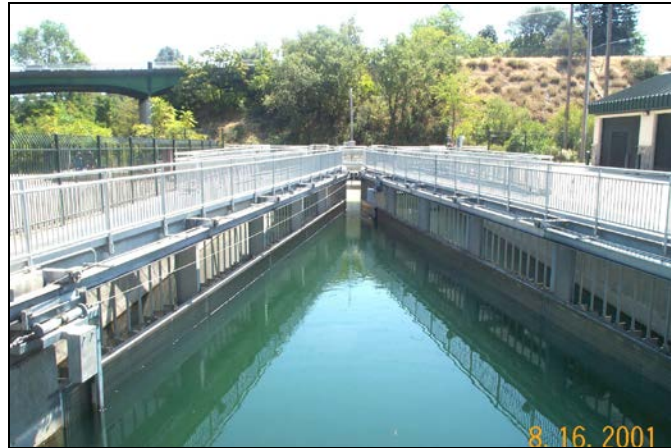
Figure 45: ACID Diversion Vertical Flat-plate Fish Screen in “V” Formation, Sacramento River, CA (CA Dept. of Water Resources)

screen at the Anderson Cottonwood Irrigation District diversion on the Sacramento River near Redding (Figure 45) and the inclined flat-plate screen at the Rancho Esquon diversion on Butte Creek near Chico (Figure 46). Examples of uses at larger hydropower facilities are the “V” screen intakes for the Pelton Round Butte Hydroelectric Project’s juvenile collection facility atop the \$108 million dollar Selective Water Withdrawal Tower in Lake Billy Chinook and the Baker River Hydroelectric Project’s floating surface collector in Upper Baker Lake (please see the case studies for these projects). At hydropower facilities in California, these types of screens are used at the Beaver Creek Diversion, part of the North Fork Stanislaus River Hydroelectric Development Project, and the Kilarc-Cow Creek Project on South Cow Creek (CEC 2005).

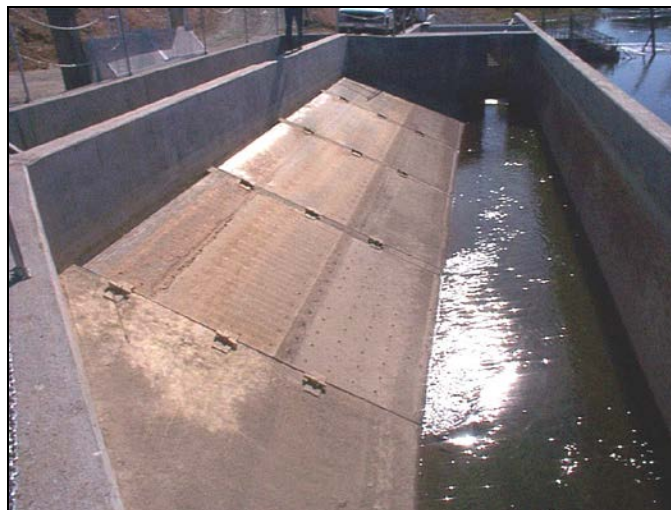
Figure 46: Rancho Esquon Inclined Flat-plate Fish Screen, Butte Creek, CA – Shown at a low forebay elevation (CA Dept. of Water Resources)

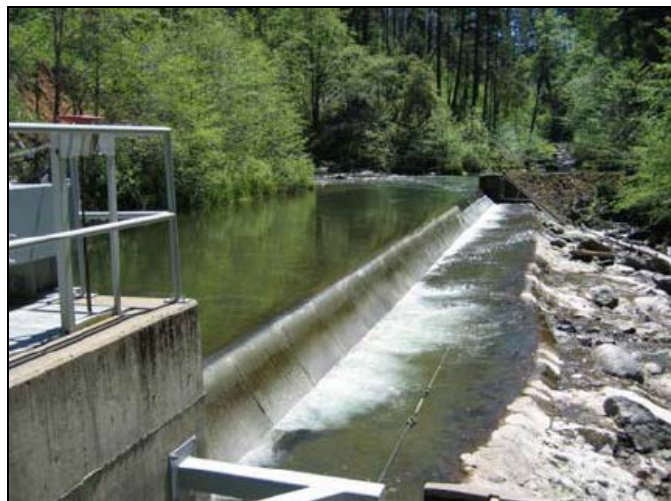
Figure 49: Montgomery Creek Coanda Fish Screen (Wahl 2003)

A version of the downward sloping screen that does not have a flat-plate is the Coanda screen (Figures 48 and 49). Typically, the Coanda screen has a concave face, consisting of wedge-wire, and its contoured shape is designed to mimic the nappe of water as if it were free spilling. Because the flow follows the contour, the distribution of flow through the screen is more uniform (WDFW 2000a).

Coanda screens are generally installed on downstream faces of overflow weirs. Water passes over the crest of the weir and a solid acceleration plate, and then flows across and through the screen. Flow that passes through the screen is collected in a channel below the screen and the remaining water, containing debris and fish, passes over the downstream end of the screen. Water velocities across the screen are relatively high, typically ranging from 6 to 12 fps, and are a function of the height from the upstream pool to the top of the screen. Sufficient depths must be maintained over the downstream portion of the screen to prevent fish contact with the screen (USBR 2006).

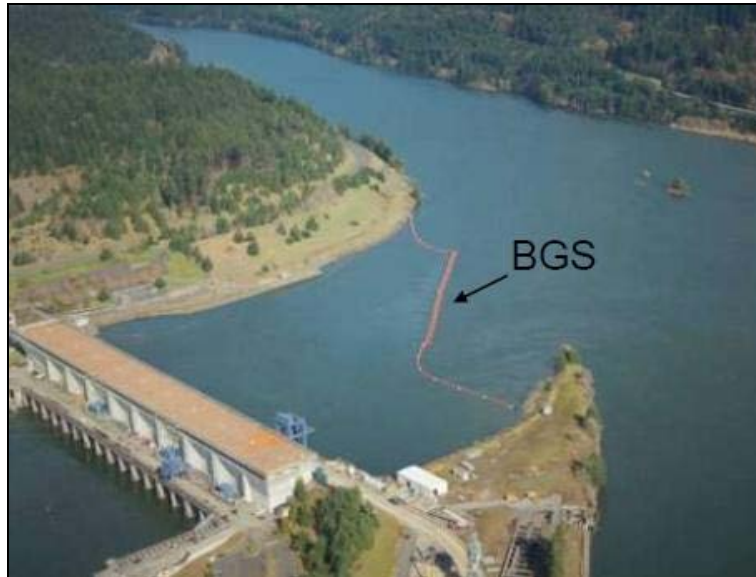
Figure 54: Behavioral Guidance System at Bonneville Dam (Courtesy USACOE)

In 2008, a prototype Behavioral Guidance System (BGS) was installed in the forebay of the second powerhouse at Bonneville Dam (Figure 54). The BGS is a 700-foot-long, 10-foot-deep physical barrier, intended to increase the guidance of juvenile salmon to the corner collector fish bypass. The USACE Portland District asked Pacific Northwest National Laboratory (PNNL) to conduct an acoustic telemetry study to evaluate the prototype BGS. The PNNL found the BGS increased passage percentage into the corner collector for yearling Chinook salmon by up to 9%, but no improvements were observed for subyearling Chinook or juvenile steelhead when comparing 2008 study results to passage distributions observed in 2004-2005 radio-telemetry studies. However, it should be noted that in 2004-2005 all turbines were operating, while in 2008 one turbine unit was offline, making it difficult to compare passage percentages (PNNL 2010).

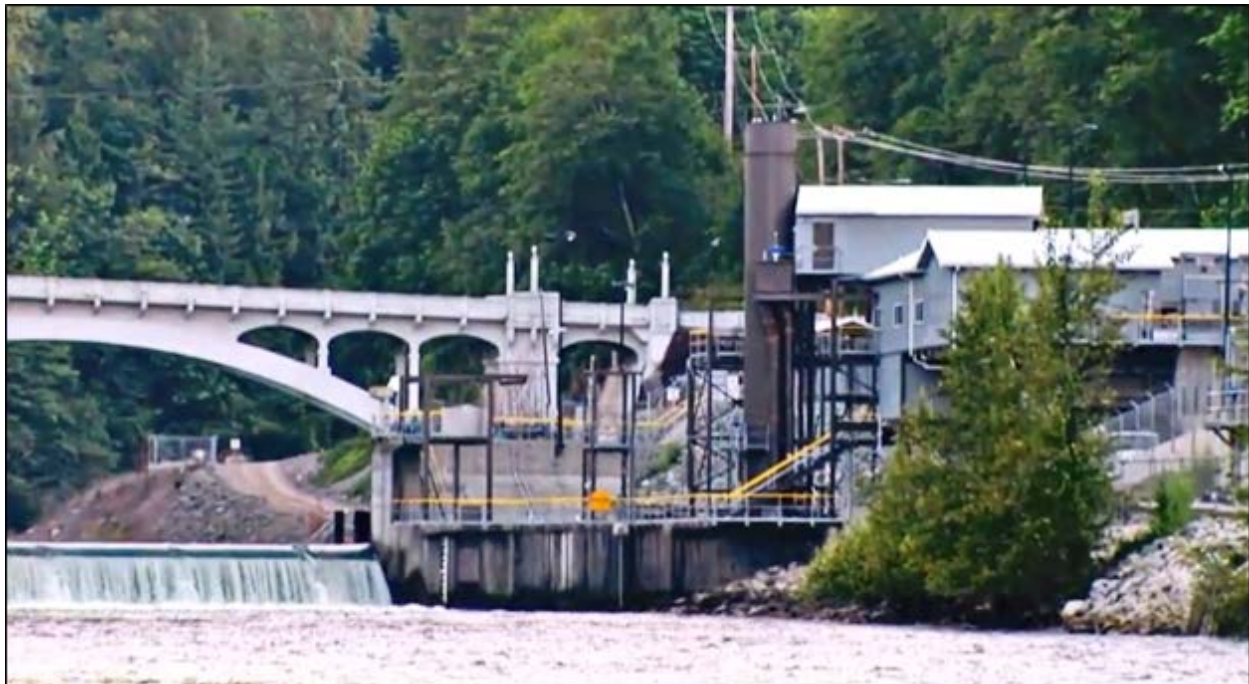
Figure 63. Adult fish trap facility, below Lower Baker Dam (Courtesy of PSE)

In 2010, PSE completed construction of a new adult fish trap in the same location as the original trap about 0.5 miles upstream from the Skagit River (Figures 63 and 64). It cost approximately \$25M and replaces the original trap that was built in 1958. Upstream migrating fish are blocked by the barrier dam and are attracted into the entrance pool. They then move through two holding ponds to get to the brail pond. From the brail pond fish enter a water-filled tower, 7 feet in diameter and 60 feet tall, which raises fish from the river level to the facilities on the river bank (Figure 65). Fish exit at the top of the lock by means of a false weir (Figure 66). There is a programmable control system for sorting fish by species and separating them into six holding pools (Figure 67). From the holding pools, fish are transferred to a fish box on a flatbed truck via automated systems with minimal handling of fish (PSE 2010b).

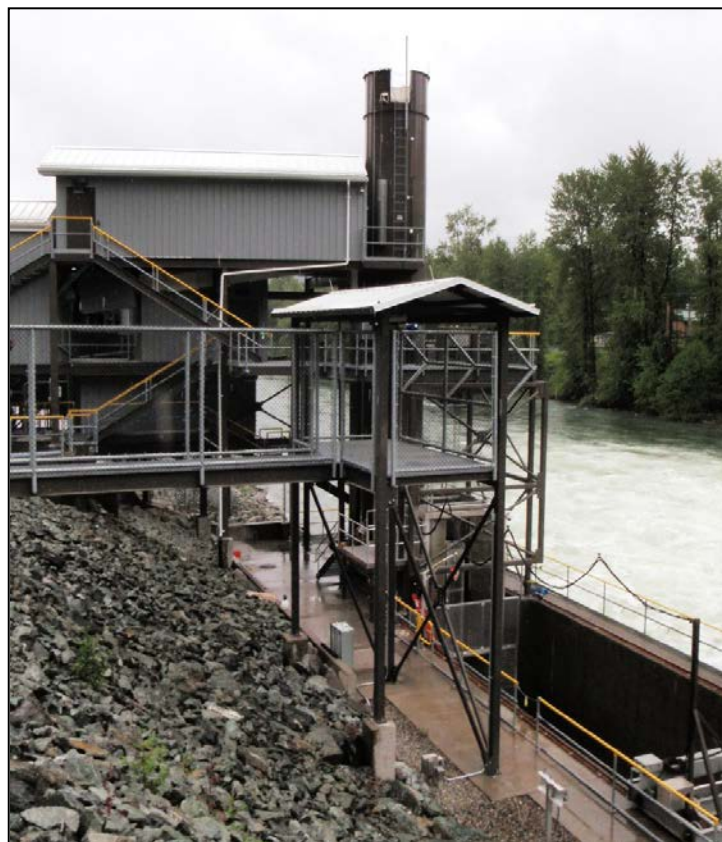
Figure 65: Holding pond #2, brail pond, and fish lock (CA Dept. of Water Resources)

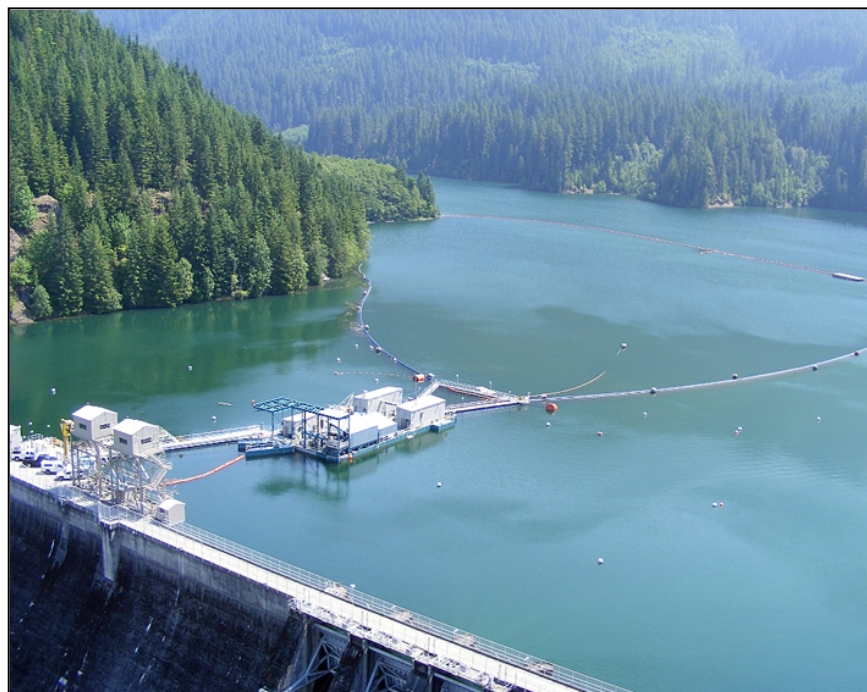
Figure 68. Upper Baker Dam FSC (courtesy of PSE)

The Floating Surface Collector (FSC) behind Upper Baker Dam is the primary facility for downstream passage of outmigrating juvenile salmonids from Baker Lake to the Skagit River. Figures 68 and 69 show the completed FSC in operation and Figure 70 shows an isometric view. A May 12, 2009 news release from PSE describes the system and its success:

The new floating surface collector is a one-of-a-kind, 130-foot-by-60-foot barge equipped with a series of submerged screens, water pumps, fish-holding chambers, a fish-evaluation station, equipment-control rooms, and a fish-loading facility. The guide nets, extending from each side of the collector to the opposing lake shores and from the lake's surface to its bottom, form an impassible netting funnel to lead small migrating fish to the

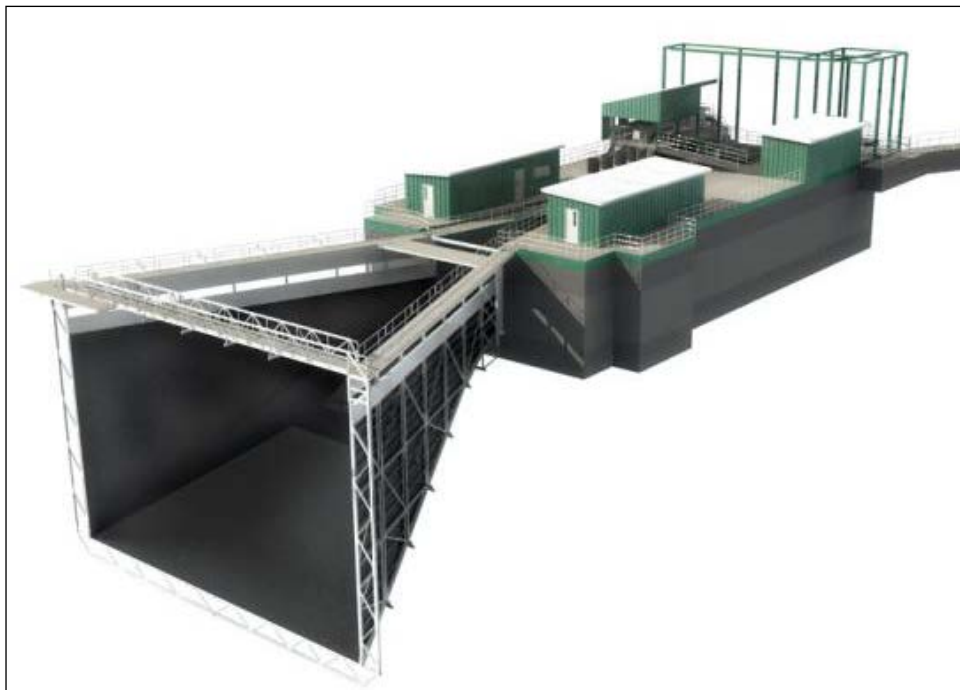
Figure 70: Isometric view of Upper Baker FSC and net transition structure (Courtesy of PSE)

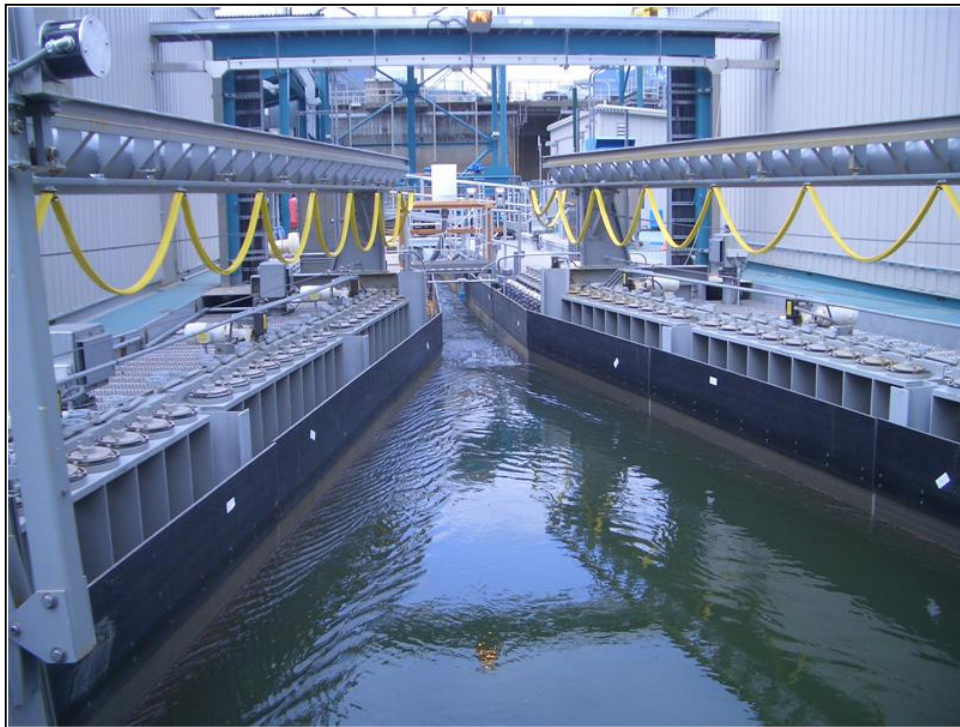
Figure 74: Upper Baker Dam FSC primary fish screens (NOAA Fisheries)

After passing the net transition structure, fish are swept past the primary fish screens (Figure 74) as the channel narrows from 16 feet to 2.85 feet at the entrance to the secondary fish screens (See Table 350 for FSC attributes). At an FSC entrance flow of 500 cfs, the primary fish screens remove 365 cfs and 135 cfs enters the secondary fish screens. The primary screens are cleaned by a horizontal brush system that moves vertically. The secondary screens (Figure 75) remove 132 cfs as the channel narrows to 1 foot wide. The secondary screens are cleaned by a water backwash system.

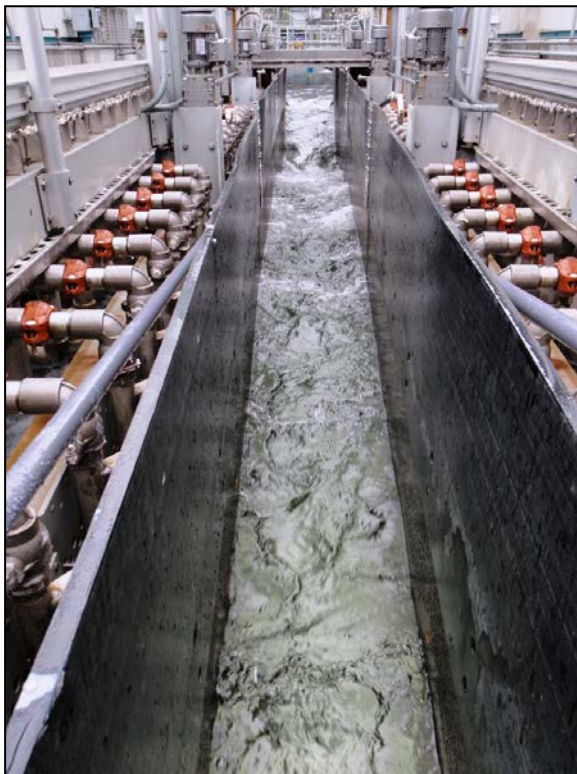
Figure 75: Upper Baker Dam FSC secondary fish screens - looking upstream (CA Dept. of Water Resources)

As fish move through the FSC past the capture point in the secondary screen channel, a PIT tag detector is used to record tagged fish. Special gates are used to move fish with tags to a specific raceway. All fish that are collected in the FSC are held in raceways until they are ready to be evaluated. Crowders move fish from the raceways to a hopper. The hopper, containing water and fish, is lifted by a crane and moved by tram rail to the evaluation station. Next, crowders move fish into a dewatering channel and into a pre-anesthesia raceway to reduce stress. Small groups of fish are netted and are placed into a higher concentration of anesthesia to induce them to sleep. The fish can be evaluated for species type, weight, length, time of capture, and markings. Juveniles are then moved into special holding tanks for use in studies or into transport tanks for recovery (PSE 2008).

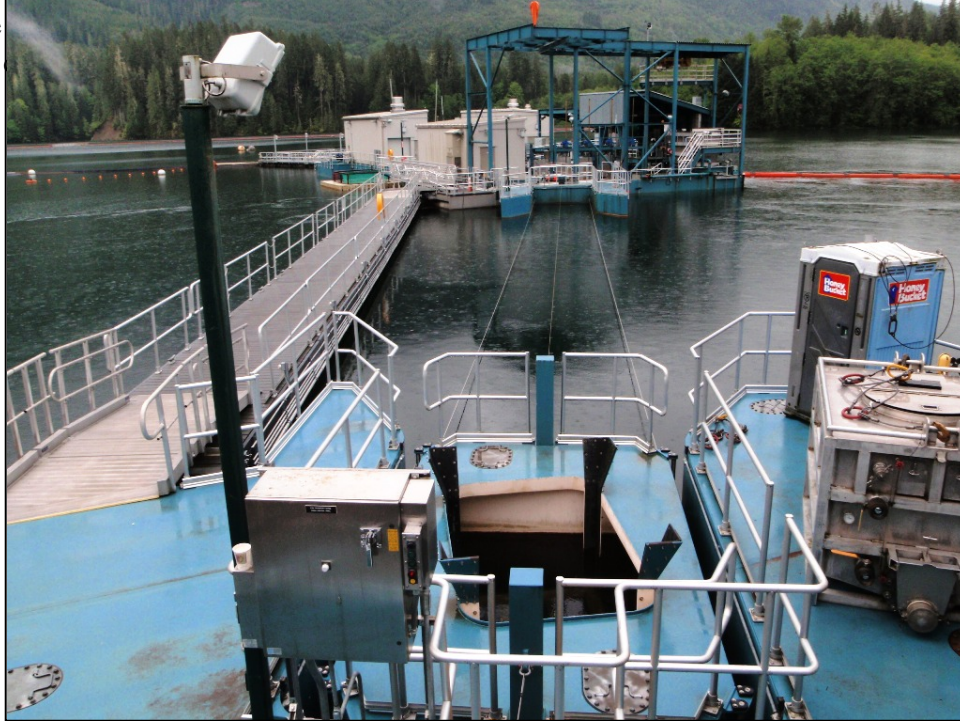
Figure 76: Upper Baker Dam FSC fish barge and tank (right) – photo taken from dam (CA Dept. of Water Resources)

The transport tanks, self-contained vessels that have oxygen diffusers and aerators, are moved to the docking station. A barge transfers the transport tanks to loading facilities on the dam (Figure 76). The transport tanks are then loaded onto flat bed trucks or trailers for transport to stress relief ponds

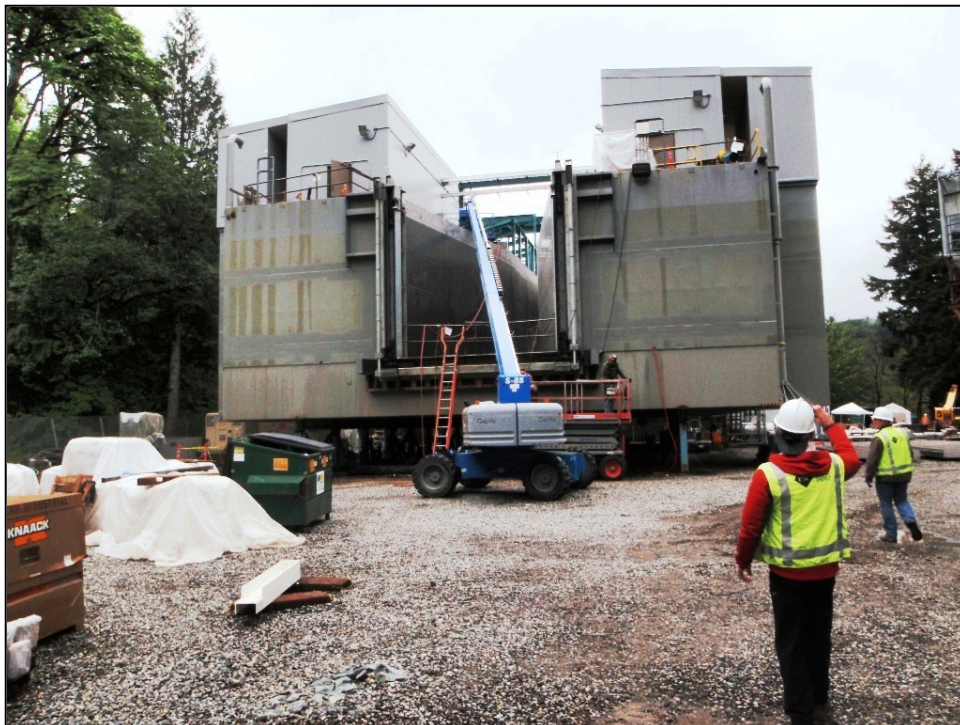
Figure 77: New FSC for Lake Shannon - Upstream side showing primary fish screens (CA Dept. of Water Resources)

2012 (Figures 77 - 79). This FSC will be similar to the one in Upper Baker Lake, but will be much farther from the dam and thus two reservoir transport vessels are being constructed to move the fish from the juvenile

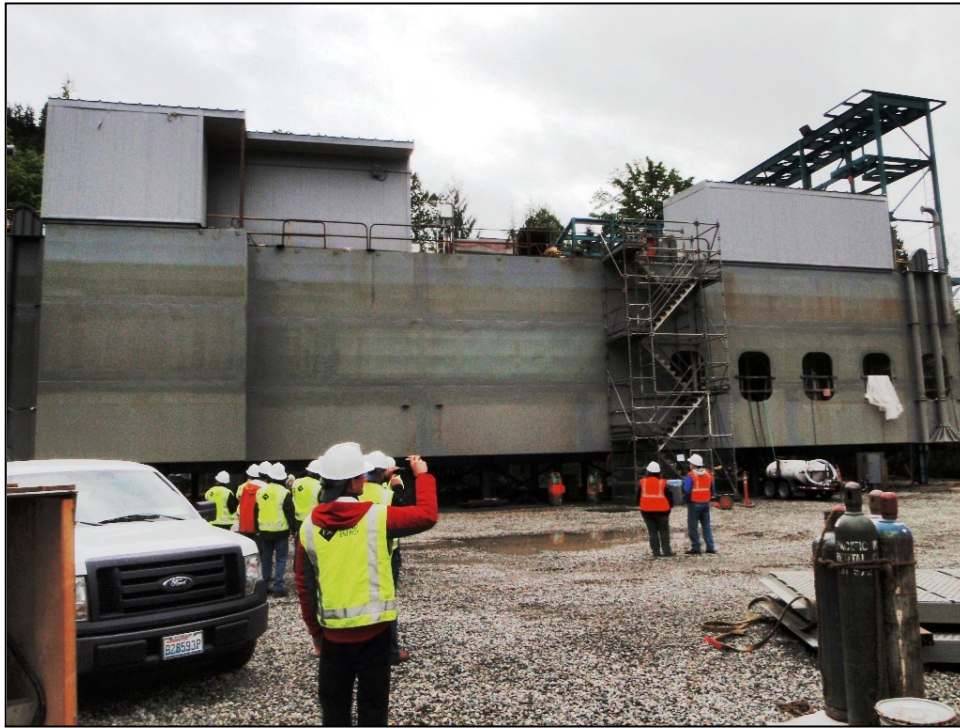
Figure 78: New FSC for Lake Shannon – Side view showing water exit ports (CA Dept. of Water Resources)

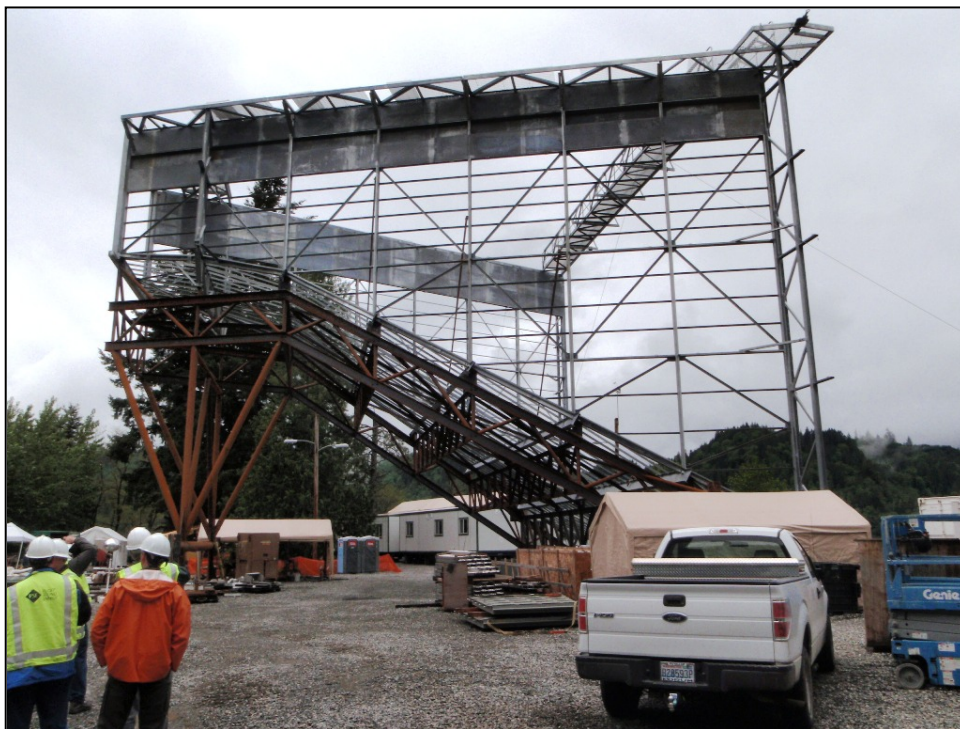
Figure 79: Net transition structure framework for Lake Shannon FSC (CA Dept. of Water Resources)

The net transition structure (NTS), attached to the upstream end of the FSC and the downstream end of the guide net, is a narrowing channel with inclined floor that provides a gradual physical and hydraulic transition from the open lake and the guide net to the FSC. It extends the entrance of the FSC to include the range of migration depths for most migrating fish (0-50 feet). The NTS modifies initial approach conditions, removing flow discontinuities, and controlling acceleration and velocity leading to the primary screens of the FSC. The NTS walls and floor are supported by galvanized steel truss frames lined with sheets of high density polyethylene (HDPE) plastic. Two trusses span the top walls to provide rigidity. The NTS is detached from the FSC during the non-operation season, when the FSC is raised for maintenance activities.

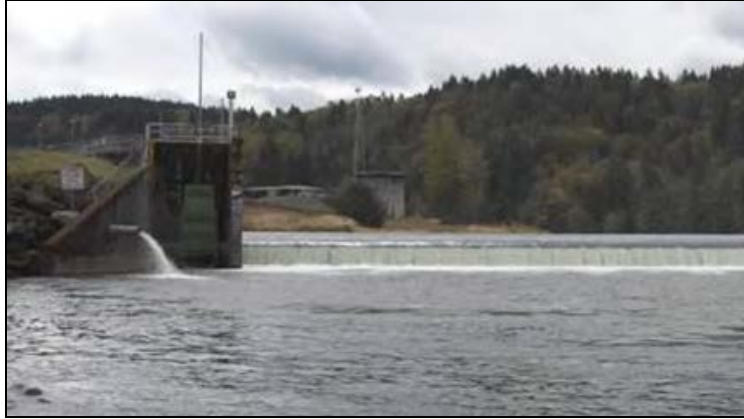
Barrier Dam (Figure 83), 2.5 miles downstream of Mayfield Dam, was constructed in 1969 to direct migrating adult fish into a ladder that connects to the Cowlitz Salmon Hatchery. The salmon hatchery was completed in 1968 and produces nearly 13 million fish each year, including about 1.3 million spring-run Chinook, 5.0 million fall-run Chinook and 2.4 million coho (Tacoma Power 2010b).

Figure 83: Barrier Dam with Downstream Migrant Outfall Pipe (Photo Courtesy of Tacoma Power)

The Barrier Dam (Figure 83) is a velocity barrier, effectively preventing fish from migrating further upstream. This barrier directs the adult fish into a fishway entrance on the north side of the river. There are right and left bank entrances to the fish ladder and an under-dam transport channel connecting the two ladder entrances. Neither the transport channel nor left bank entrance are in use because of design problems with the attraction flow. There is also an electrical field at the Barrier Dam to aid in blocking fish (NOAA Fisheries 2004).

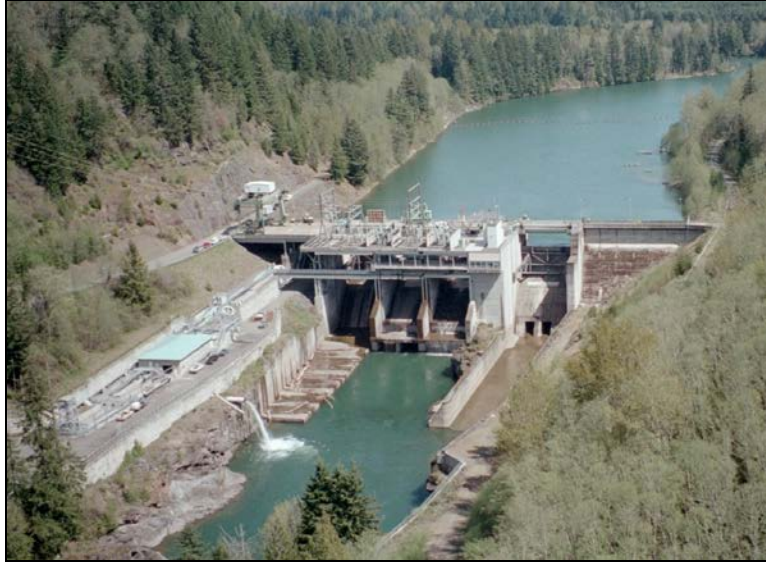
Cowlitz Falls Dam (Figure 84), the only dam in the Cowlitz Falls Project, lies just downstream of the confluence of the Cispus and Cowlitz Rivers. The 140-foot-high concrete gravity dam holds back 11,000 acre-foot Lake Scanewa, which extends upstream into the Cowlitz and Cispus River valleys 10.5 miles and 1.5 miles, respectively (Tacoma Power 2008c).

Figure 84: Cowlitz Falls Dam with Fish Facility on Left Side of Photo (Photo Courtesy of Lewis County Public Utility District)
