State of California
The California Natural Resources Agency
Department of Water Resources
FloodSAFE Environmental Stewardship and Statewide Resources Office

Technologies for Passing Fish at Large Dams

June 2013

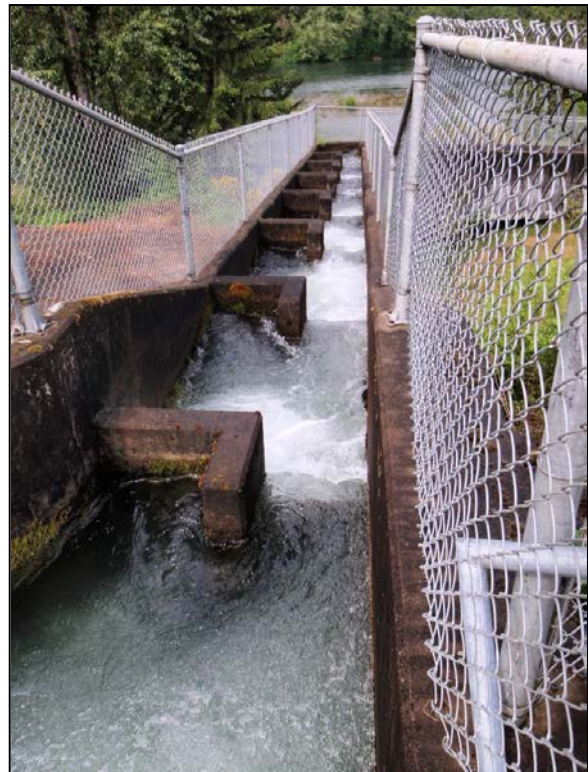
There are three segments to the fish ladder: the 250-foot-long entrance ladder, the 450-foot-long fishway pipe, and the 225-foot-long separator ladder (Figures 87 and 88), which raises fish to the height of the holding pool. The ladders are of the half-Ice Harbor configuration and are approximately 5 feet wide with 2-foot-wide weirs. The ladders and fishway pipe are designed for 22 cfs and auxiliary river water is added at the lower end of the entrance ladder to increase the attraction flow to 200 cfs, which is 10% of the minimum flow established for the Cowlitz River below Mayfield Dam and 3% of the average annual flow of the Cowlitz River below Mayfield Dam. A minimal amount of additional hatchery raceway drain water is added to the ladder flow to entice the fish to climb the fish ladder. At the top of the separator ladder, fish jump over a finger weir and into a holding pool (Figure 89). The

Figure 88: Cowlitz Salmon Hatchery separator ladder (CA Dept. of Water Resources)

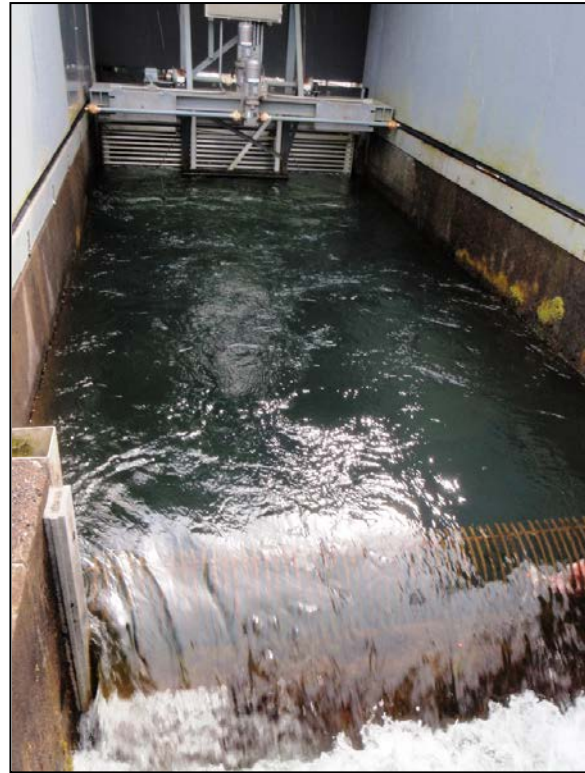
Figure 89: Cowlitz Salmon Hatchery finger weir and holding pool (CA Dept. of Water Resources)

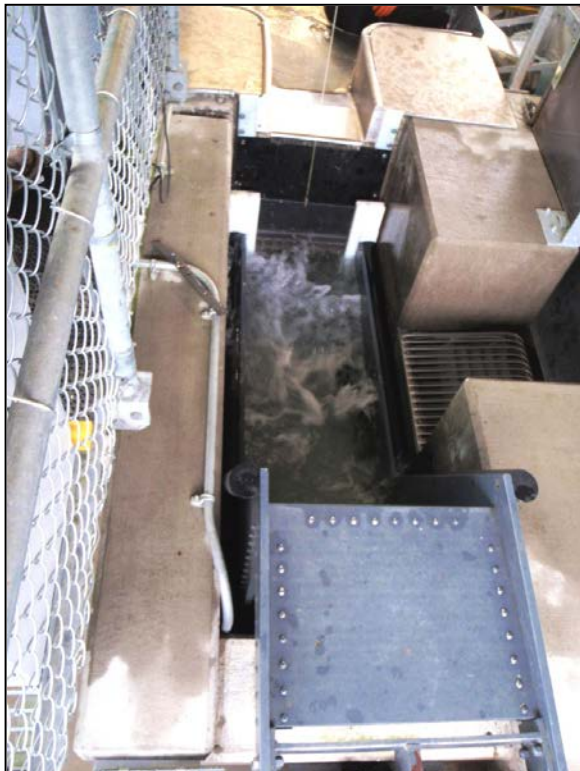
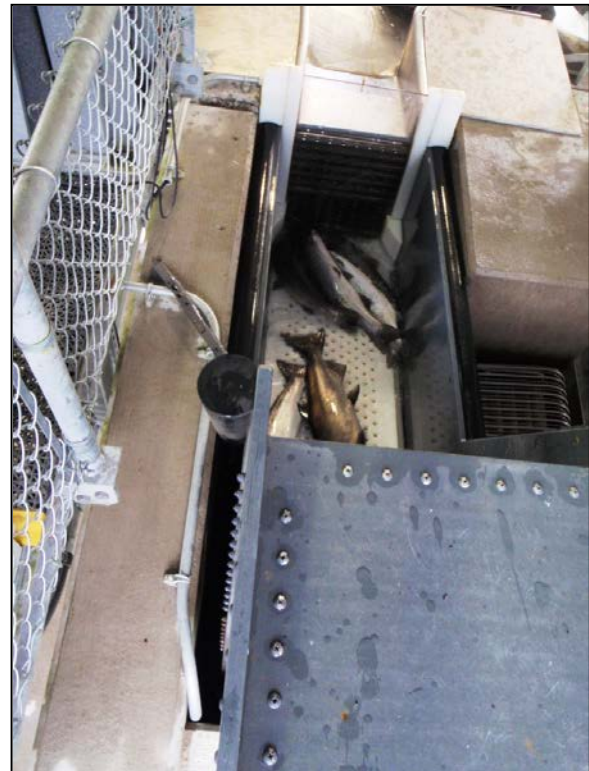
To begin the sorting process, a crowder is lowered into the holding pool, which then moves forward and lifts, reducing the available area and a false weir begins flowing, encouraging fish to jump over the weir and into a box (Figures 90 and 91). In the box, the fish are given a low voltage shock for 1.5 minutes to make them immobile. The shock takes 5 to 6 minutes to wear off. The shocked fish then are shunted down a slide to a sorting table (Figure 92).

Figures 90 and 91: Cowlitz Salmon Hatchery - Fish shock box - Non-shocked fish on left, shocked fish on right – false weir on right side of photos (CA Dept. of Water Resources)

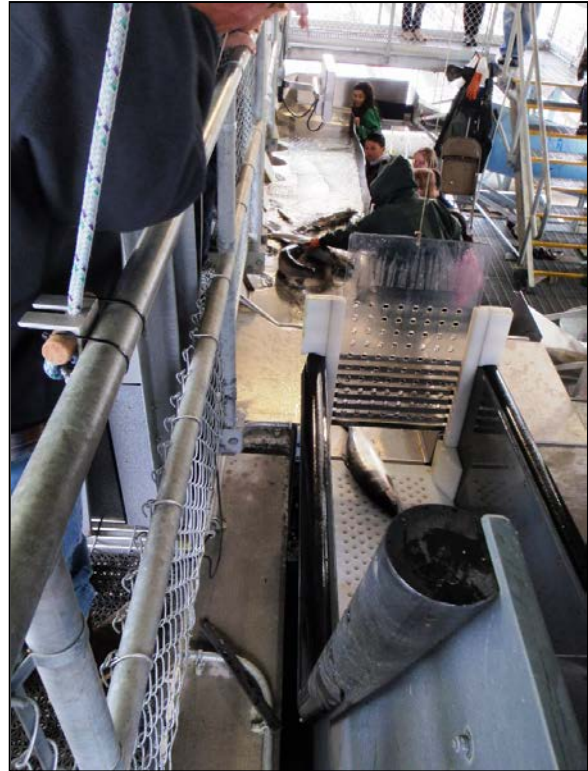
Figure 92: Cowlitz Salmon Hatchery – Fish being moved from shock box to upper sorting table (CA Dept. of Water Resources)

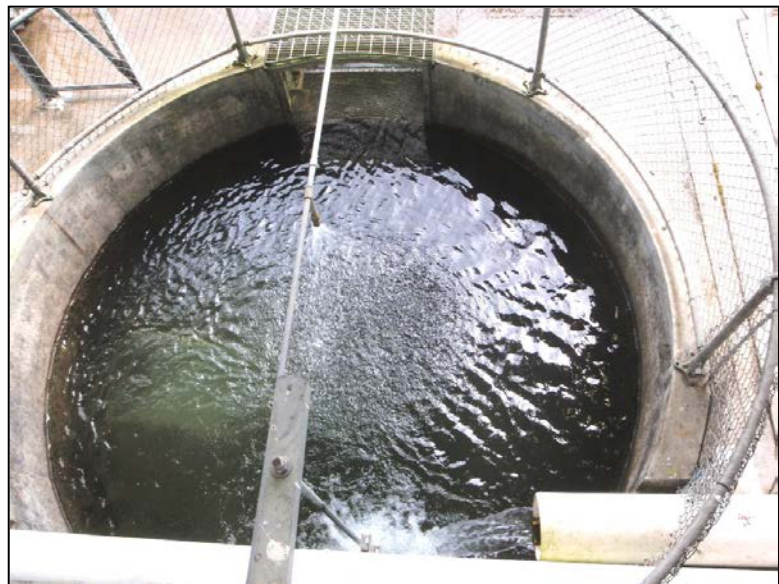
Figure 93: Cowlitz Salmon Hatchery – Adult holding tank (CA Dept. of Water Resources)

Fiberglass tubes transport the fish by gravity into one of the six holding tanks or into a flume to the hatchery ponds reserved for brood stock. The adult holding tanks have an up-well water supply, constant overhead water spray and fencing around the tanks. Each adult holding tank (Figure 93) has a 1,500 gallon capacity and is operated

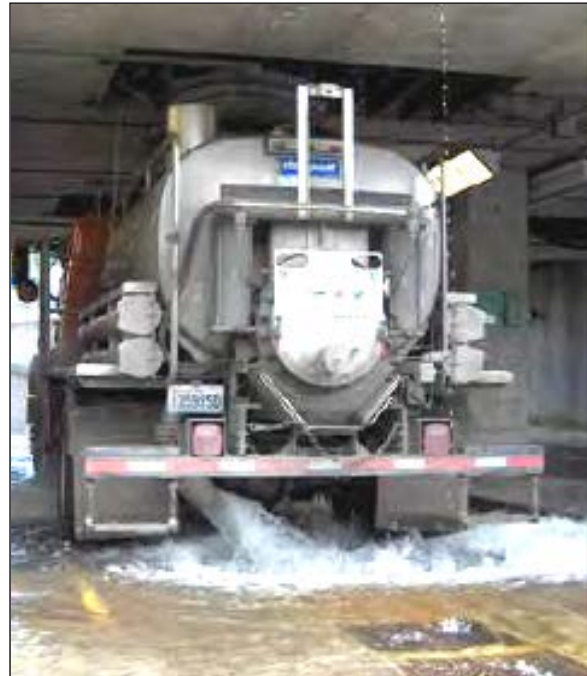
Just like the holding tanks, the fish trucks have a 1,500 gallon capacity. The trucks drive under the elevated holding tanks and are filled by draining the holding tanks through moveable bellows (Figure 94). The trucks are then driven to designated release sites.

Figure 94: Cowlitz Salmon Hatchery Truck Loading (Photo Courtesy of Tacoma Power)

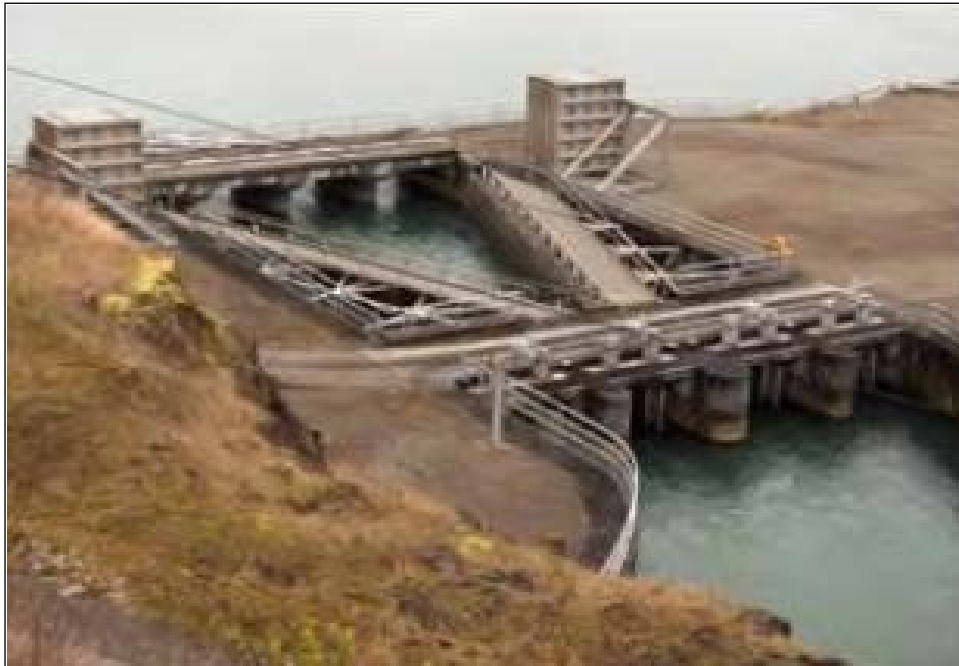
Figure 95: One of two Mayfield Dam Downstream Migrant Collection Louver Arrays (Photo Courtesy of Tacoma Power)

Downstream migrants in Mayfield Lake, mostly coho salmon mainly produced in the Tilton River system (the only major tributary to Mayfield Lake), are collected via two louver intake facilities (Figure 95). The intake facilities are 33 feet deep and consist of a series of vertical louvers which are set 2.5 inches apart in a V-formation (Figures 96 and 97). Juvenile fish are directed into a bypass system where they encounter a secondary screening system (Figure 98), where they are guided through the dam in a pipe to a sorting/counting facility (Figure 99).

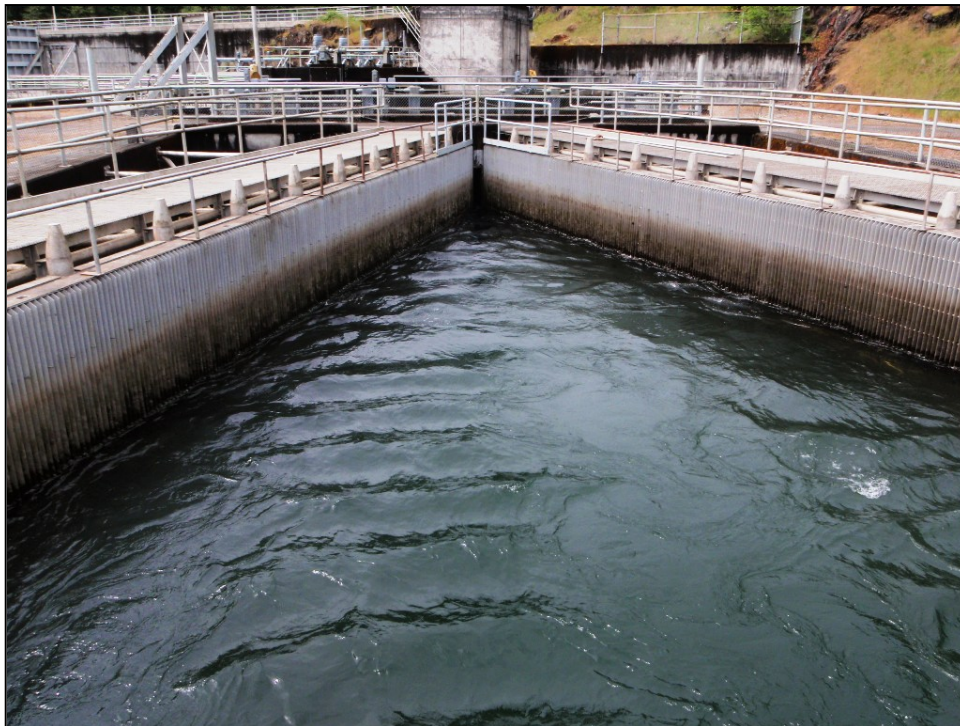
Figure 96: Mayfield Downstream Migrant Collection Louver Array (CA Dept. of Water Resources)

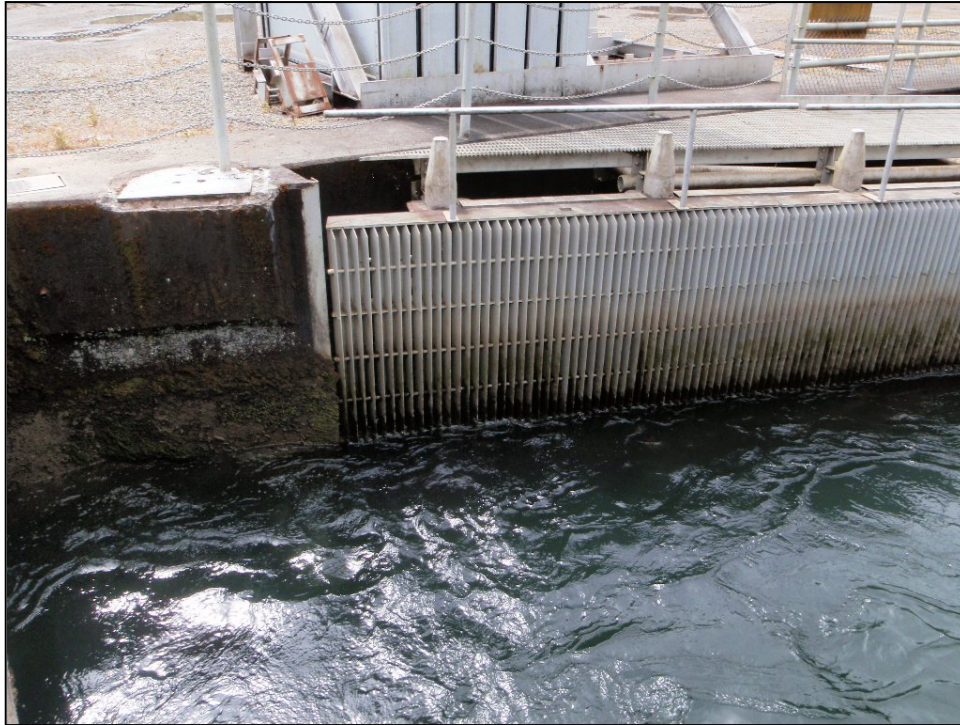
Figure 97: Mayfield Downstream Migrant Collection Facility Louvers (CA Dept. of Water Resources)

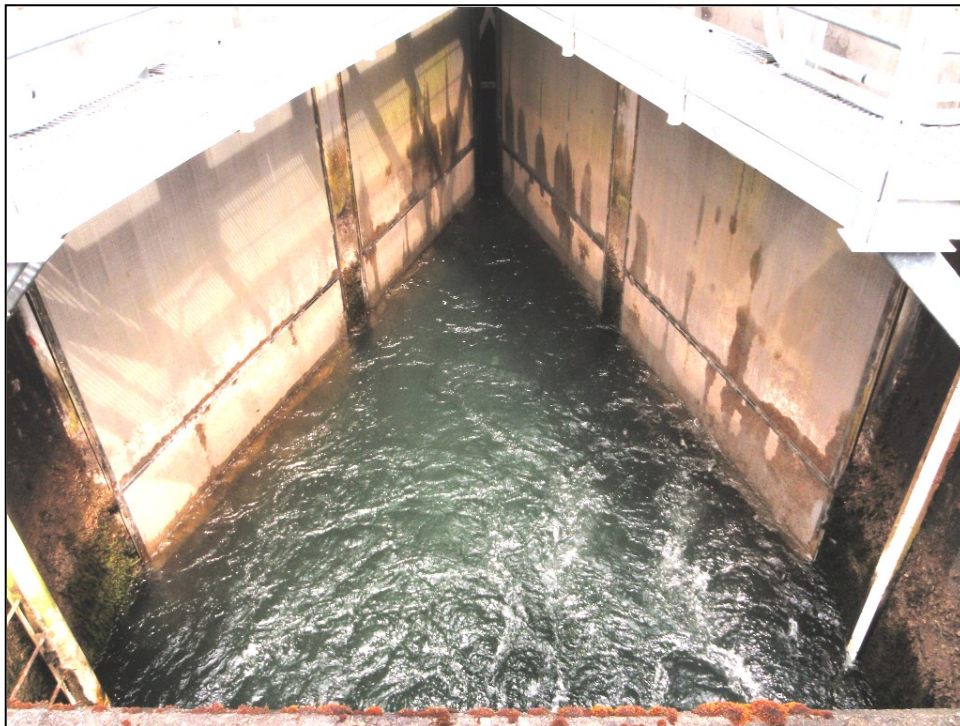
Figure 98: Mayfield Downstream Migrant Collection Facility Secondary Screens (CA Dept. of Water Resources)

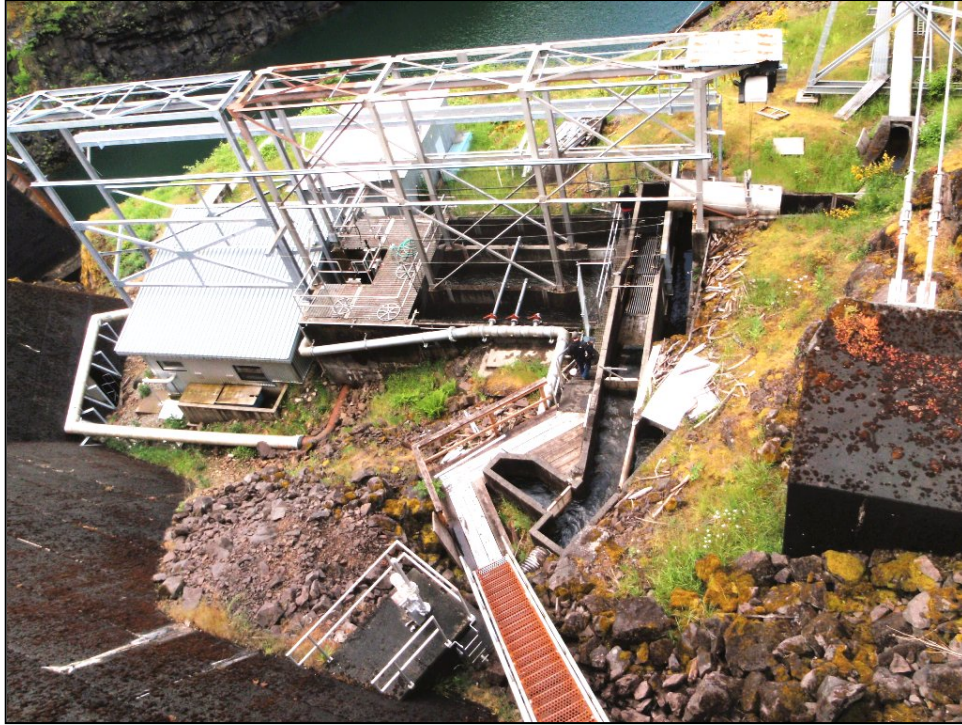
Figure 99: Mayfield Downstream Migrant Sorting and Counting Facility (CA Dept. of Water Resources)

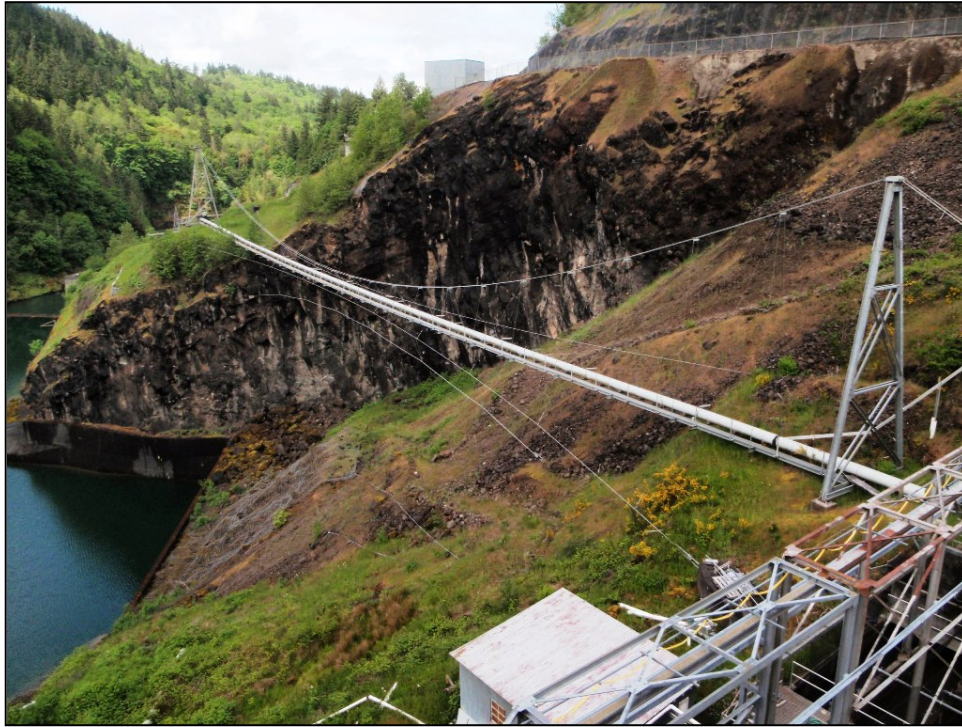
Figure 101: Mayfield Downstream Migrant Bypass Pipe (CA Dept. of Water Resources)

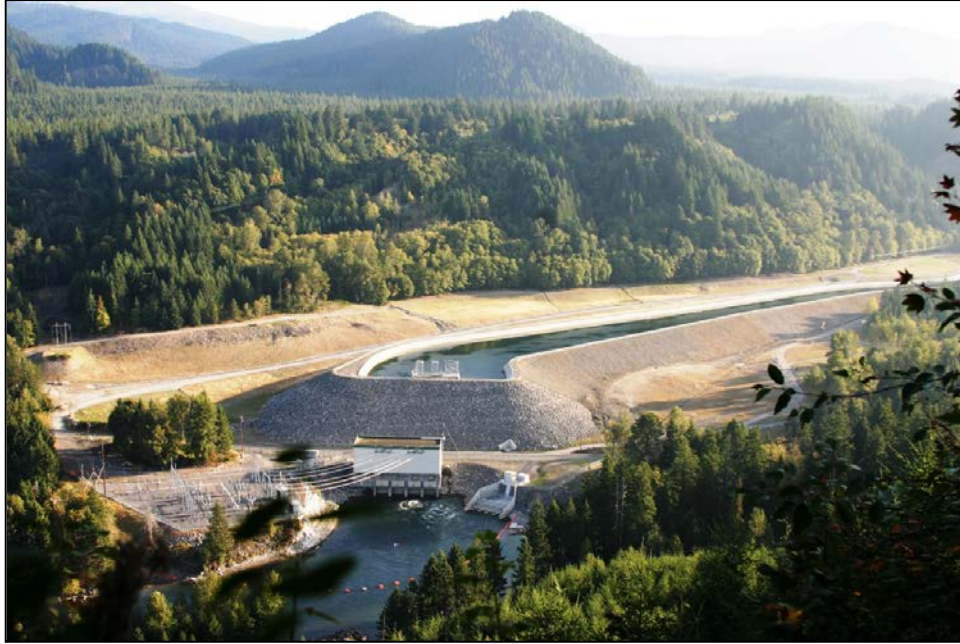
The hydroelectric projects on the Lewis River consist of three dams and four powerhouses. The three dams, Merwin, Yale, and Swift, and associated powerhouses are owned by PacifiCorp. In addition, a 70 MW hydroelectric project, Swift No. 2, is owned by Cowlitz PUD and located at the downstream end of the tailrace canal below Swift Dam (Figure 104).

Figure 104: Swift No. 2 Powerhouse (Courtesy of Cowlitz PUD)

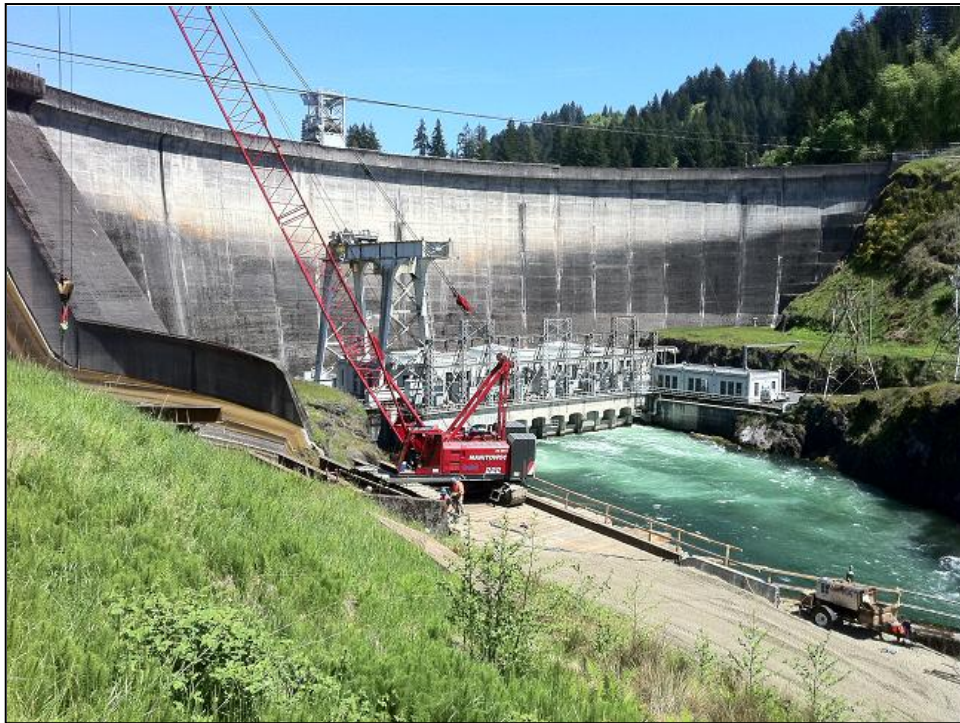
The furthest downstream dam is Merwin Dam (Figure 105), which was completed in 1931. It is a 313-foot-high (230 foot hydraulic height) concrete arch structure that creates 423,000-acre-foot, 14.5-mile-long Lake Merwin. The Merwin powerhouse has a total generating capacity of 136 MW and maximum flow capacity of 11,470 cfs (FERC 2008).

Figure 105: Merwin Dam (Courtesy of PacifiCorp)

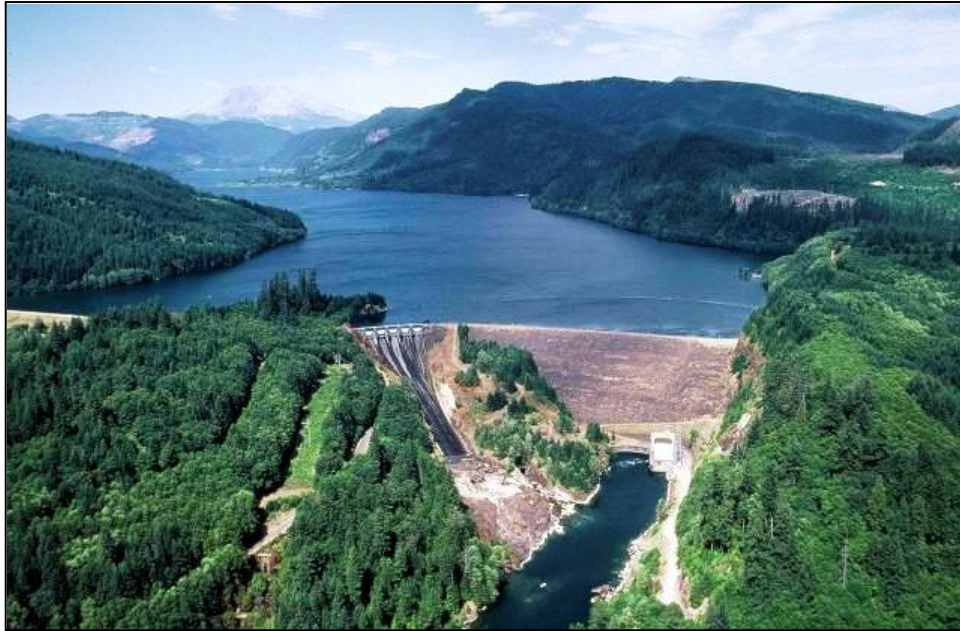
The middle dam is Yale Dam (Figure 106), a 323-foot-high (309 foot hydraulic height) mainly earthfill embankment dam, which was completed in 1953. It impounds 401,000-acre-foot, 10.5-mile-long Yale Lake, and its powerhouse has a total generating capacity of 134 MW and maximum flow capacity of 9,640 cfs (FERC 2008).

Figure 106: Yale Dam (Courtesy of Low Impact Hydropower Institute)

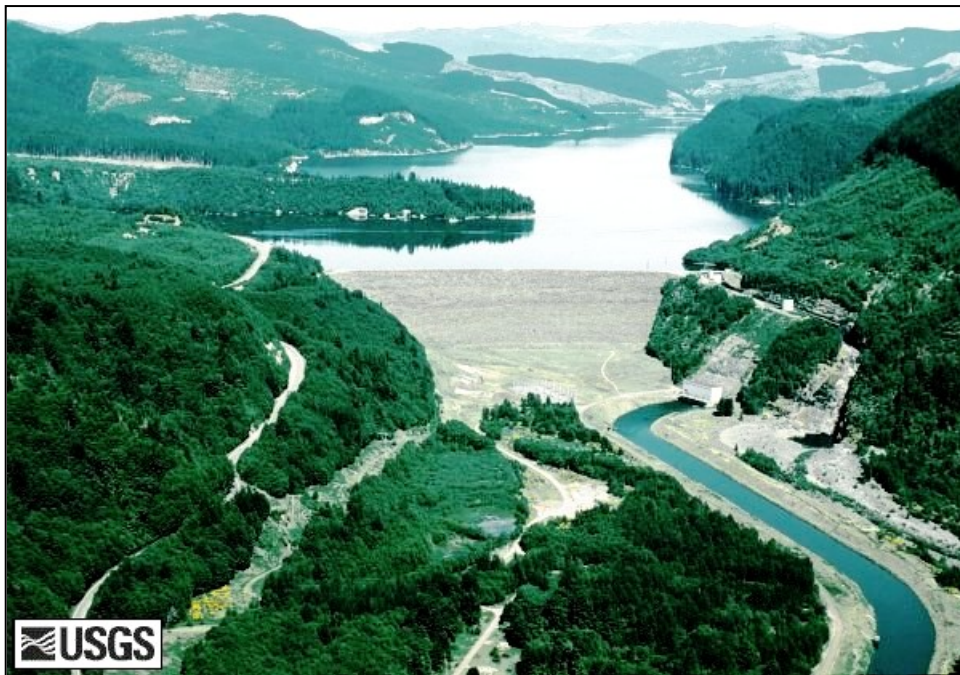
Figure 107: Swift Dam (Courtesy of the USGS)

The upper dam in the series is 512-foot-high (400 foot hydraulic height) Swift Dam (Figure 107), which retains 755,000-acre-foot, 11.5-mile-long Swift Reservoir. The Swift No. 1 powerhouse has a generating capacity of 240 MW and a maximum flow capacity of 9,120 cfs (FERC 2008). When built in 1958, Swift Dam was one of the highest earthfill dams in the world (PacifiCorp 2013).

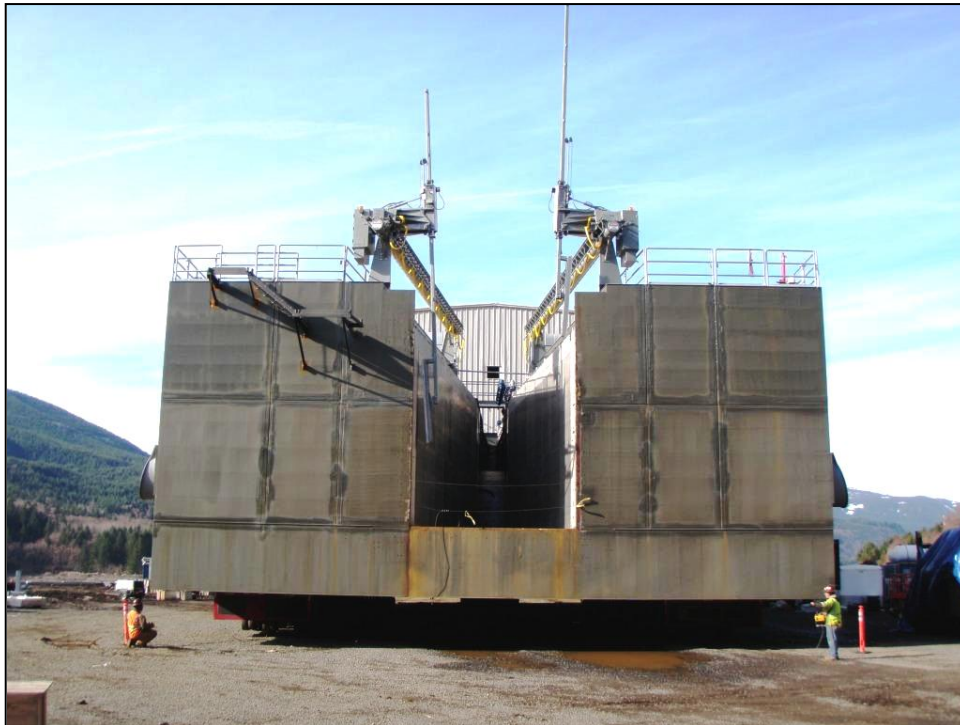
A floating surface collector (FSC) was completed and deployed in Swift Reservoir in 2012. Juvenile fish, the offspring of the salmon and steelhead that spawned upstream of Swift Reservoir, come downstream through the reservoir as they migrate to the ocean. The Swift Reservoir Fish Facility is a 170' by 60' FSC (Figures 108 and 109) which creates flow conditions to attract these fish by the use of large pumps. Full-depth, shore-to-shore nets guide the juveniles, which are typically 3 - 6 inches long

Figure 108: Swift FSC Fish Entrance (Courtesy of PacifiCorp)

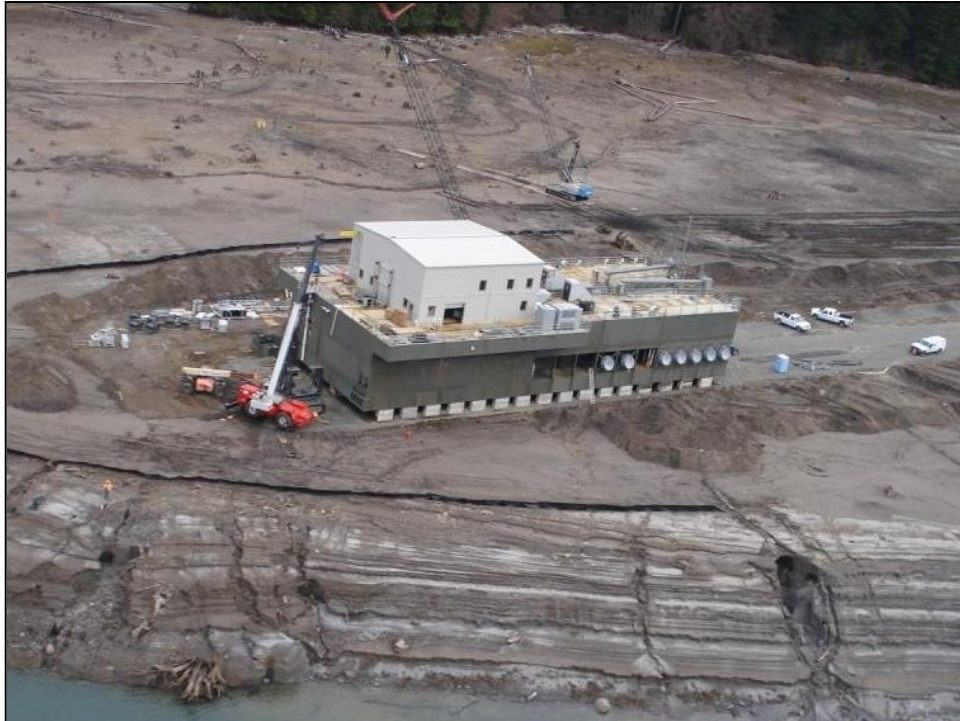
Figure 109: Swift FSC (Courtesy of PacifiCorp)

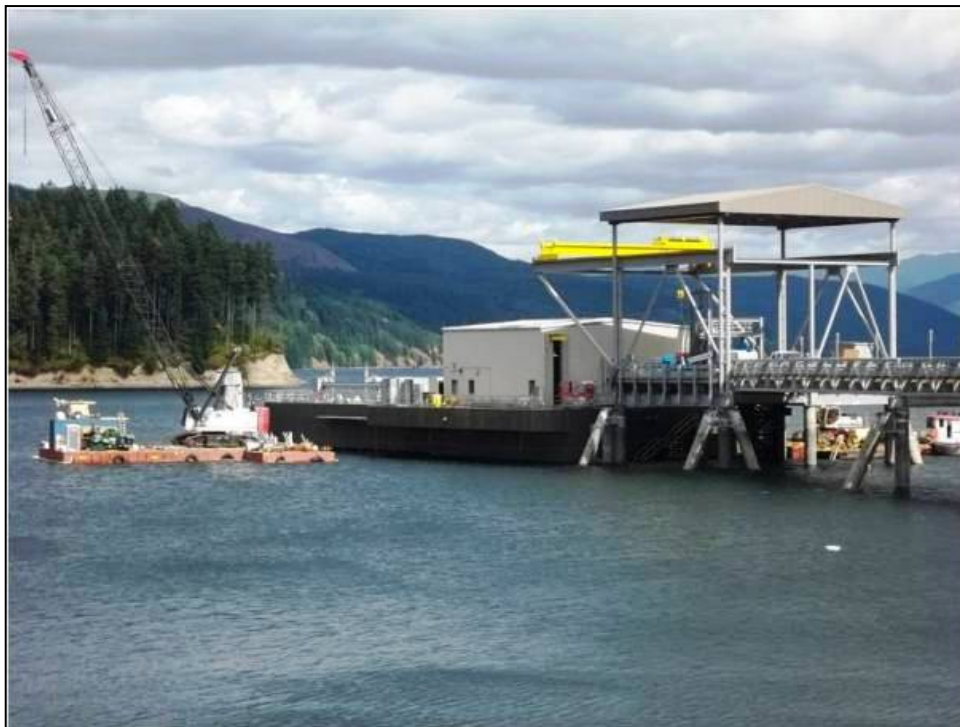
The FSC is located near the south end of Swift Dam, anchored by a mooring tower and connected to the dam by a 650-foot-long access trestle (Figure 111). The tower and trestle are supported on piles, and the FSC rises and falls with the reservoir level (PacifiCorp 2013).

Figure 111: Swift FSC and Access Trestle (Courtesy of PacifiCorp)

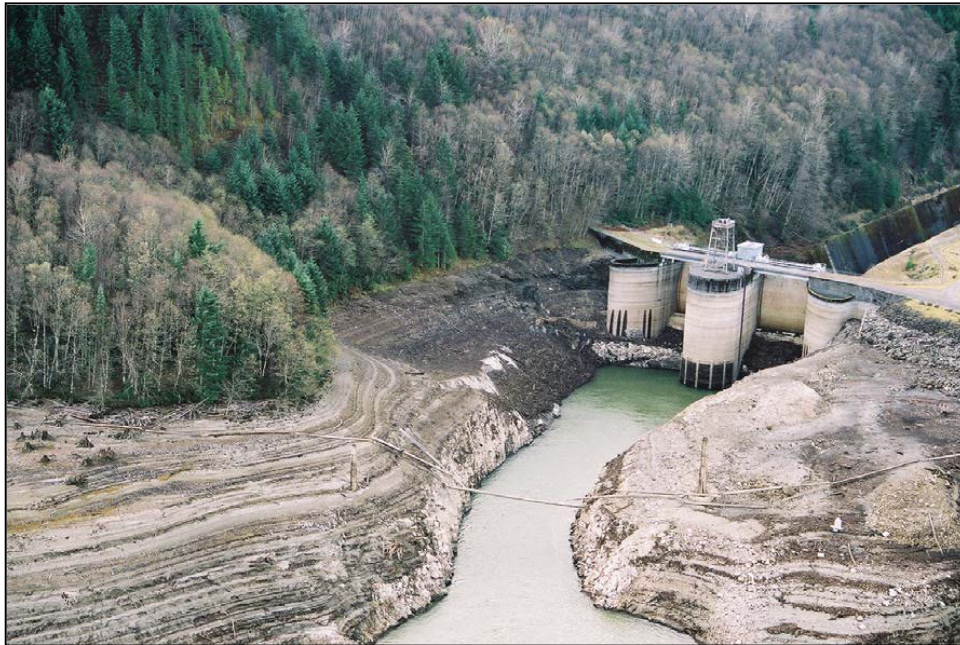
Figure 113: Swift Intake Channel at Low Reservoir Elevation (Courtesy of PacifiCorp)

After considering the fish tracking studies and the CFD modeling, the conclusion was that the FSC should be located as close to the intake as possible. However, due to the restricted width of the intake channel, the FSC could not be located within the channel (Figure 113). As a result, the FSC will be located just upstream of the intake channel (Shallenberger et al 2009).

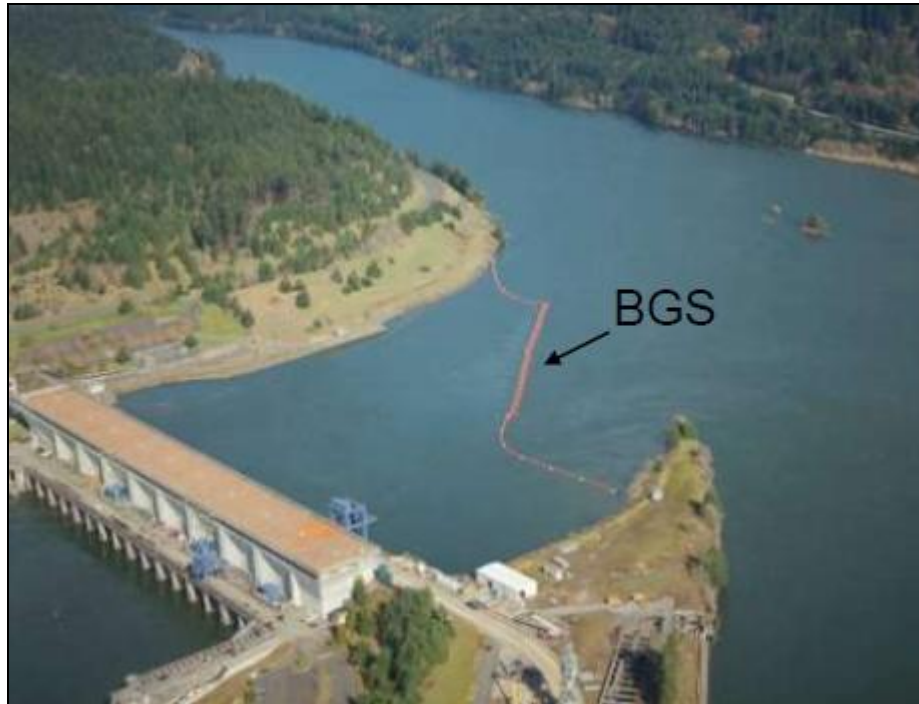
Figure 121: Behavioral Guidance System in the second powerhouse forebay (source: USACE)

In 2008, a prototype Behavioral Guidance System (BGS), 700 feet long and 10 feet deep, was installed in the forebay of the second powerhouse (Figure 121). The purpose of the BGS was to increase the passage of juvenile salmon into the corner collector. Since the corner collector is known to be a relatively benign route for downstream passage, it was expected that passage survival of juvenile salmon and steelhead would increase at the second powerhouse. The USACE Portland District asked Pacific Northwest National Laboratory (PNNL) to conduct an acoustic telemetry study to evaluate the prototype BGS. The PNNL studied approach and passage distribution of juvenile salmon relative to the BGS location. They also estimated route-specific survival of tagged juvenile salmon and steelhead passing downstream through the second powerhouse. The PNNL found the BGS increased passage percentage into the corner collector for yearling Chinook salmon by up to 9%, but no improvements were observed for subyearling Chinook or juvenile steelhead when comparing 2008 study results to passage distributions observed in 2004-2005 radio-telemetry studies. However, it should be noted that in 2004-2005 all turbines were operating, while in 2008 one turbine unit was offline, making it difficult to compare passage percentages. The BGS was designed to be used with total powerhouse operation. Overall, the corner collector efficiency was 75% for juvenile steelhead, 49% for yearling Chinook salmon, and 40% for subyearling Chinook salmon. For the relatively high flow year in 2008, there were high survival rates for all passage routes of the second powerhouse. For yearling Chinook salmon, paired and triple release survival estimates were at or near 100% for the corner collector and juvenile bypass system, and 97% -98% for turbine routes. For subyearling Chinook salmon, paired and triple release survival estimates were near 100% for the corner collector and juvenile bypass system, and 95% - 97% for turbine routes. There were no controlled releases for juvenile steelhead, so survival was evaluated using single-release Cormack-Jolly-Seber models. The PNNL found survival estimates near 98% for steelhead for all routes at the second powerhouse through the tailrace. (PNNL 2010)

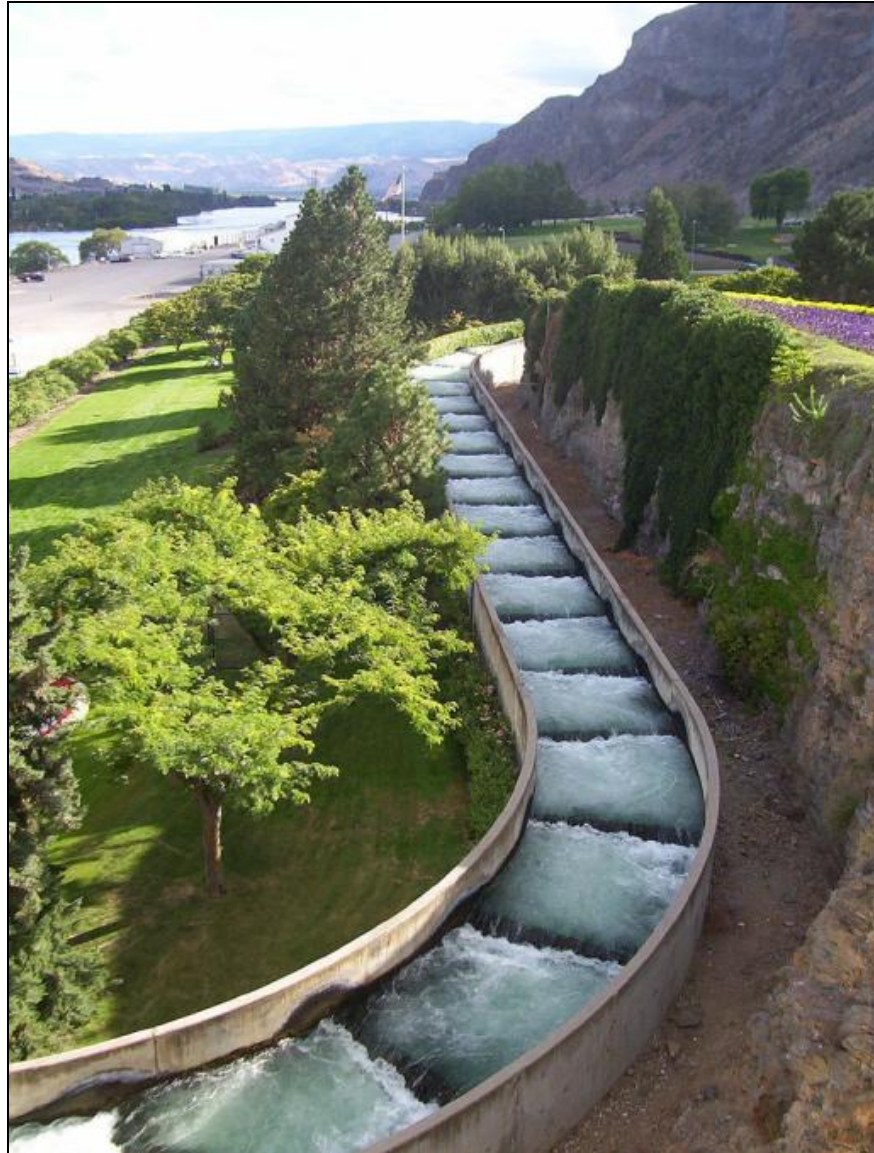
Figure 123: Pool and weir fish ladder at Rocky Reach Dam (This file is licensed under the Creative Commons Attribution ShareAlike 3.0 License. Photo taken by: Garrett Fitzgerald)

The fish ladder at Rocky Reach is a pool and weir type ladder. Each weir has a “perched orifice”, a square hole in the weir wall located on alternating sides of each weir. Fish have the option of passing through the orifice instead of going over the weir (Hemstrom, personal communication, 2010c). The pools are 16 feet wide by 16 feet long. The total elevation gain through the ladder is 90 feet. Each weir is set one foot below the previous weir (Hemstrom, personal communication, 2010d). A photograph of the fish ladder is shown in Figure 123.

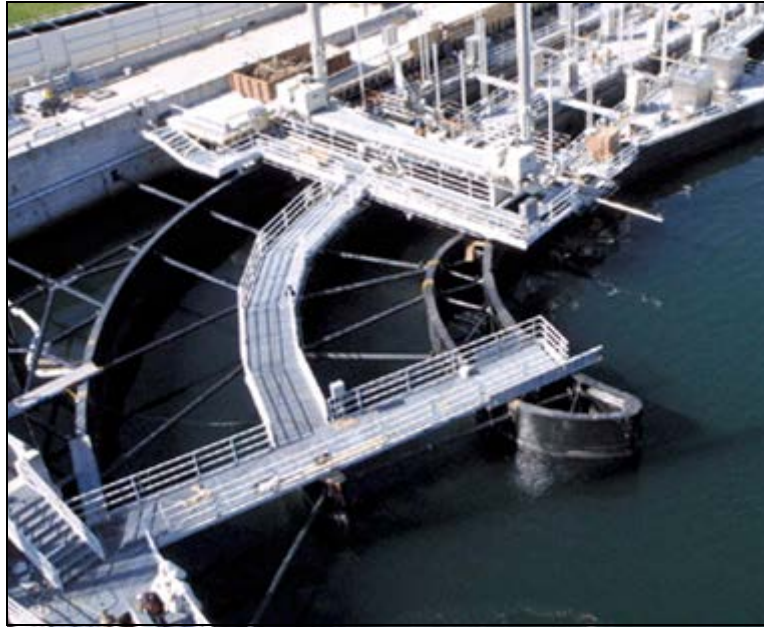
Figure 124: Twin entrances to juvenile bypass surface collector, forebay Rocky Reach Dam (Courtesy of Chelan County PUD)

A prototype collection and bypass system was installed in 1995. This was added after trying prototypes of more traditional screening systems that worked on other Columbia River hydroelectric projects, but not on Rocky Reach. The surface collector was designed to use natural and turbine-induced surface currents in the upper 60 feet of the river to provide fish with an alternative to passing through the turbine intakes. Some benefits of this design include the minimal volume of flow that is lost and low installation cost. The prototype surface collection system was modified each year, based upon test results from the previous year, until the configuration was considered satisfactory. A permanent surface collection system (Figures 124 through 127) was installed in 2002-2003. The final design uses 29 pumps to create a strong current which helps attract juvenile fish to the collector. (Chelan County PUD [date unknown-b])

Flow from the forebay enters the Surface Collector (SC) at a rate of 6,000 cfs (3,000 cfs per entrance – two entrances). Smolts enter one of two SC channels in the forebay (each 20 ft wide x 57 ft deep x 191 ft long) where flow from each channel is dewatered through fine screening from 3,000 cfs down to 120 cfs (water is pumped back into the forebay). Water velocity in the SC channels is maintained at 2.85 fps. Fish enter the bypass pipe from the SC channels with a flow of 240 cfs. Vertical Barrier Intake Screens in turbine units 1 & 2 also deliver screened fish and 120 cfs flow into the Bypass pipe. Total flow inside the bypass pipe delivering smolts from the forebay and turbine units is 360 cfs, giving fish a transport time of approximately 7-8 minutes. Water and fish are released several hundred yards downstream of the dam in a fast moving area of the river. Prior to exiting to the downstream side of the Project, the pipe runs through a juvenile sampling station where smolts are sampled each day from 0800-1130. Juvenile and adult separation occurs here also. The sampling facility serves to examine the condition of the bypass fish, provide estimates of run-timing for each species past Rocky Reach dam, and to collect run-of-river smolts to conduct Project Survival studies required by Chelan PUD's first and only in the nation, Anadromous Habitat Conservations Plans (HCPs) for the Rocky Reach and Rock Island Projects.

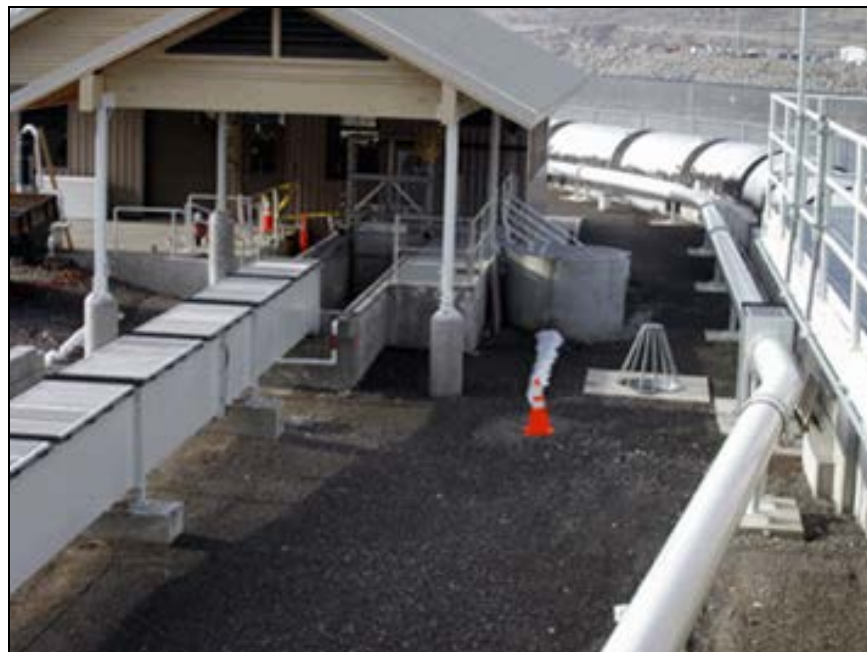
Figure 125: Rocky Reach juvenile bypass sampling facility: fish condition and run-timing is monitored. Smolts are also collected for acoustic tagging in survival studies. (Courtesy of Chelan County PUD)

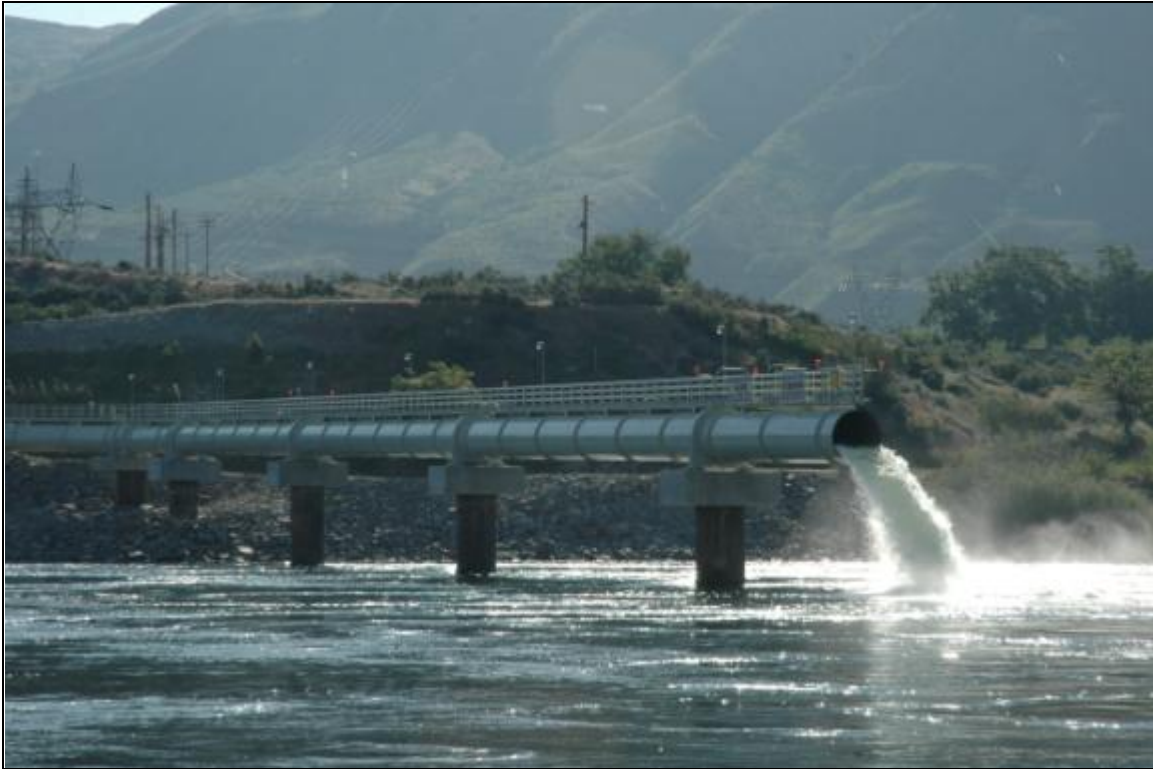
Figure 127: Close-up of Rocky Reach juvenile bypass system tailrace exit (Courtesy of Chelan County PUD)

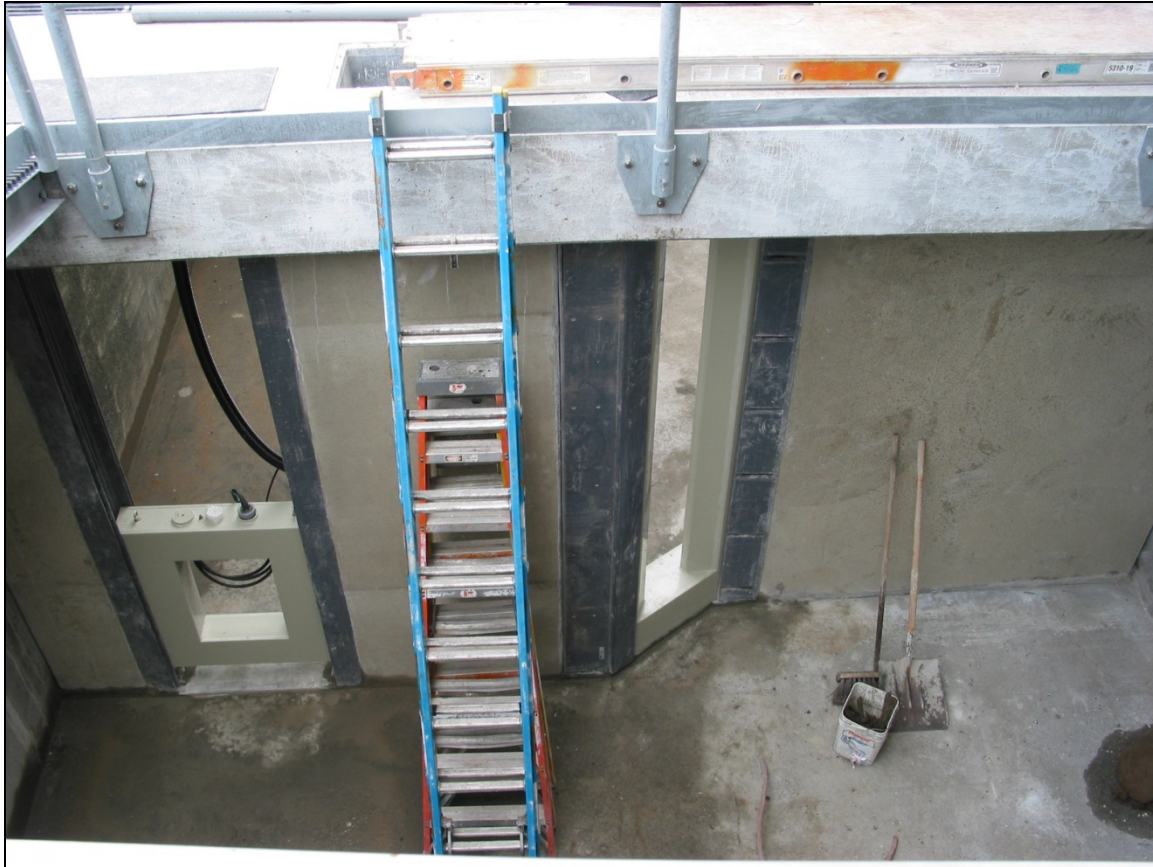
Figure 134: Lower Granite Dam Fish Ladder: Vertical slot and weir orifice antennas during installation (Courtesy of PTAGIS)

Most of the upstream passage facilities can be seen in Figure 133. In 2003, PIT tag detectors were installed on four weirs in the upper section of the ladder. Figure 134 shows the fish ladder during antenna installation and Figure 135 shows the ladder post-installation when the ladder is operational.

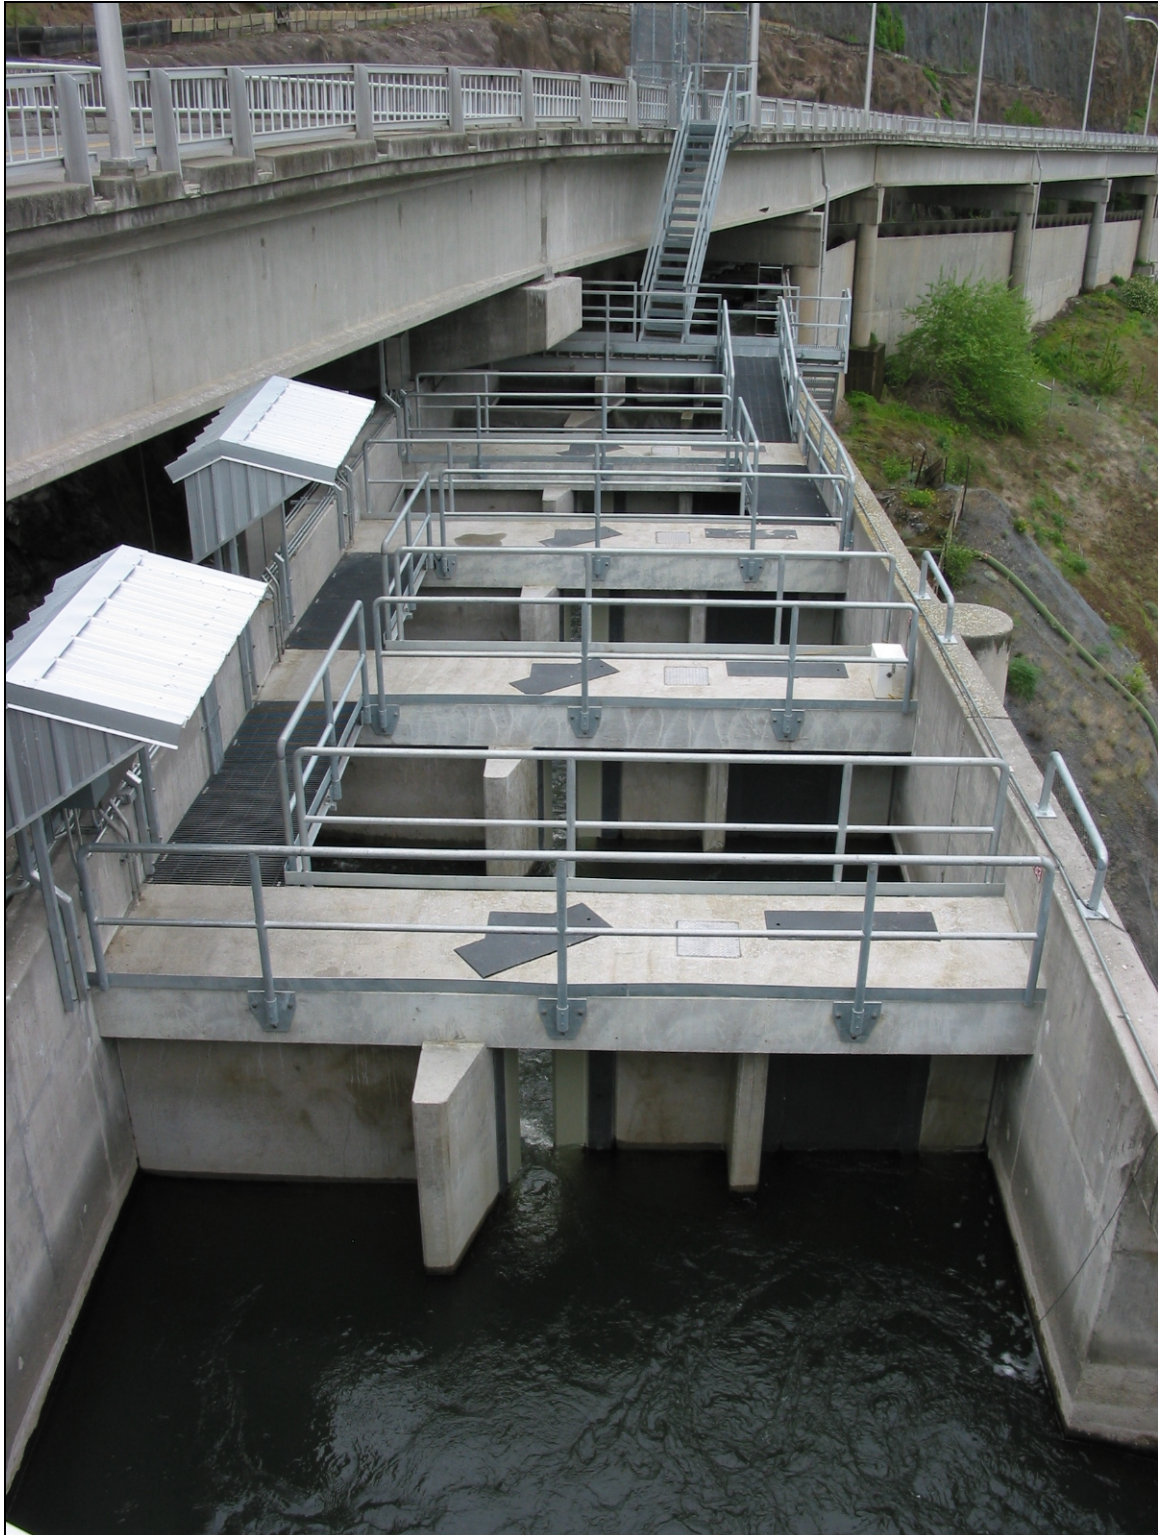
Figure 135: Lower Granite Dam Fish Ladder: Vertical slot and weir orifice antennas after installation, when the ladder is operational (Courtesy of PTAGIS)
