State of California
The California Natural Resources Agency
Department of Water Resources
FloodSAFE Environmental Stewardship and Statewide Resources Office

Technologies for Passing Fish at Large Dams

June 2013

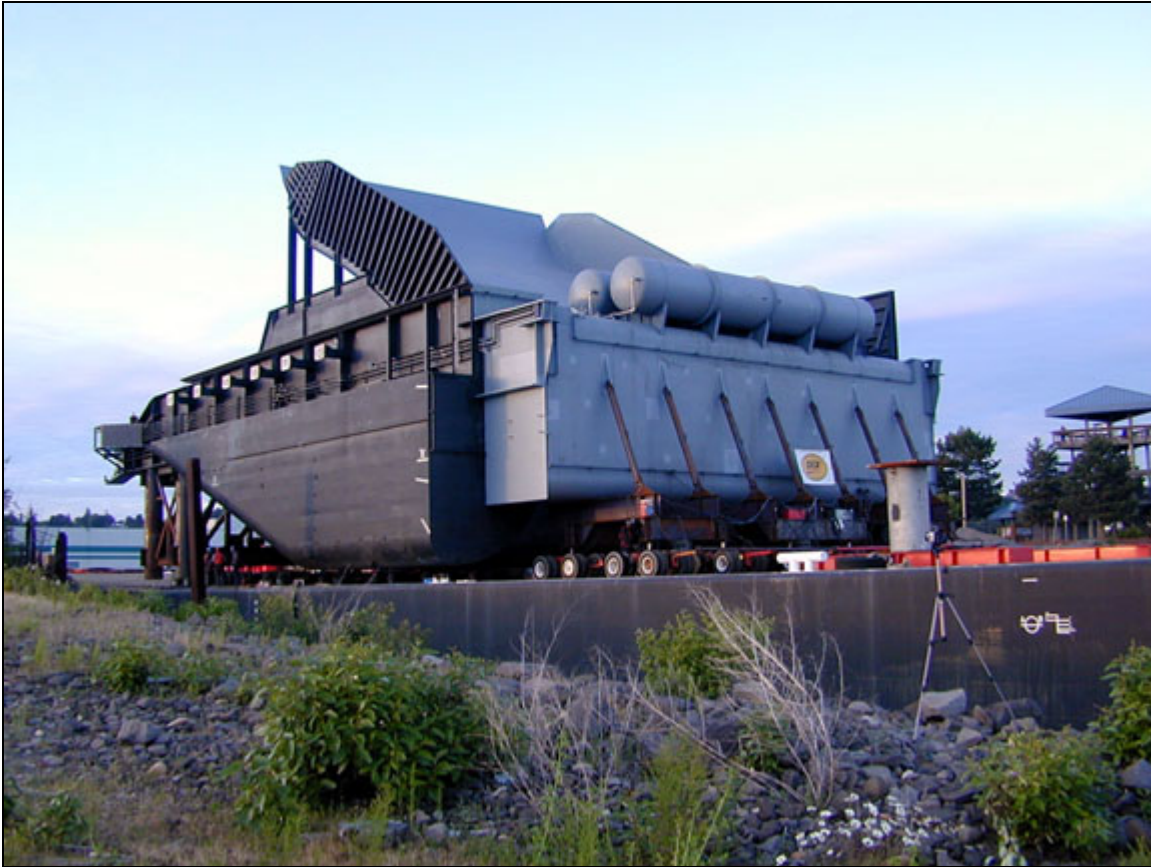
Figure 136: Removable Spillway Weir, before installation at Lower Granite Dam (source: USACE)

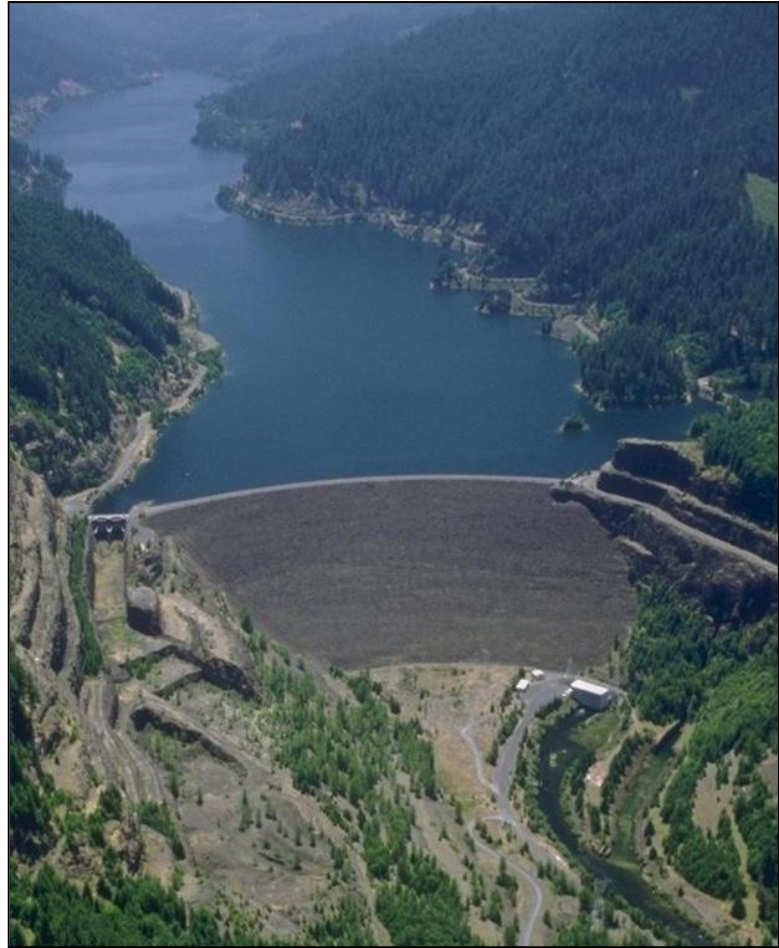
Figure 144: Cougar Dam and Reservoir (Courtesy of USACE)

One of the dams constructed was Cougar Dam (Figure 144), located on the South Fork McKenzie River approximately 42 miles east of Eugene and 4 miles upstream of the confluence with the mainstem McKenzie River. The 519-foot-tall (structural height) rock-fill embankment dam was completed in 1963 and holds back the 6.5-mile-long, 219,000-acre-foot Cougar Reservoir. The power plant penstock and the regulating outlet are both fed by the same intake structure, with the regulating outlet intake 60 vertical feet above the penstock intake. The 13.5-foot-diameter regulating outlet releases water down a steep, 225-foot-high outlet chute (Figure 145). As much as 13,500 cfs can be released through the regulating outlet and 76,140 cfs over the spillway with the reservoir at maximum pool elevation. In addition, up to 1,050 cfs can be run through the 2 turbines of the power plant, located at the downstream toe of the dam, generating as much as 25 MW. Generally, the reservoir is operated mainly for flood control and water storage, with low water surface elevations in the winter, filling operations February through May, and release of conserved water May through November. The target elevation for the reservoir in winter is about 160 feet below the maximum conservation storage elevation (CH2M Hill 2000).

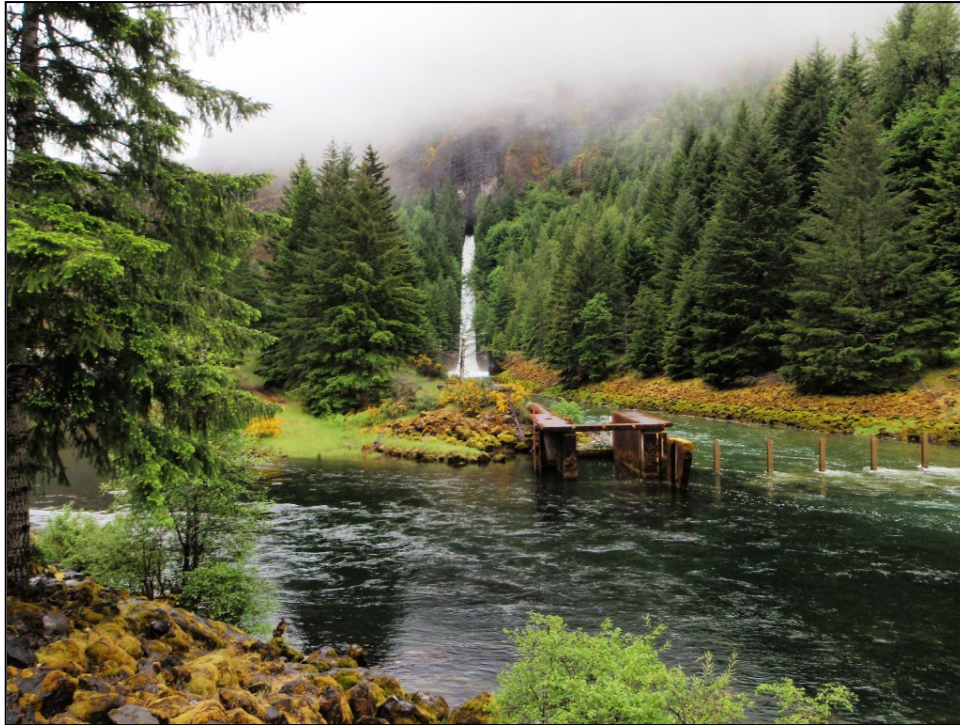
Figure 145: Regulating Outlet (CA Dept. of Water Resources)

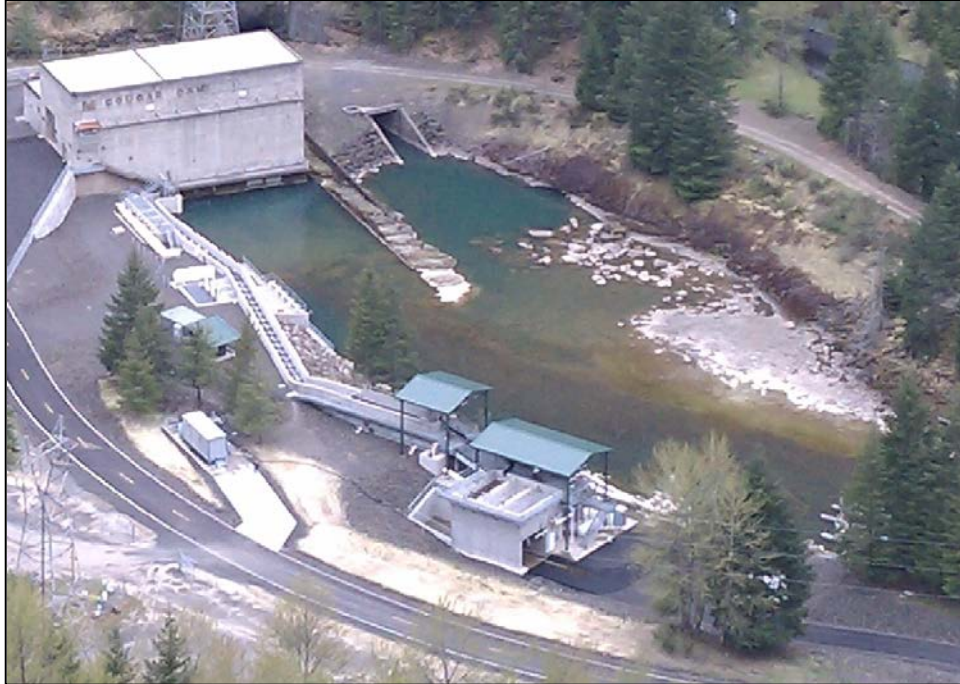
Figure 148: Overview of the Adult Collection Facility (Courtesy of USGS)

In 2010, a \$10.4 million dollar adult collection facility was completed in the powerhouse tailrace channel on the right bank of the South Fork McKenzie River (Figures 147 and 148). The facility was constructed to allow for collection, sorting, holding, and transporting adult migrating fish. A Half-Ice Harbor fish fishway was constructed to get the upstream migrants to the collection area (Figures 149 and 150). The entrance to the fishway is just downstream of the powerhouse outfall to help fish easily find it. The fishway flow is 30 cfs and 100 cfs of auxiliary water is added at the downstream end to better attract fish to the entrance. At the top of the fishway, fish jump over a finger weir into the pre-sort pool (Figure 151). A crowder is used to concentrate fish at the upstream end of the pre-sort pool and

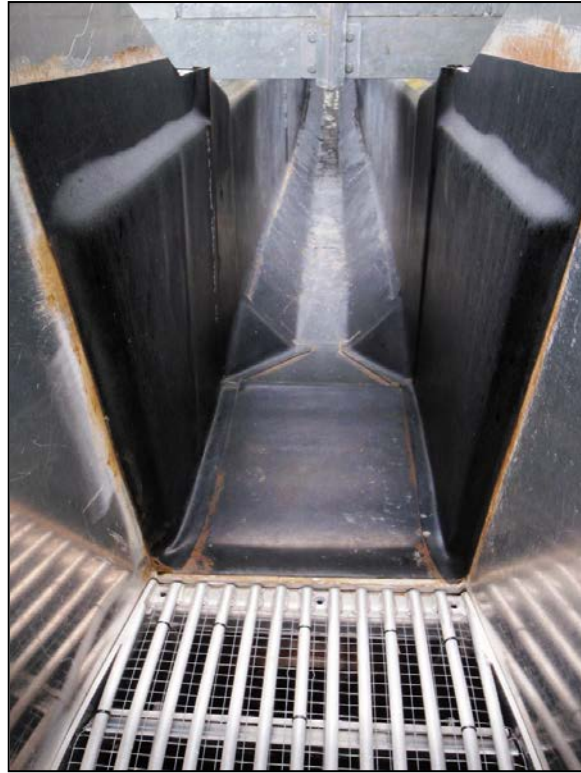
Figure 152: False Weir and Flume to Sorting Area (CA Dept. of Water Resources)

then they are attracted to a false weir which they jump over and slide down a flume to an anesthetic tank or to a post-sort pool (Figures 152 and 153). The post-sort pools (Figure 154) sit directly over the truck loading area (Figure 155). The pools are emptied through a 3-foot-diameter port in the bottom which is attached to the truck by movable bellows (Figure 156). The loaded fish are transported approximately 9 miles and released at a location about a mile upstream of the head of the reservoir (Figure 157). The USACE are using a new truck based on the design of the Tacoma Power trucks used in the Cowlitz River system (Greg Taylor, Personal Communication, Nov 7, 2011).

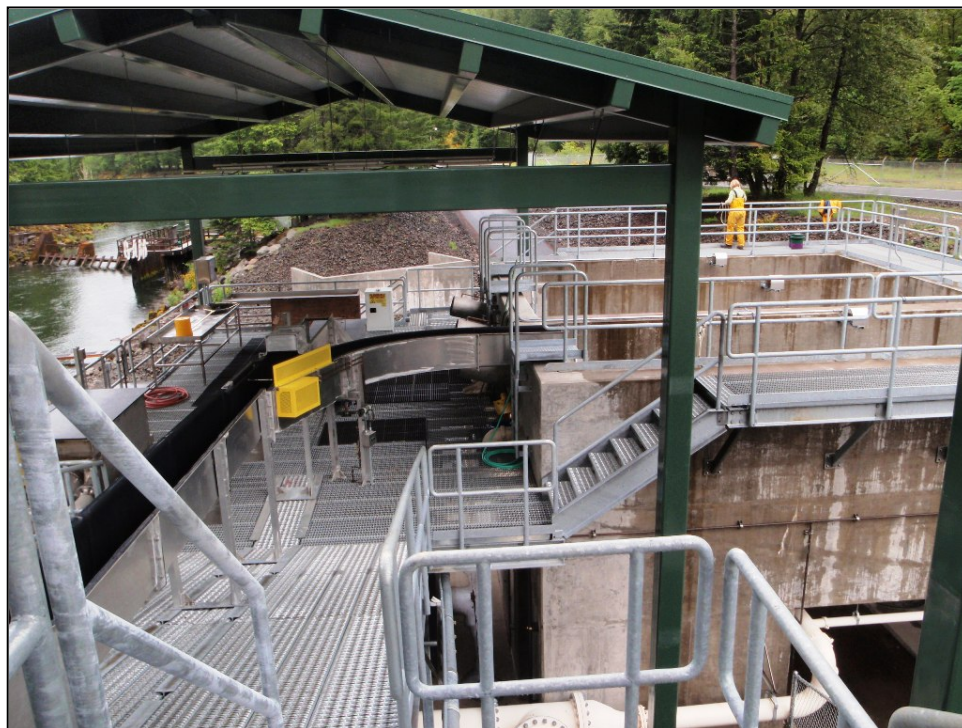
Figure 153: Sorting Area and Post-Sort Pools (CA Dept. of Water Resources)

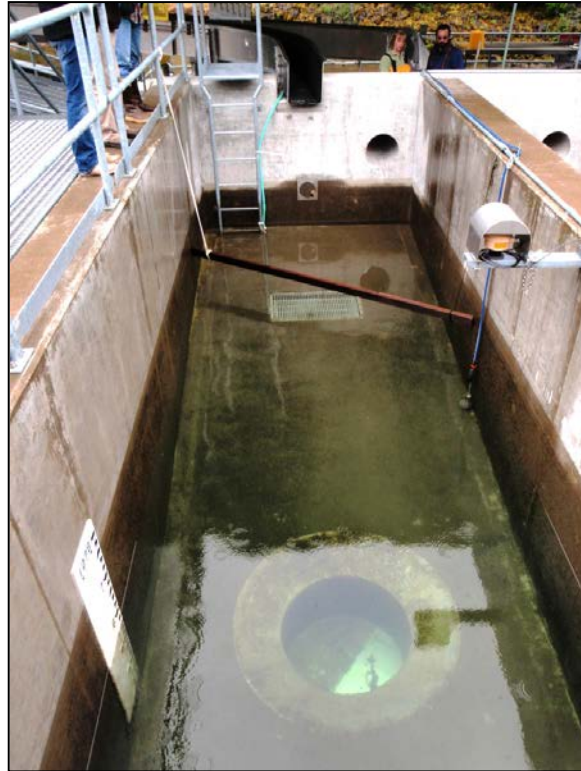
Figure 154: Post-Sort Pool and Fish Loading Port (CA Dept. of Water Resources)

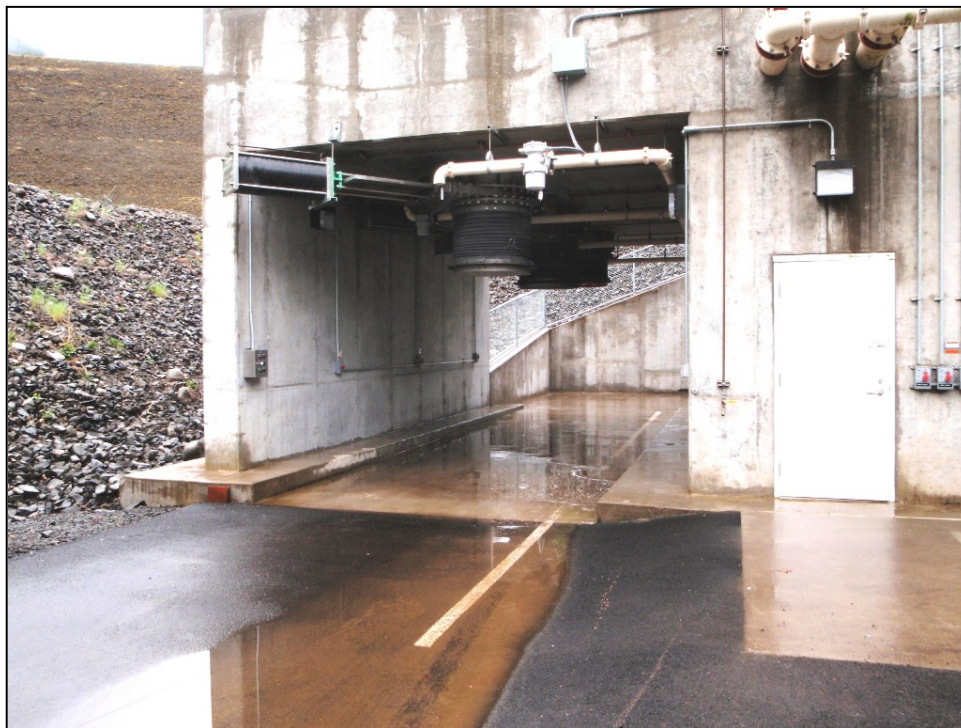
Figure 155: Truck Loading Area (CA Dept. of Water Resources)

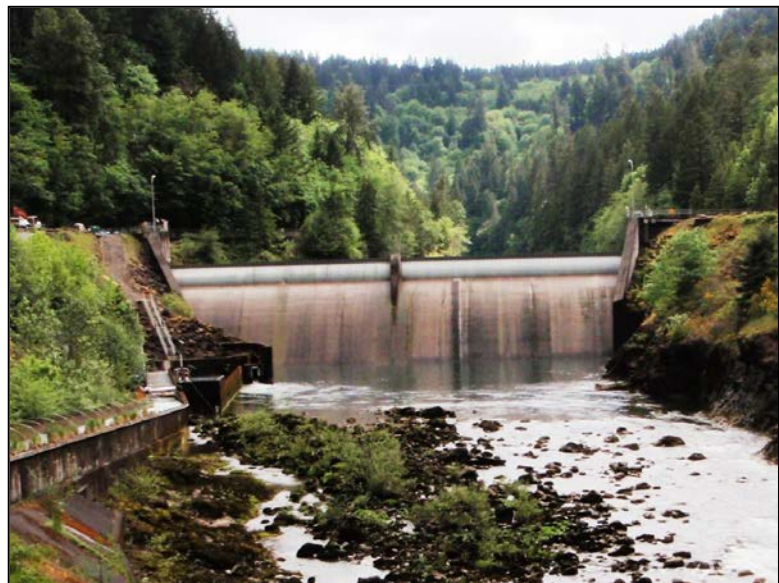
Figure 160: Faraday Dam (CA Dept. of Water Resources)

Faraday Division Dam, the middle dam for the Project, is 84 feet high (56-foot hydraulic height) and 407 feet long (Figure 160). It was completed in 1965 and backs up the Clackamas River for 1.6 miles in 1,200-acre-foot Diversion Dam Reservoir. The spillway for the dam is 255 feet long, consisting of two sections topped by 125-foot-long, 10-foot-high steel drum gates. The dam does not have any power generating facilities but is used to divert water into a 23-foot-diameter, 5-mile-long tunnel which flows into a canal, then into Faraday Lake. Faraday Lake is small, with only 430 acre-feet of volume, and is backed up behind Faraday Lake Dam. The lake is also the forebay for the Faraday Powerhouse, which is capable of generating as much as 46 MW of power using 6 Francis turbines. The Faraday Dam also has an emergency spillway containing five gated outlets (PGE 2004).

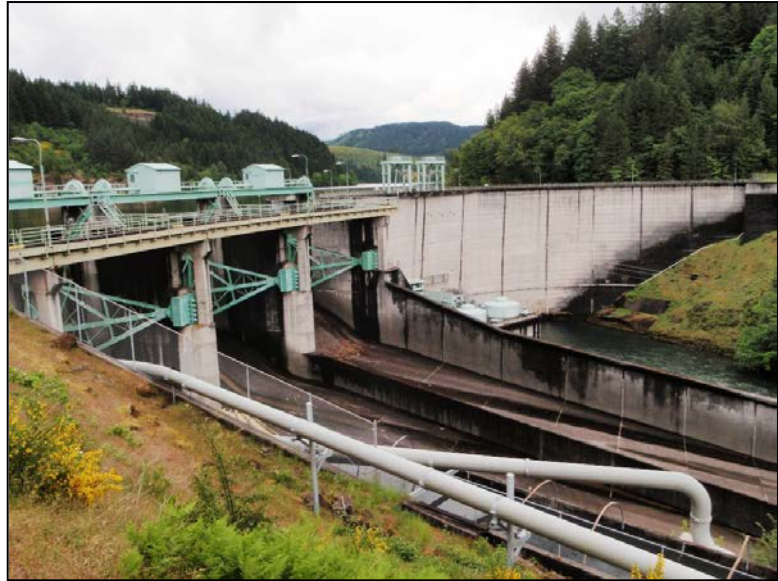
Figure 161: North Fork Dam (CA Dept. of Water Resources)

North Fork Dam was completed in 1958 and is the most upstream development of the Project (Figure 161). It is a 207-foot-high (145-foot hydraulic height), 676-foot-long concrete arch dam which creates the 21,000-acre-foot North Fork Reservoir. North Fork Reservoir impounds approximately 4.6 miles

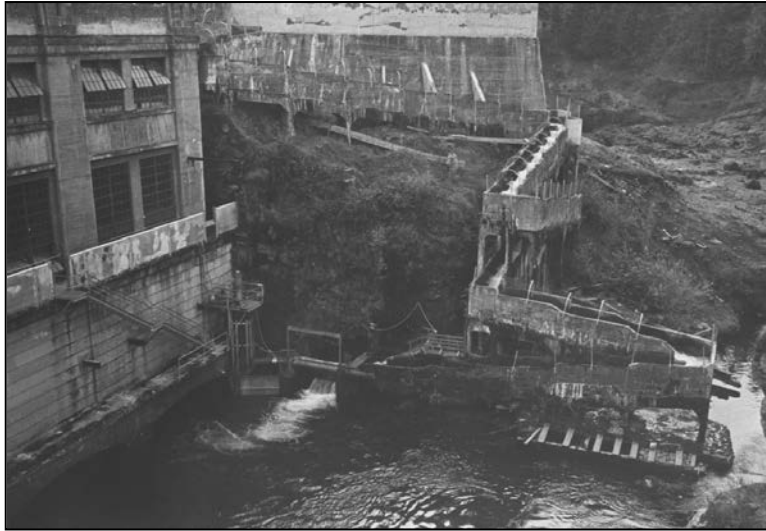
Figure 162: Old River Mill Fish Ladder - 1968 (NOAA Fisheries)

Upon completion, River Mill contained a concrete fish ladder that had received approval from Oregon's Master Fish Warden. The ladder was considered a model design for its day. Fish propagators immediately placed a fish rack below the ladder entrance to collect brood stock. The rack prevented full use of the fish ladder for migration over the dam until 1940. Eggs were taken below the ladder from 1913 through 1939, when the hatchery was abandoned.

In 1926, Portland General Electric improved the ladder at River Mill, although salmon migration was stopped most of the time by egg-taking operations. They constructed additional pools at the lower end of the ladder, widened turning and resting pools, and moved apertures between the pools to meet new state requirements. The ladder was improved again in late 1939 (Figure 162). This time the company improved the fish ladder entrance and installed an attraction water pump and diffusion chamber as recommended by the U.S. Bureau of Fisheries.

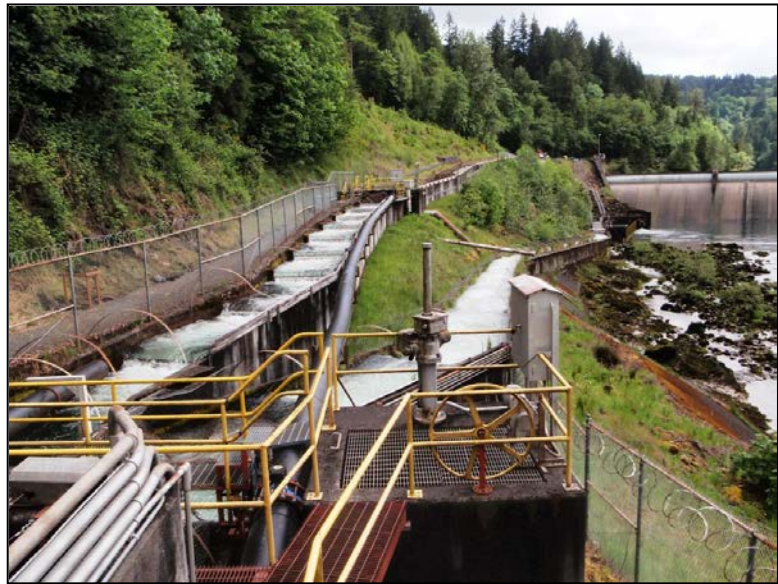
Figure 166: North Fork Fishway - Photo taken from Adult Trapping Facility (CA Dept. of Water Resources)

North Fork Fishway provides passage for upstream migrating fish around Faraday and North Fork dams. The fishway is a concrete pool and weir type, with pools 10 feet wide by 6 feet deep (Figure 166). The fishway has both long and short pools. The short pools have 17” square orifices that alternate sides and the long pools have a central 24-inch-wide by 18-inch-high orifice. The weirs in the fishway are 7 feet wide and the typical pool differential is 1 foot (PGE 2012b). The 1.9-mile-long fishway is proclaimed by PGE to be the longest one in operation in the world (PGE 2011). It rises approximately 200 feet and has a design flow of approximately 45 cfs, with about 10 cfs passing through the orifices and 35 cfs spilling over the weirs (PGE 2012b).

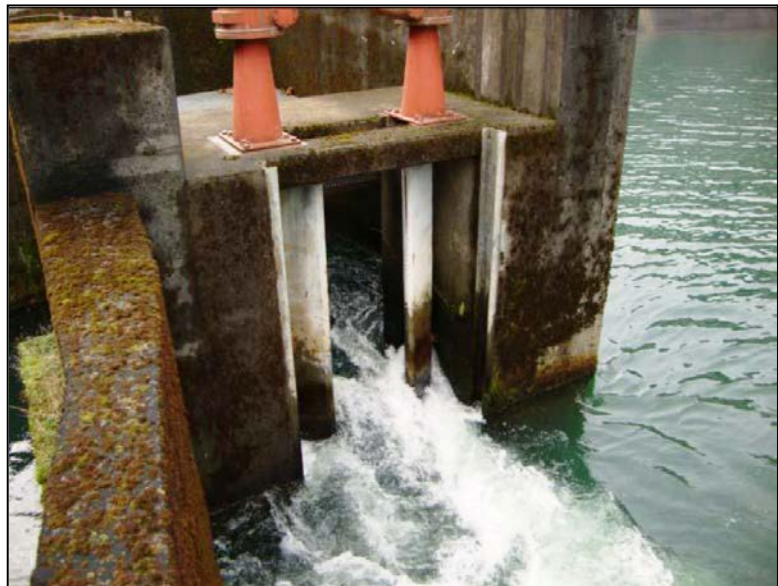
Figure 167: North Fork Fishway Entrance (PGE 2012b)

The entrance of the fishway is a 4-ft wide slot with two leaf gates which allow restriction down to 28 inches for adjustment of head differential (Figure 167). Auxiliary flow of 100 cfs is currently added to the 45 cfs fishway flow for a total of 145 cfs at the entrance. PGE are adding 90 cfs of auxiliary flow in summer 2012 to increase the entrance flow to 235 cfs (Doug

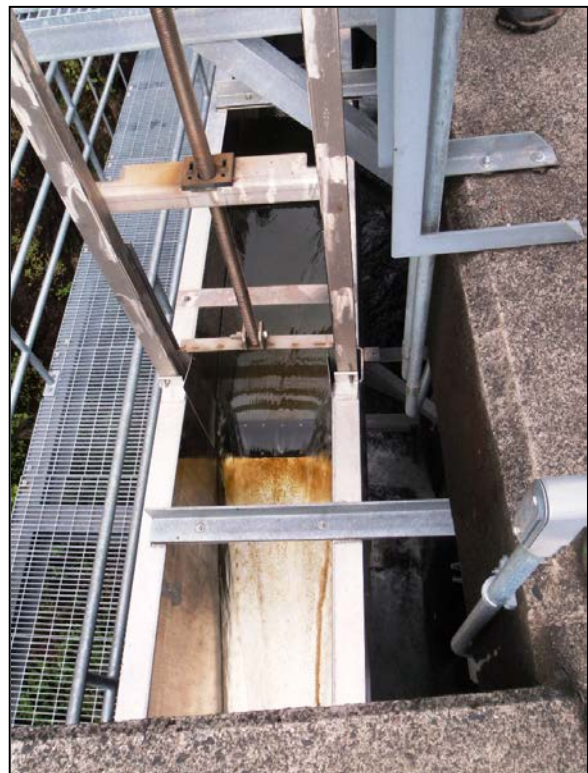
Figure 169: Downstream Migrant Entrance Ramp Weir (CA Dept. of Water Resources)

In the new configuration, fish and approximately 10 cfs exit the traveling screen sump via a new bypass connection and enter a 2-foot-wide rectangular flume (Figure 168) **INSERT DS MIGRANT ENTRANCE FLUME ISOMETRIC DRAWING WITH BLOCK - AS FULL PAGE LANDSCAPE ORIENTATION**. The flume contains a debris rack, an isolation gate, and a ramp weir (Figure 169), which controls the flow into the pipeline. After the weir, the flume transitions into the 20-inch-diameter bypass pipeline (Figure 170). Currently, the pipeline runs to a temporary dewatering structure, about 600 feet downstream of North Fork Dam. The temporary dewatering screen structure removes 3 cfs of screened flow from the 10 cfs bypass flow. Because flows of up to 25 cfs could pass through the 20-inch pipeline if the new ramp weir fails in the down position, the temporary dewatering structure will include an unscreened emergency overflow. In 2015, a second fish bypass pipe will be

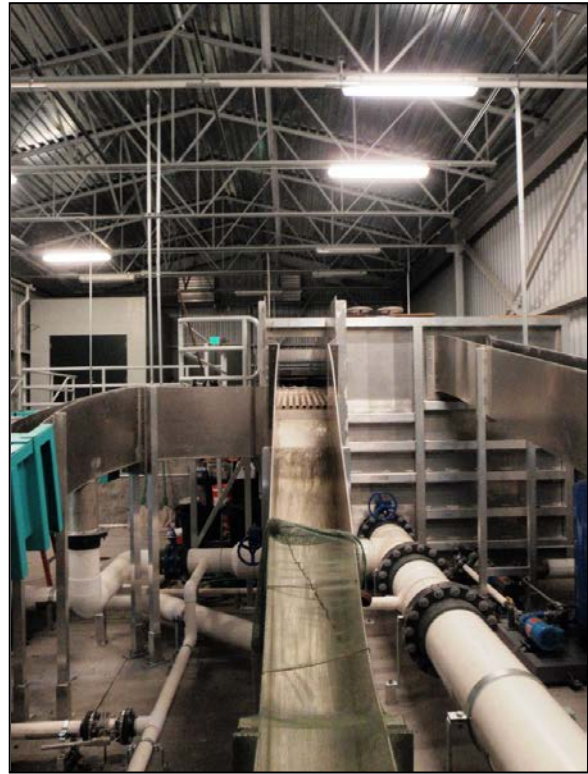
Figure 172: Timber Park Fish Sampling Facility (CA Dept. of Water Resources)

In the sampling configuration, fish will move down the main flume past a similar dewatering screen to a separator. The juveniles will move through the bars of the separator (Figure 172), and the adults and debris will continue down the main flume. The separator bars are made of PVC and the spacing between the bars is 1". After the separator, the juveniles are directed by flume into a holding tank. The juvenile fish are manually collected and placed in the anesthetic tank at a sampling station. After sampling, the juveniles are placed in a recovery tank before being released back into the main flume. The downstream end of the main flume connects with the bypass flume and then transitions to a 16" HDPE pipe (McMillen 2011). The fish move down about 700 feet of pipe and are released downstream of River Mill Dam (Figure 173).

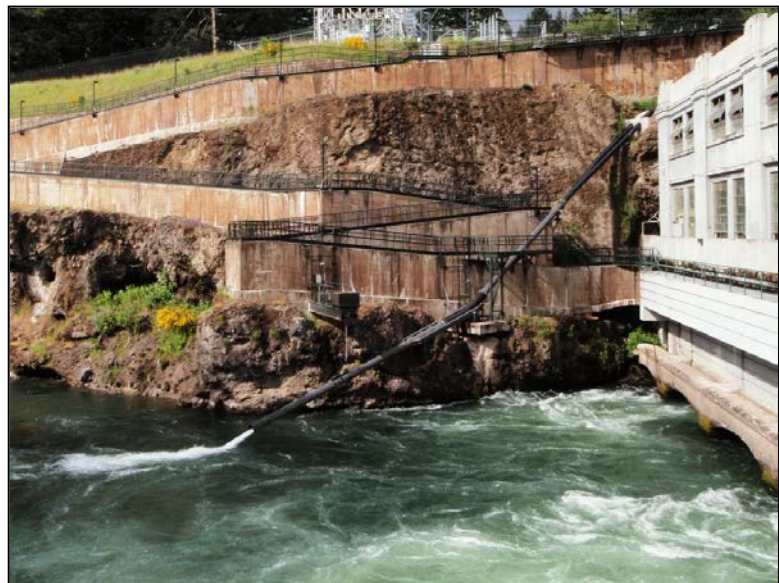
Figure 173: Downstream Migrant Release Pipe (CA Dept. of Water Resources)

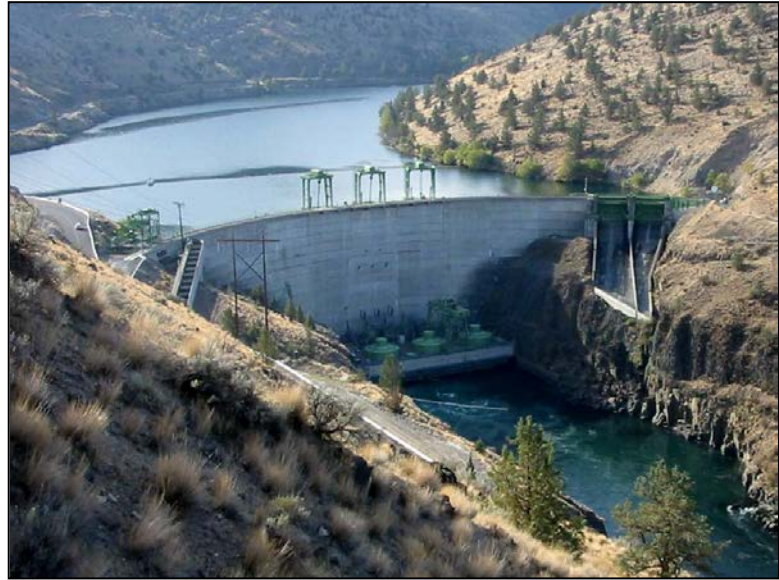
Figure 176: Pelton Dam and Upstream End of Pelton Ladder (Courtesy of PGE)

Pelton Dam is a 210-foot-high (204-foot hydraulic height), 965-foot-long concrete arch dam (Figure 176). The construction of the dam created Lake Simtustus, a 31,000-acre-foot reservoir which backs up 7 miles of the Deschutes River to the base of Round Butte Dam. The dam has three 16-foot-diameter, 100-foot-long penstocks, which route water to three Francis turbines with a total power generating capacity of 100.8 megawatts (PGE and CTWSRO 2004). The dam also has a concrete spillway equipped with two, 34-foot-wide, 22-foot-high steel Tainter gates (FERC 2005).

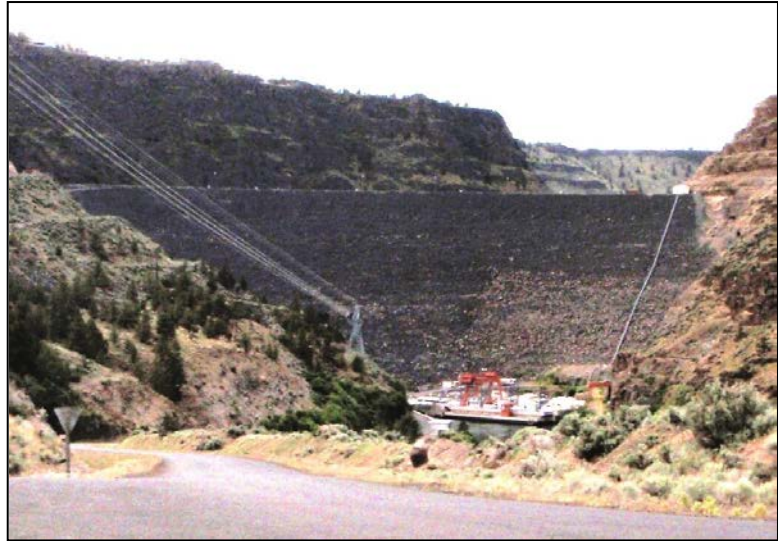
Figure 177: Round Butte Dam and Hatchery (CA Dept. of Water Resources)

Round Butte Dam was completed in 1964 and is the most upstream development of the Project (Figure 177). It is a 440-foot-high (425-foot hydraulic height), 1,382-foot-long rock-filled embankment dam which creates the 535,000-acre-foot reservoir Lake Billy Chinook. Lake Billy Chinook impounds 9 miles of the Deschutes River, 7 miles of the Crooked River, and 13 miles of the Metolius River (PGE and CTWSRO 2004). A 1,425-foot-long, 23-foot-diameter power tunnel routes water to a powerhouse containing three Francis turbines, each capable of generating up to 82.4 MW, for a total power capacity of approximately 247 megawatts. The dam has a concrete spillway intake structure topped with a 30-foot-high, 36-foot-wide radial gate, which is connected to a 1,800-foot-long, 21-foot-diameter spillway tunnel (FERC 2005).

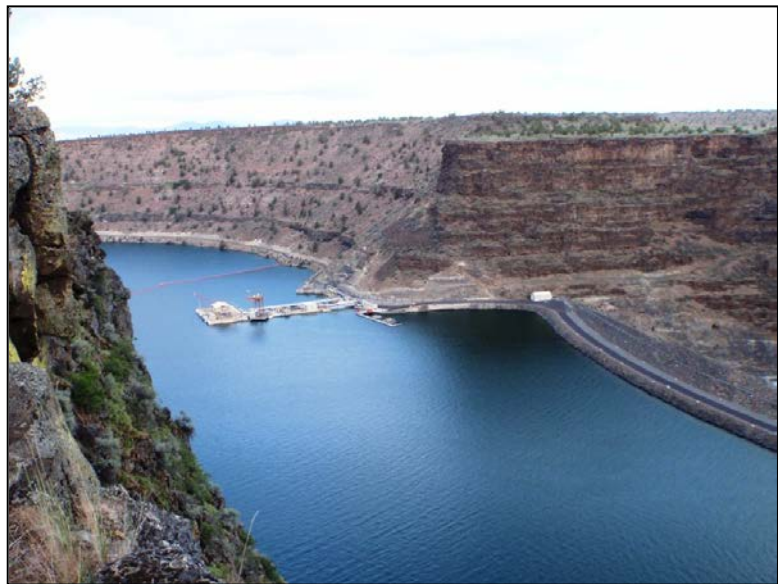
Figure 178: Round Butte Dam and the Downstream Fish Collection Facility (CA Dept. of Water Resources)

Construction of the Selective Water Withdrawal Tower (SWWT), located in Lake Billy Chinook approximately 700 feet upstream of Round Butte Dam (Figure 178), was completed in December 2009 at a cost of \$108 million dollars. The tower's multiple-level intakes regulate the temperature of the lower Deschutes River, provide proper currents within Lake Billy Chinook, and lower the temperature of the reservoir. The tower also provides the foundation for the fish collection and transfer facility

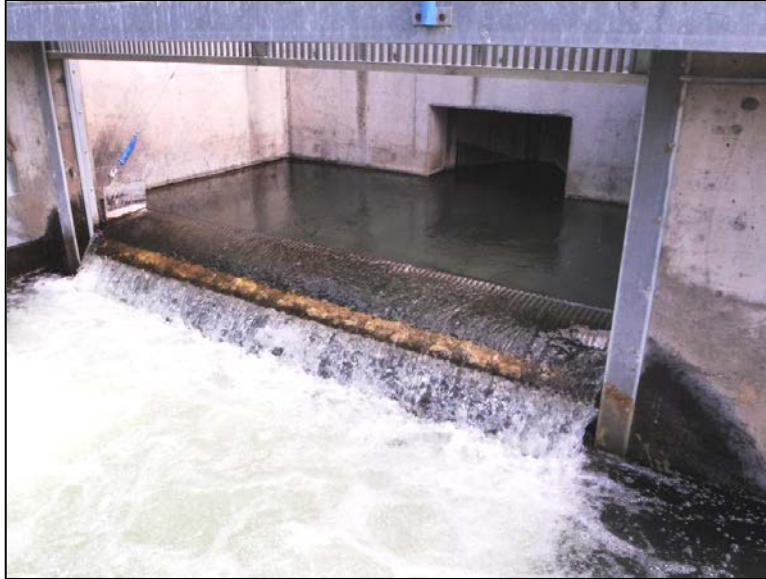
Figure 180: Pelton Trap Finger Weir and Entrance Pool (CA Dept. of Water Resources)

The Pelton Fish Trap is a Buckley-style trap, originally composed of three concrete pools: an entrance pool (Figure 180), a brail pool (Figure 181), and a hopper pool. Fish swam upstream into the flow of water through the two lower pools and eventually ended up in the hopper pool. Once fish were in the hopper pool, the hopper (Figure 182) was raised out of the pool and lowered over a tank truck and emptied. The truck hauled the fish to a release point upstream, where it was backed into the water and released the fish into Lake Simtustus (Ratliff and Madden 2006).

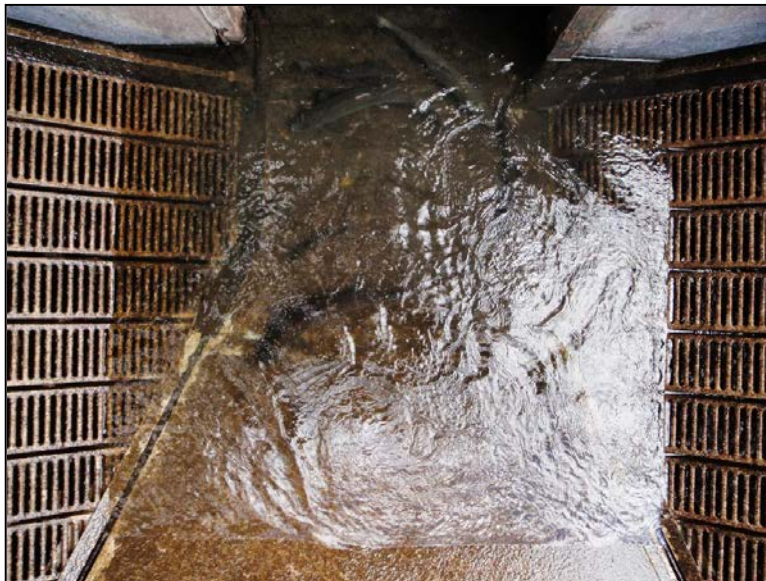
Figure 181: Pelton Trap Brail Pool (CA Dept. of Water Resources)

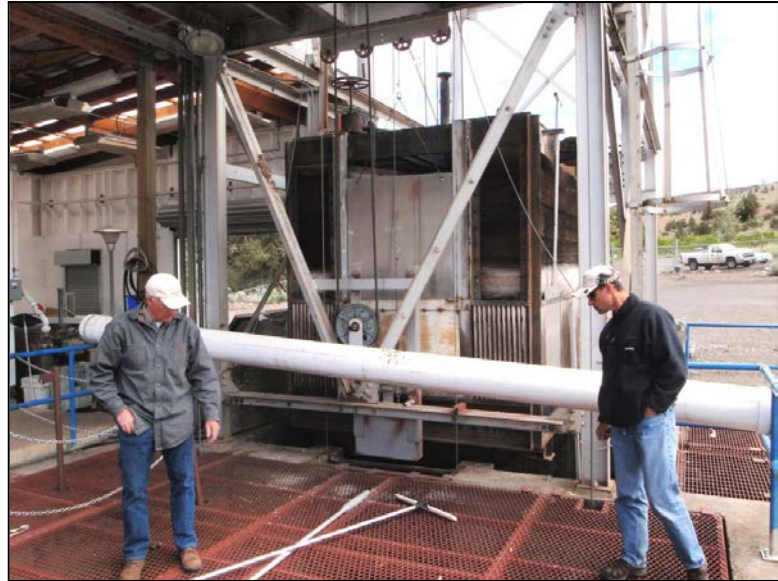
Figure 182: Pelton Trap Hopper (CA Dept. of Water Resources)

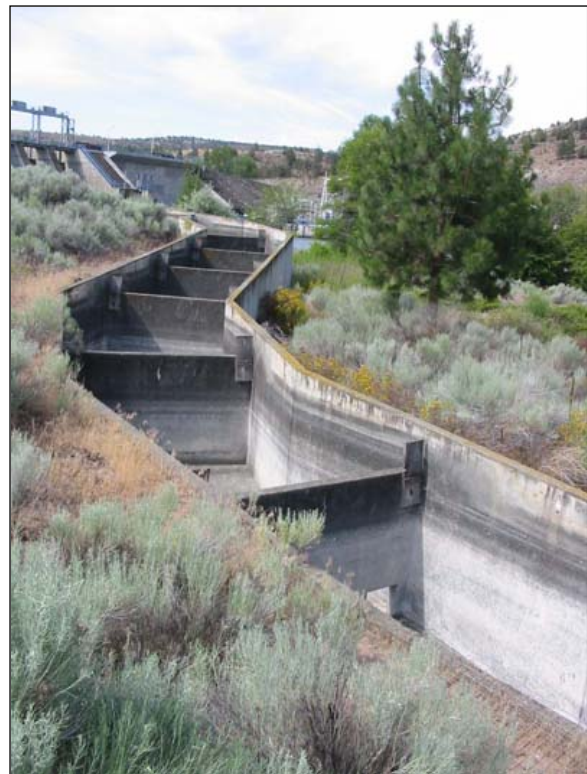
Figure 183: The Lower End of the Pelton Fish Ladder (Courtesy of PGE)

In April 1957, the 2.84 mile long Pelton Fish Ladder became operational (Figures 183 and 184). The Pelton Fish Ladder is a pool and weir type fishway which provided upstream passage from the Pelton Fish Trap to Lake Simtustus above Pelton Dam. At the time it was constructed, it was the longest pool-type fishway in the world with the second highest lift (230 feet). The fishway is not currently operated for fish passage, but the lowest section of fishway connects the Deschutes River to the Pelton Fish Trap (PGE and CTWSRO 2009b), and lower portions are used for the rearing of salmonid fry from the Round Butte Hatchery (ODFW 2010).

The fishway measures 10 feet wide by 6 feet deep, and it originally had a maximum flow capacity of 43 cfs (Gunsolus and Eicher 1962 in Ratliff and Schulz 1999). However, following construction,

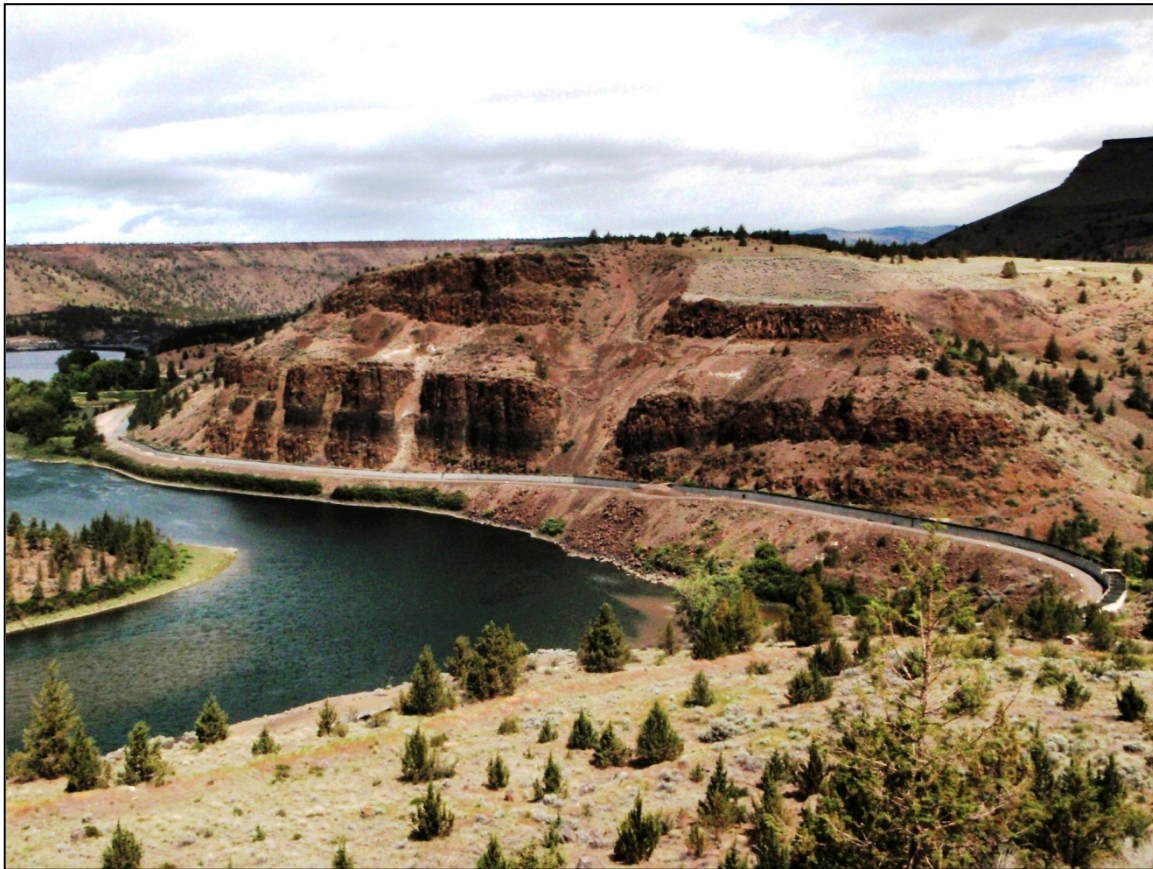
Figure 184: Pelton Fish Ladder along Reregulating Reservoir (CA Dept. of Water Resources)

boards were attached to the weirs to reduce oscillation that reduced capacity to 36 cfs (Ratliff et al 1999). The gradient in the steeper sections of the ladder is one foot of rise for a 16-foot-long pool. Much of the fishway, however, is of a lesser gradient, with weirs spaced at irregular intervals ranging from 100 to 300 feet apart and each providing a 6 inch rise (Gunsolus and Eicher 1962 in Ratliff and Schulz 1999).

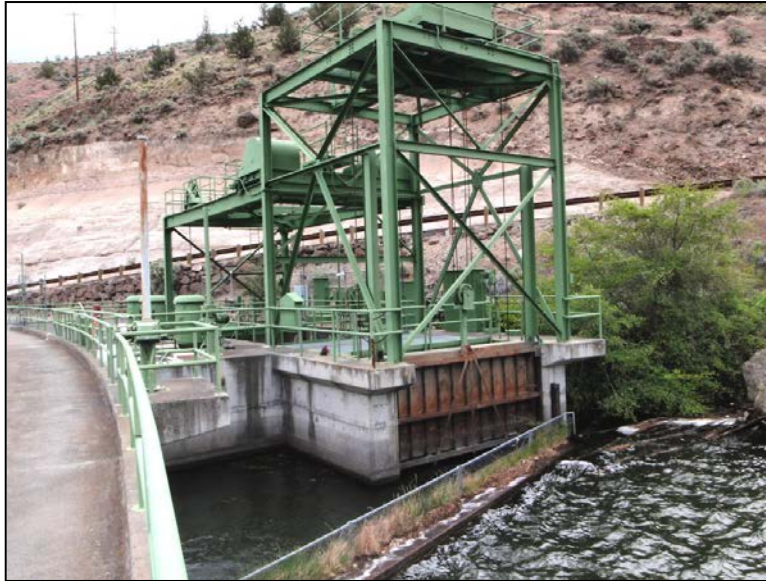
Figure 187: Pelton Skimmer (CA Dept. of Water Resources)

Downstream passage from Lake Simtustus at Pelton Dam, consisted of a horizontal, inclined-plane artificial outlet, referred to as the Pelton Skimmer (Figures 186 and 187). The skimmer was constructed on the right (east) abutment of Pelton Dam and used pumps to pull 200 cfs of water through a 15 foot wide screen assembly (perforated plate). The screen assembly was inclined, allowing about 6 cfs of water and downstream migrating fish to move over the end, and then through a bypass pipe into the fish ladder junction box. The smolts then entered the fish ladder and traveled down to the Deschutes River below the Reregulating Dam (Ratliff et al 1999).

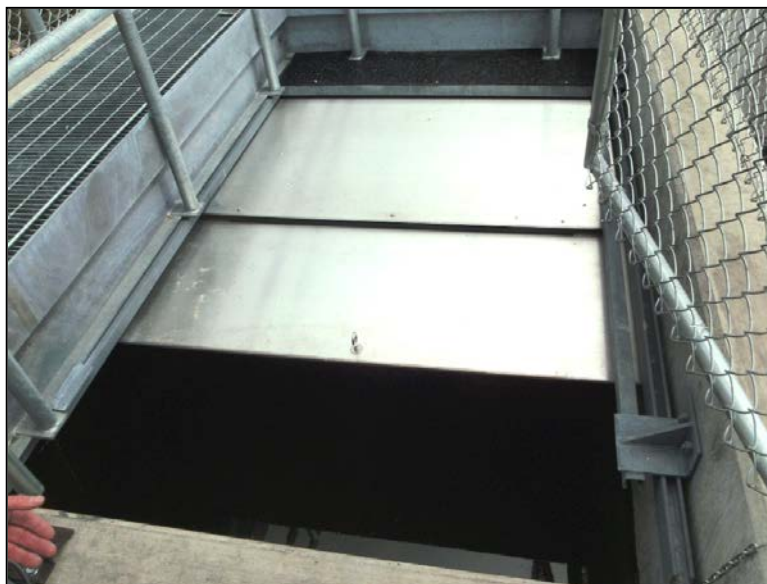
Figure 188: Adult Release Facility (CA Dept. of Water Resources)

An upstream release facility for adult migrants, constructed on the shoreline of Lake Billy Chinook, will allow them to be released safely into the hypolimnion of the reservoir during the summer (Figure 188). Design of the facility was completed during 2009 and construction was completed during a special reservoir drawdown period in late 2010. The facility consists of a concrete vault positioned in the reservoir near the shore with an adjacent truck access point. Fish will be released from the

transport truck into the vault and an opaque cover on a roller will be pulled over the top of the vault. Fish will volitionally swim out of the vault through the release pipe which will extend approximately 30 feet below the surface of the reservoir (PGE and CTWSRO 2009b).

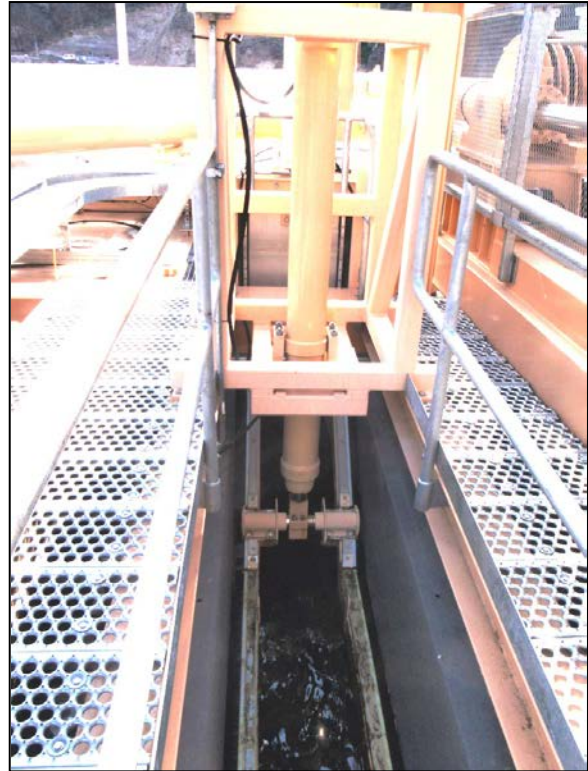
Figure 193: Secondary Fish Screen Channel and Cleaning System (CA Dept. of Water Resources)

The secondary screens are located downstream of the primary v- screens and reduce the flow down to 30 cfs for each channel. The sides of the secondary channel are parallel and only 2.5 feet apart and the screens are made of 60% porosity bar screen with 3/8 inch slots aligned horizontally. The secondary screens are cleaned with horizontal brushes that move vertically (Figure 193).

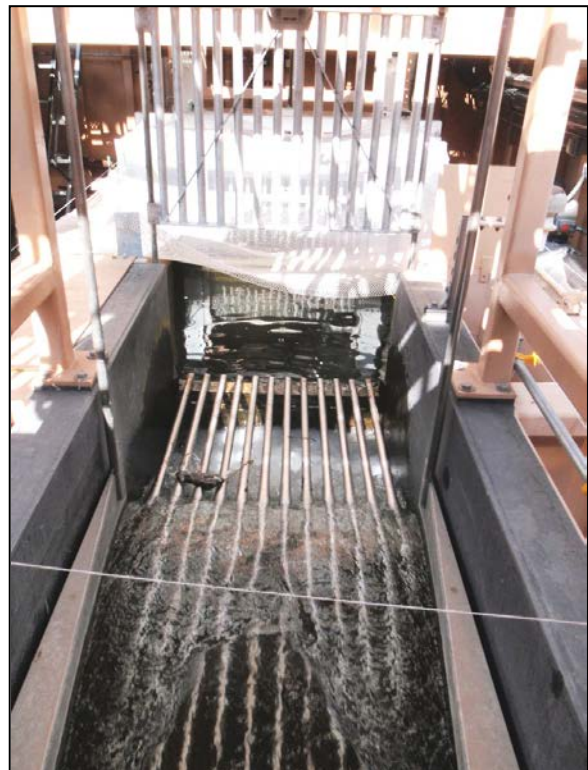
Figure 194: Large Fish Separator (CA Dept. of Water Resources)

Immediately downstream of the tertiary screen reach, the remaining water, fish, and debris move over a control weir that is integrated with a large fish separator (Figure 194). The large fish separator is a combination wet-dry separator designed to exclude salmonids larger than about 15 inches. Fish less than about 15 inches pass with water through the separator bars (wet) and are pumped to the fish transfer facility. Larger fish slide along the bars out of the water (dry), are processed, and then released back into the reservoir.

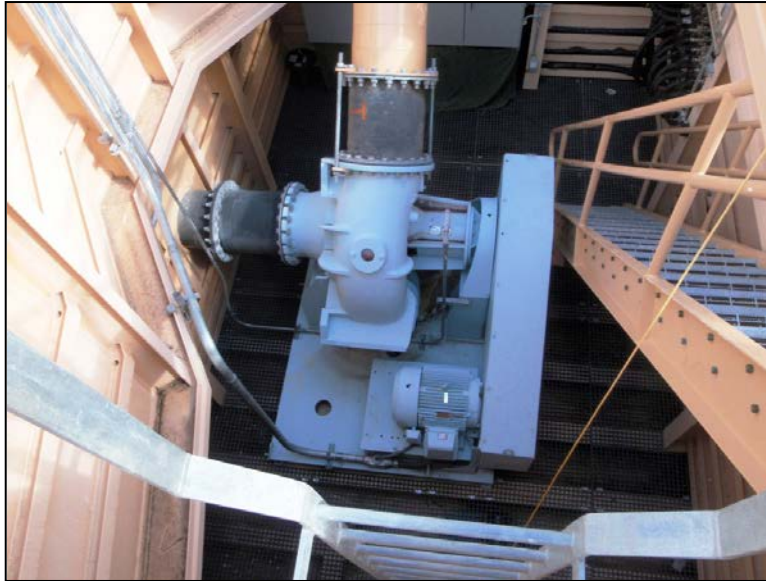
Figure 195: Hidrostal Fish Pump (CA Dept. of Water Resources)

After passing through the bars of the large separator, the 12 cfs of remaining water and fish less than about 15 inches long are pumped up about 15 vertical feet to an elevation 7 feet above the normal reservoir surface level using a Hidrostal 20 inch helical fish pump (Figure 195). The fish are then routed to a transfer facility via a pipe supported by a floating bridge. In the pipe, two PIT-tag detectors read any PIT-tags that are being carried by the fish. PIT-tagging evaluates reservoir passage efficiency for smolts from the tributaries and estimates the number and timing of recaptures from fish that are released back into Lake Billy Chinook.

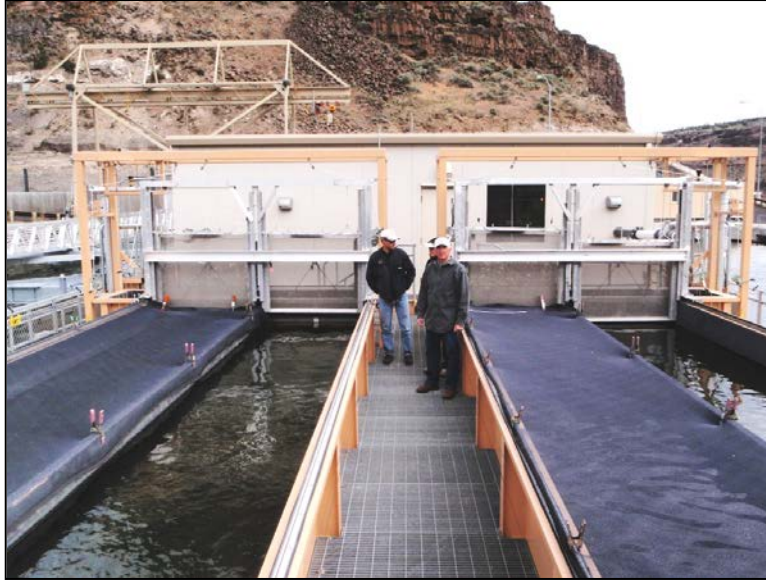
Figure 197: Holding Raceways with Fish Processing Building in Background (CA Dept. of Water Resources)

The small- and medium-sized fish in the holding raceways (Figure 197) are processed (Figure 198) and transferred to the proper recovery raceway or experimental tank. From the recovery raceways, fish can be released back to the reservoir or loaded by hopper onto a truck for transport (Figure 199). In general, each hopper load consists of half the capacity of a recovery raceway. Three hopper loads are

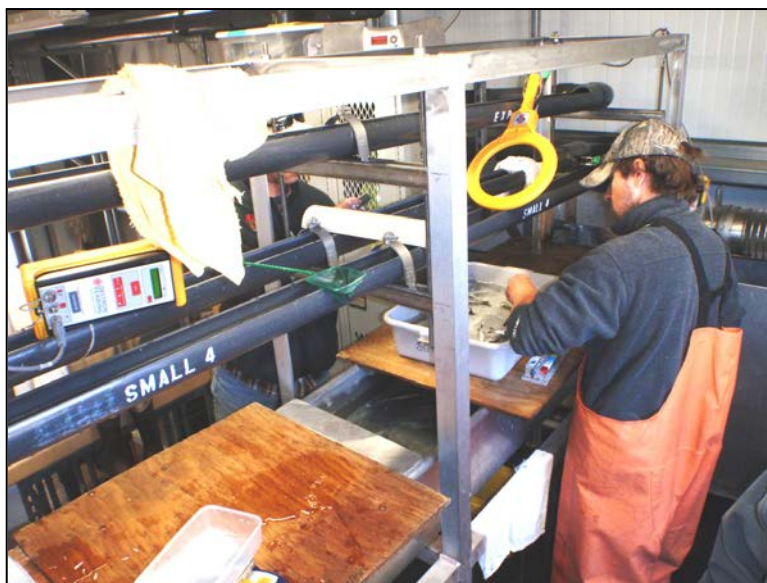
Figure 198: Fish Processing (CA Dept. of Water Resources)

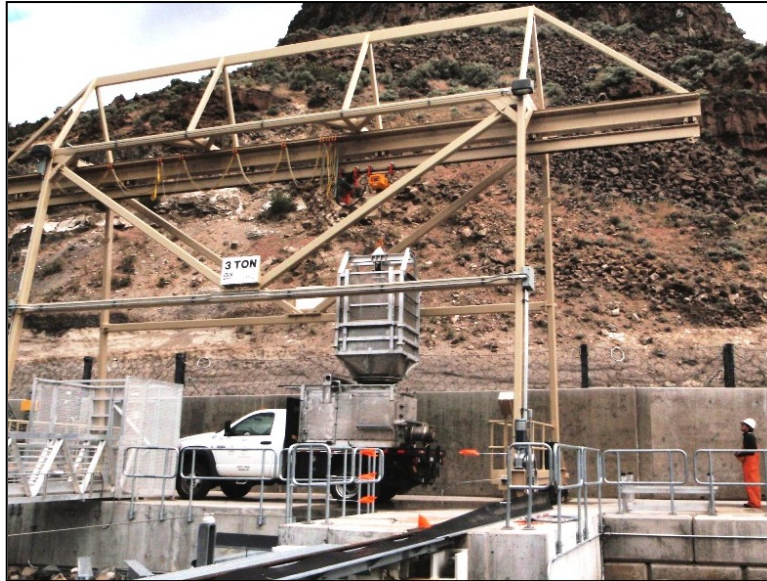
Figure 199: Fish Loading (CA Dept. of Water Resources)

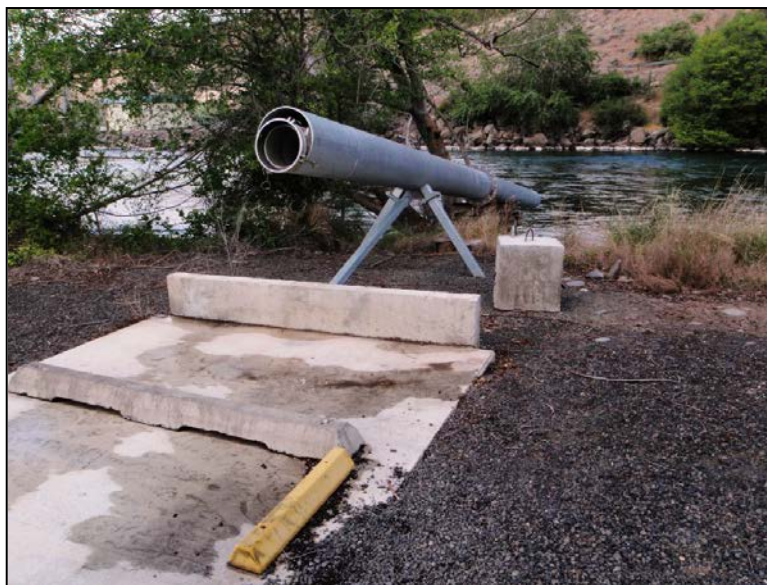
Figure 200: Fish Release Pipe (CA Dept. of Water Resources)

used to load one truck nearly to capacity. The fish are transported to the Lower Deschutes River Juvenile Release Facility is located on the east bank of the river a short distance downstream from the Reregulating Dam and just upstream of the Pelton Fish Trap. The fish are released through a short section of pipe which attaches to the back of the transport truck (Figure 200). Fish exit the release pipe in the main current about 12 feet from the shoreline.
