State of California
The California Natural Resources Agency
Department of Water Resources
FloodSAFE Environmental Stewardship and Statewide Resources Office

Technologies for Passing Fish at Large Dams

June 2013

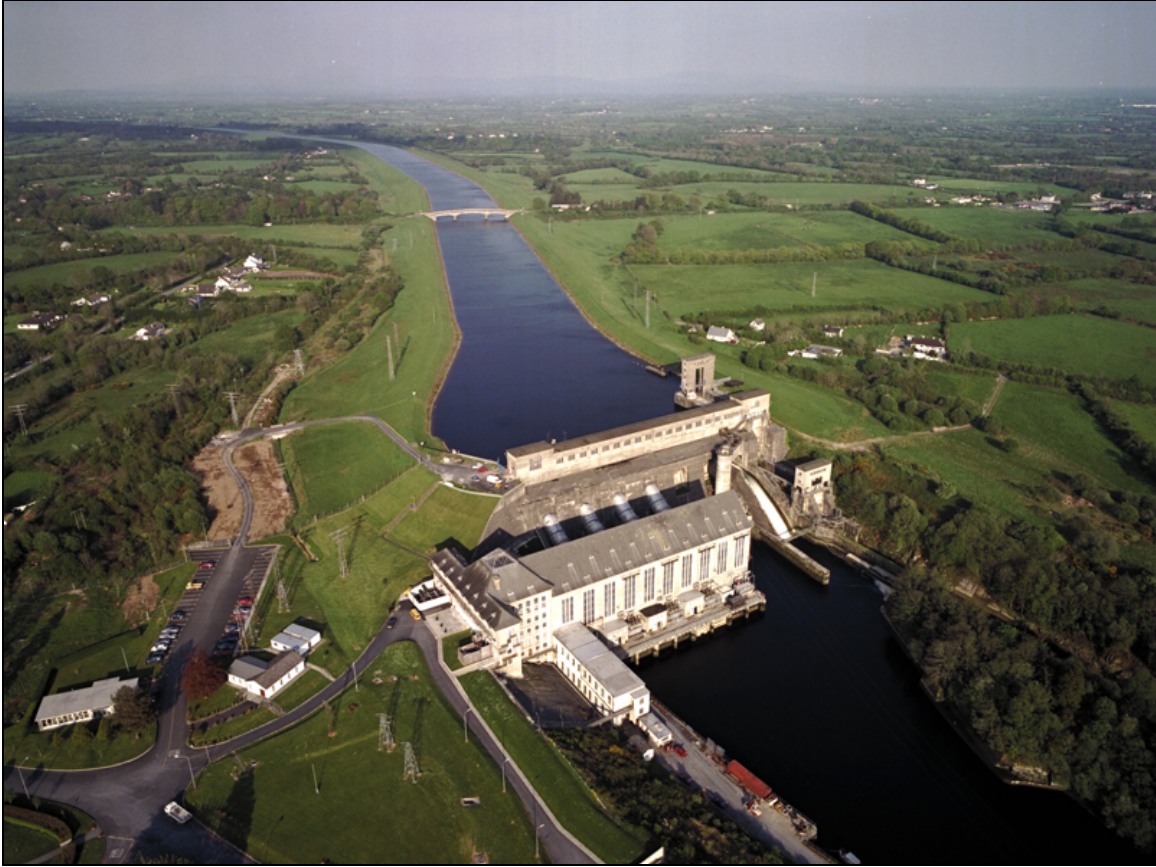
Figure 201. Aerial view of Ardnacrusha hydroelectric power plant in Ireland. (Courtesy of ESB)

The hydroelectric power plant in Ardnacrusha was originally referred to as The Shannon Scheme. It is Ireland's largest hydroelectric scheme and is composed of three vertical-shaft Francis turbine generators and one vertical-shaft Kaplan turbine generator. The system operates over an average head of 94 feet. During the 1930's, Ardnacrusha's power plant supplied nearly 90% of Ireland's electricity needs, however, it currently only accounts for less than 3% (ESB 2006). An aerial view of Ardnacrusha Dam and the power plant can be seen in Figure 201.

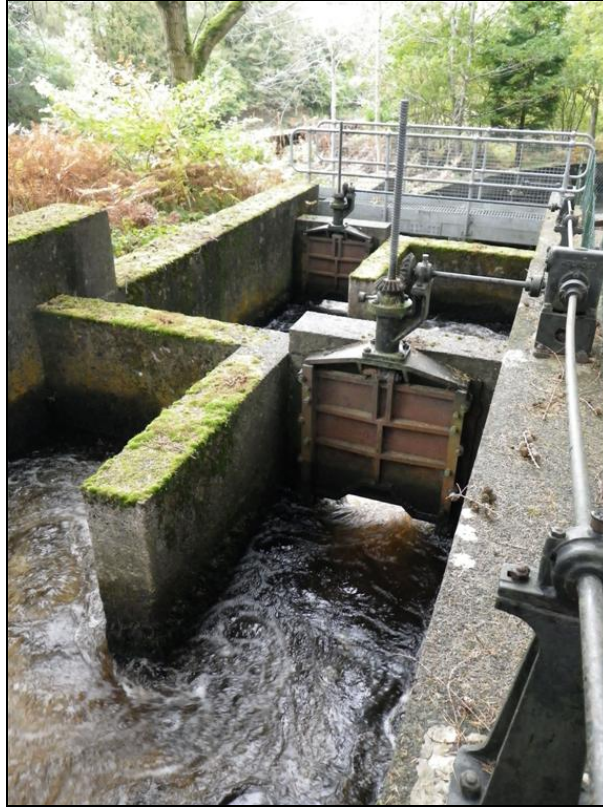
Figure 206. Orifice section – downstream view (Courtesy of Galloway Fisheries Trust)

The current layout of the various sections of the fish ladder can be seen in Figure 205. In the original design, flow was controlled by sluice gates that could vary the area of each orifice. The only sections with the orifices still in use are sections 3 and 4, with the orifices fully open above the water level (Figures 206 and 207). In other sections, the orifices and their controls remain, but within sections 1 and 2, the sluice gates have been closed and notches were cut into the walls between chambers; therefore converting them to pool and over-fall structures (Figures 208 and 209). The notches do not extend to the bottom of the pools so fish must jump up each pool as they ascend. Additional changes to the original ladder include adding a weir to the center of resting pool 3. The connection between the lower and upper pool is through a submerged orifice leading into a Vaki fish counter tunnel (Figure 210). Near the upstream end of the ladder, section 5, originally comprised of a resting pool with two chambers, which now consists of four chambers with notches to create pool and over-fall structures but with the original orifices at both ends (Figure 211). The final, most upstream, section of the ladder continues through five chambers in the dam wall which use the original orifices and contain exit gates which operate on either the 1st, 3rd, or 5th chamber depending on the level of water behind the dam. Each of the five chambers also contain wooden baffles with submerged orifices (Figure 212). (Armstrong 11/1/2010, personal communication)

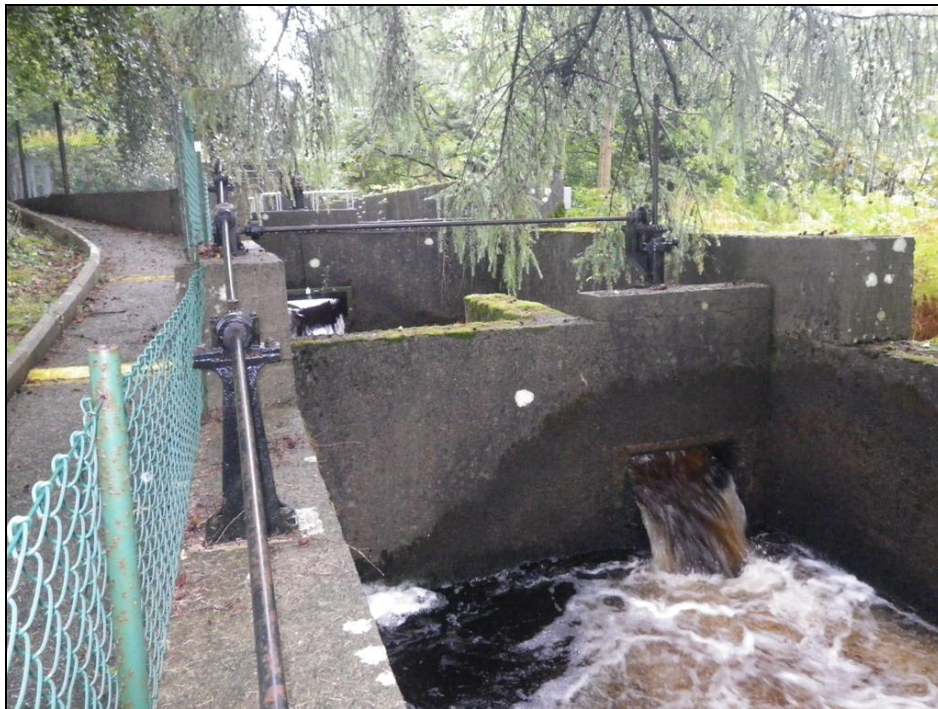
Figure 207. Orifice section – upstream view (Courtesy of Galloway Fisheries Trust)

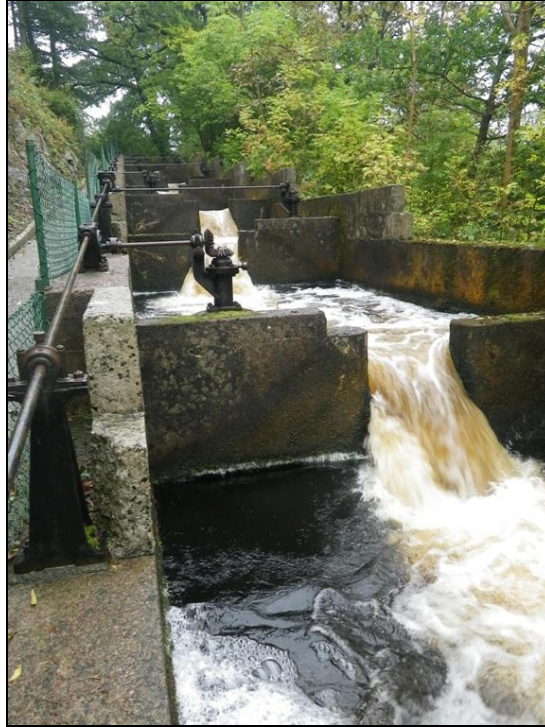
Figure 208. Notches in Section 1 (Courtesy of Galloway Fisheries Trust)

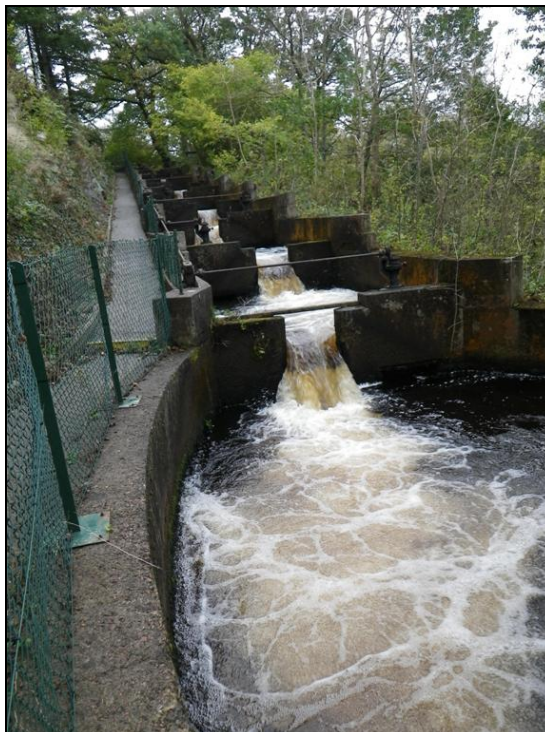
Figure 209. Notch above resting pool 1 (Courtesy of Galloway Fisheries Trust)

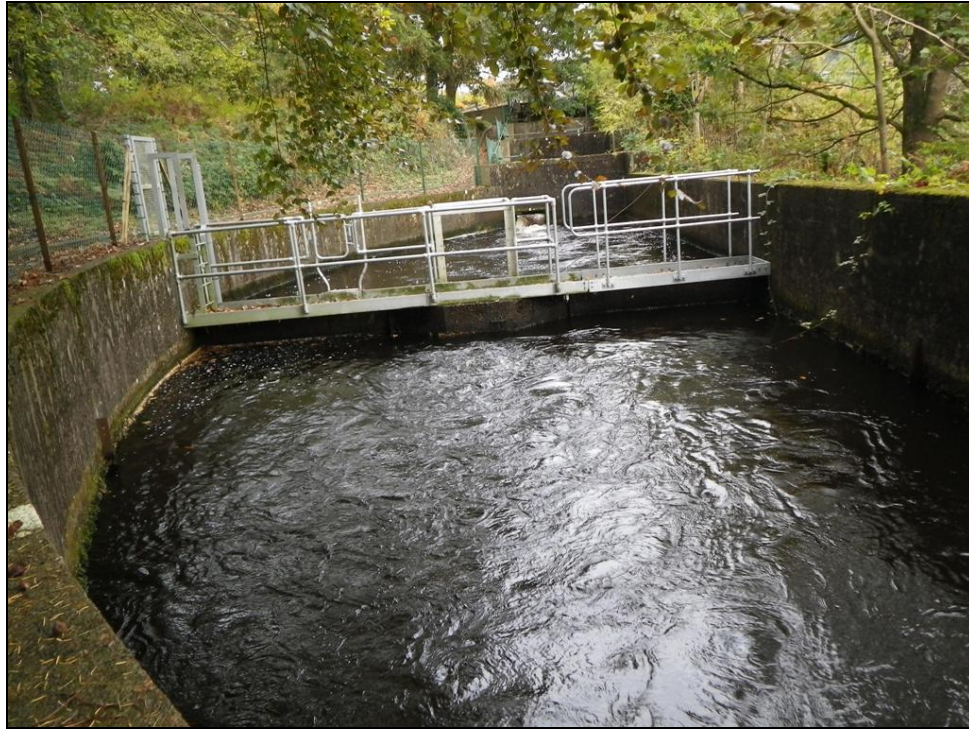
Figure 210. Weir in resting pool 3 – with submerged orifice and fish counter tunnel (Courtesy of Galloway Fisheries Trust)

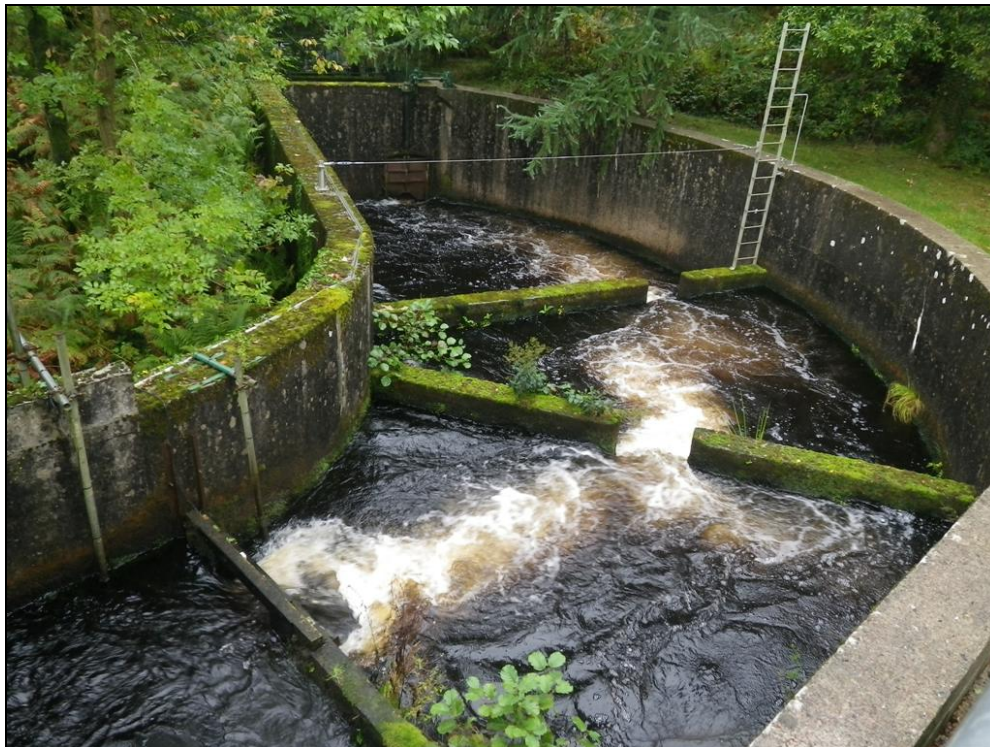
Figure 211. Section 5 of the fish ladder (Courtesy of Galloway Fisheries Trust)

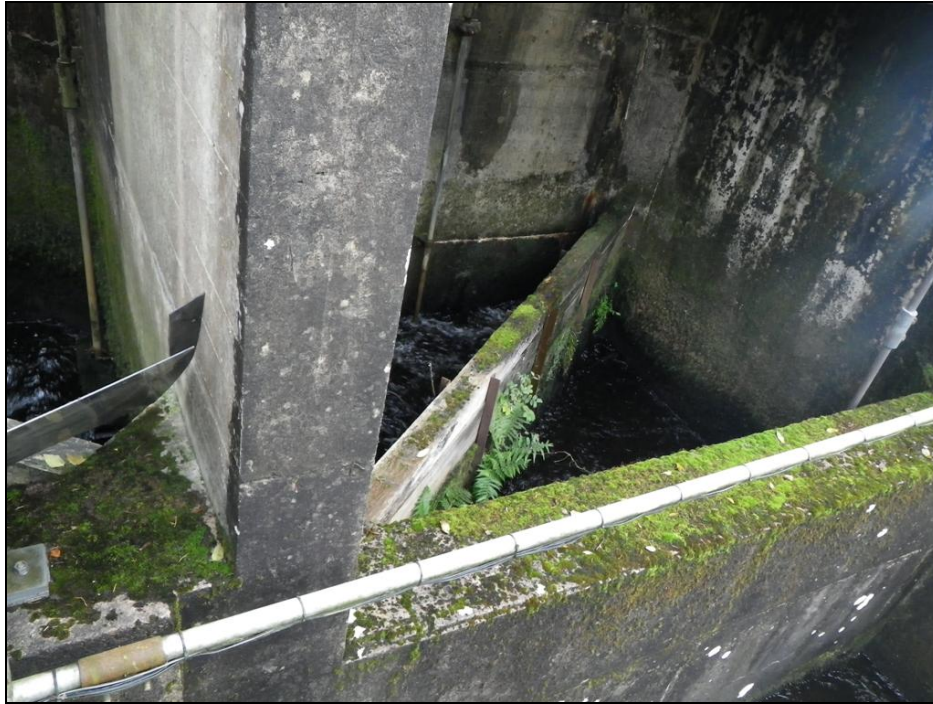
Figure 212. Fish ladder baffle section (within the dam) (Courtesy of Galloway Fisheries Trust)

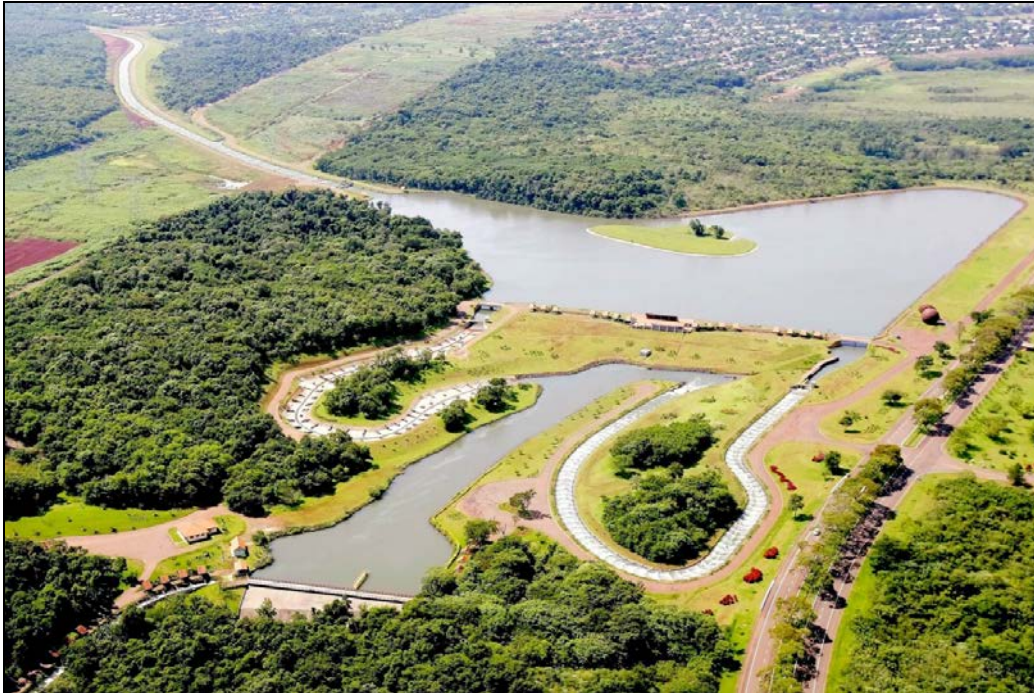
Figure 214. Aerial view of a section of the Canal da Piracema, including pond and fish ladders (Courtesy of Itaipu Binacional)

An excerpt from a journal article by Makrakis et al (2007) in *Neotropical Ichthyology*, describes the different components of the system in further detail below. Please note that the capital letter codes in the text and map below were used to signify sampling locations. Figure 213 depicts a map of the Canal and displays the different sections that will be discussed. Figure 214 shows an aerial view of a section of the Canal.

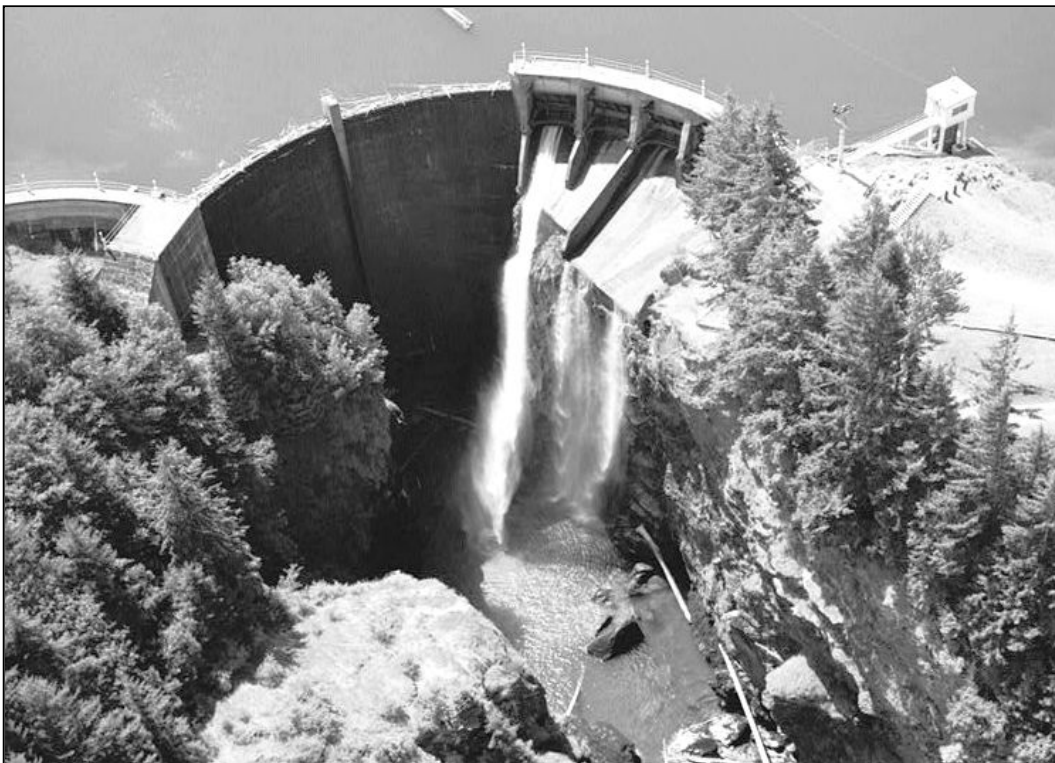
Figure 217: Glines Canyon Dam - 1995 (Photo by Jet Lowe, Library of Congress)

Olympic Power and Development Company completed construction of the Elwha Dam in 1912 (Figure 216). The 105-foot-high (98-foot hydraulic height), 450-foot-long concrete gravity dam, located 4.9 miles from the Strait of Juan de Fuca, created Lake Aldwell, which was about 2.5 miles long and had a capacity of 8,100 acre-feet. Glines Canyon Dam (Figure 217) was a 210-foot-high (200-foot hy-

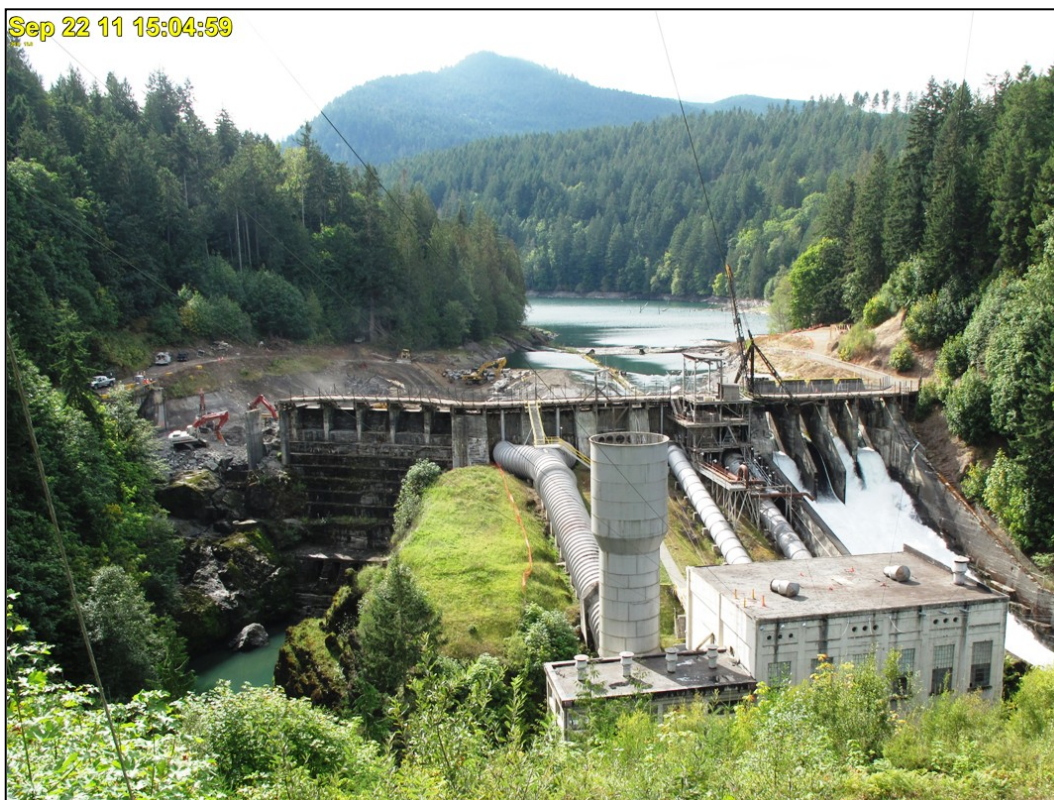
Figure 218: Elwha Dam - September 22, 2011 (Courtesy of the NPS)

The removal of Elwha Dam began on June 1, 2011, following the closure of the powerhouse. The reservoir's water level was lowered by approximately 15 feet using the dam's water intakes and spillways. As water was routed through the spillway on the left side of the dam (looking downstream), the gates on the right side of the dam were removed and a temporary diversion channel was excavated (Figure 218).

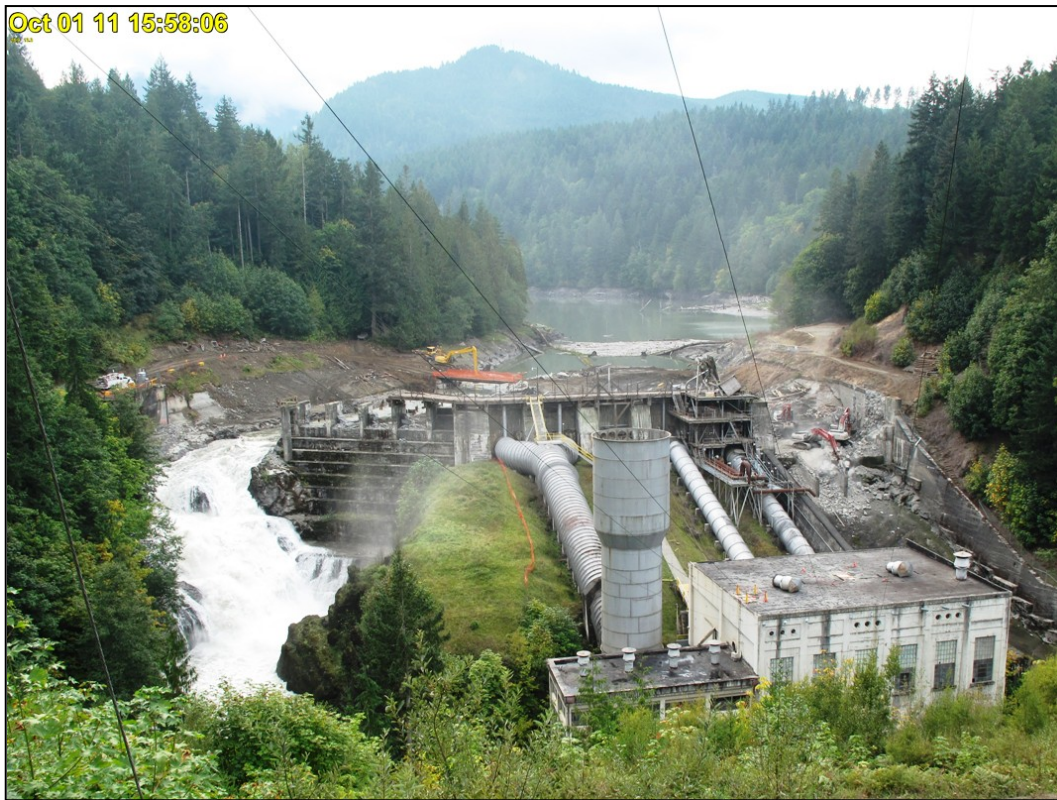
Figure 219: Elwha Dam – October 1, 2011 (Courtesy of the NPS)

Water was then routed through the temporary channel and a lower temporary channel was excavated through the spillway on the left side to allow the reservoir to be drained further (Figure 219). As this channel was excavated the central portion of the dam was removed. The outflow was then switched to the left side temporary channel and work began on lowering the concrete on the right side of the dam and removing the penstocks and powerhouse (Figure 220). The flow of water was switched to the right side channel and back to the left a couple times to excavate the channels further. On January 27, 2012, water was switched to the left side channel for the final time and the right side channel was excavated to its original bed elevation (Figures 221). On March 16, 2012, the river flowed through its original channel for the first time in over 100 years at the dam site (Figure 222). The temporary channel on the left side was filled in and the contouring of the former dam site was completed as of July 2012 (Figure 223) (NPS 2012a, NPS 2012c).

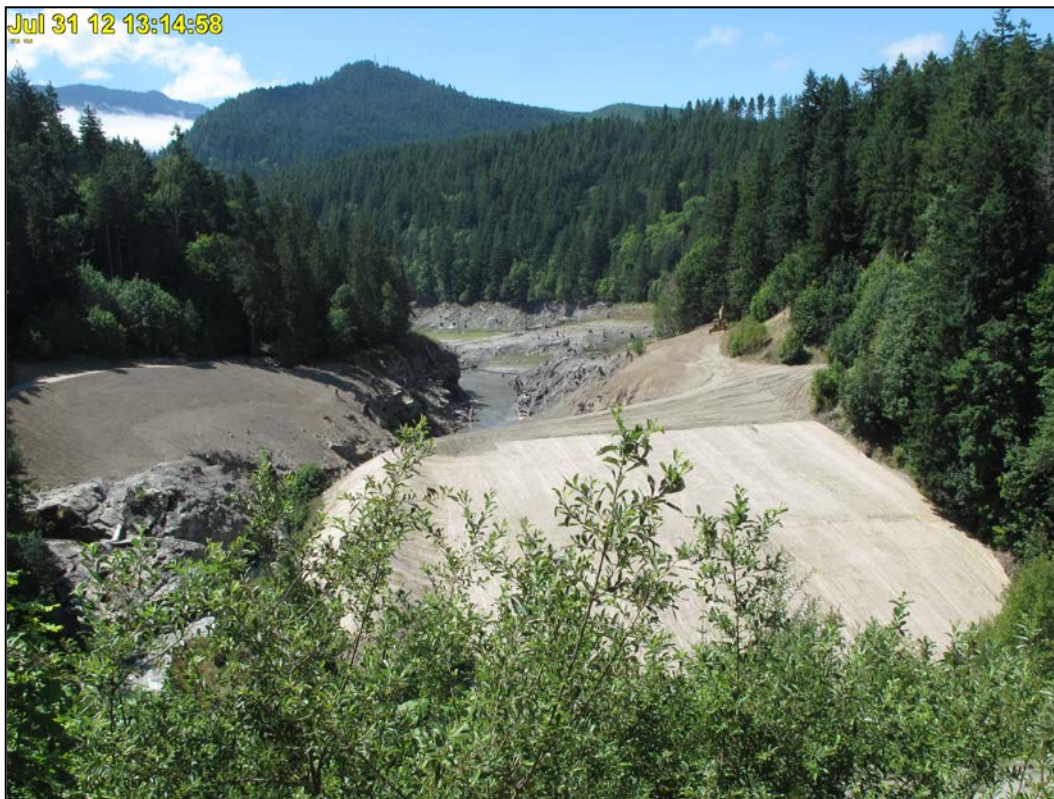
Figure 223: Elwha Dam Site after Removal - July 31, 2012 (Courtesy of the NPS)

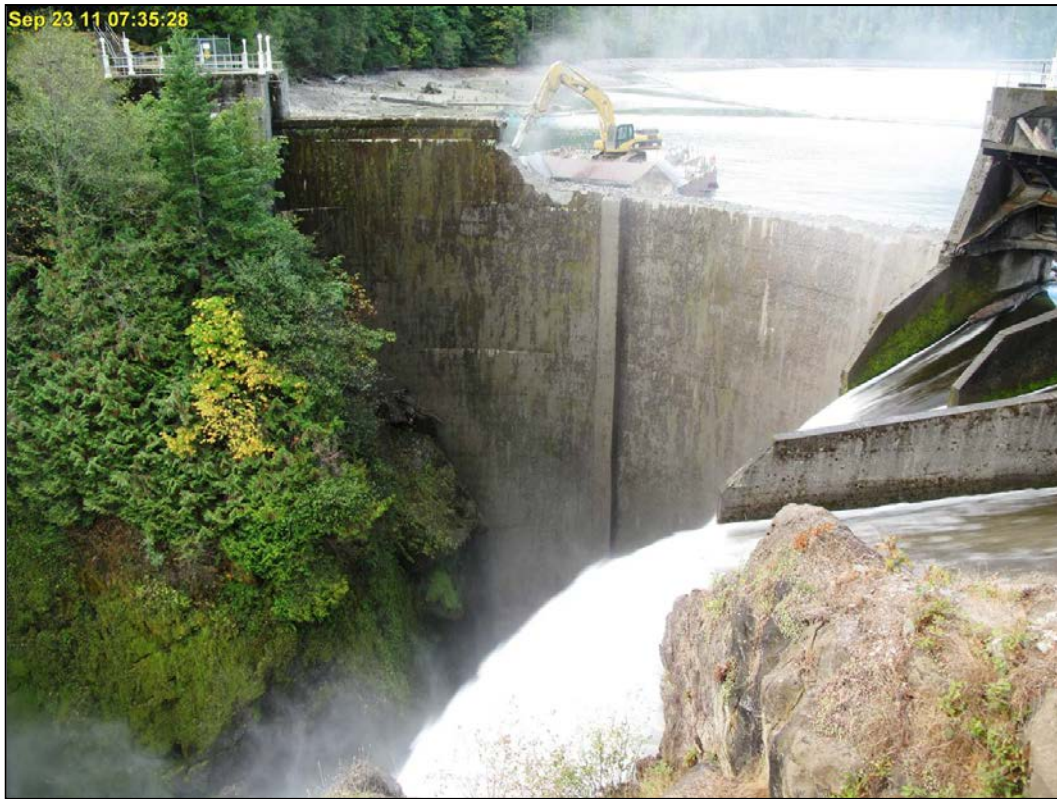
Figure 224: Glines Canyon Dam - September 23, 2011 (Courtesy of the NPS)

Removal of Glines Canyon Dam began with the lowering of Lake Mills to the bottom of the spillway gates. On September 15, 2011, barge-mounted hydraulic hammers began removing the first 17 feet of the dam down to the waterline (Figure 224). A large part of the dam was removed using a notching process. The process used the barge-mounted hydraulic hammers to create notches in the dam large enough to drain the reservoir but small enough to not allow the barge to pass (Figures 225 and 226). This process continued until mid-April 2012 (Figure 227). Since that time, lowering of the dam has been accomplished by explosives. During required deconstruction stoppages to allow sediment loads to decrease downstream, the gatehouse, surge tower, intake tower, powerhouse, and above water sections of the dam have been removed. As of September 17, 2012 the dam has been lowered approximately 125 feet, with about 85 feet remaining (Figure 228). The rest of the dam will be removed by explosives, with an expected completion date of summer 2013 (NPS 2012a, NPS 2012b, NPS 2012c). Figure 229 shows the partially drained Lake Mills as of September 2, 2012 and figure 230 shows the dam from the former reservoir bed on November 6, 2012. The contract for the removal of both dams is \$26.9 million dollars and the total cost of the Elwha River restoration is expected to be \$325 million dollars. The restoration cost includes the purchase of the dams and power plants, construction of two water treatment plants and other facilities to protect water users, a fish hatchery, a greenhouse to propagate native plants for revegetation, and construction of flood protection facilities (NPS 2012d).

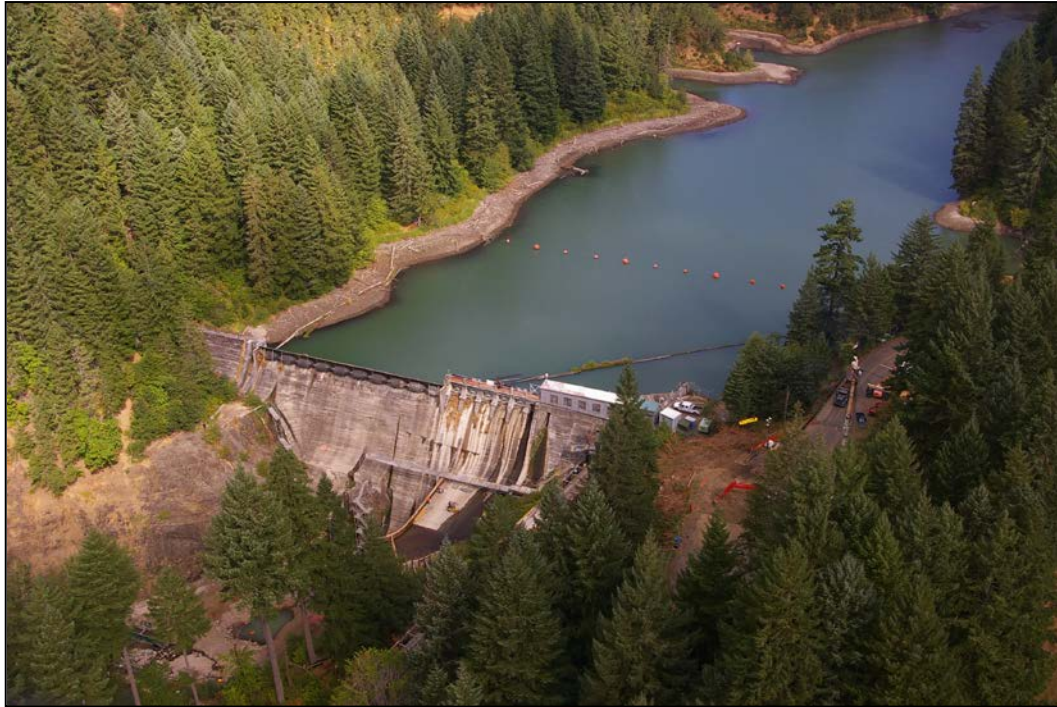
Figure 232: Condit Dam (Courtesy of PacifiCorp)

Northwestern Electric Company completed construction of Condit Dam in 1913. Originally built to power a paper mill in Camas, WA, Condit dam later generated electricity for local metropolitan areas in Oregon and Washington. The concrete gravity dam was 125 feet high and 471 feet long (Figure 232). At the dam, water was diverted into a 5,100-foot-long, 13.5-foot-diameter wood stave pipeline which fed two 9-foot-diameter, 650-foot-long penstocks. The powerhouse contained two horizontal Francis turbines with a combined generating capacity of 14.7 megawatts (NMFS 2006). Northwestern Lake, a 1.7-mile-long, 1,300-acre-foot reservoir created by the dam (NMFS 2006), contained approximately 2.3 million cubic yards of captured sediment (Inter-Fluve et al 2011).

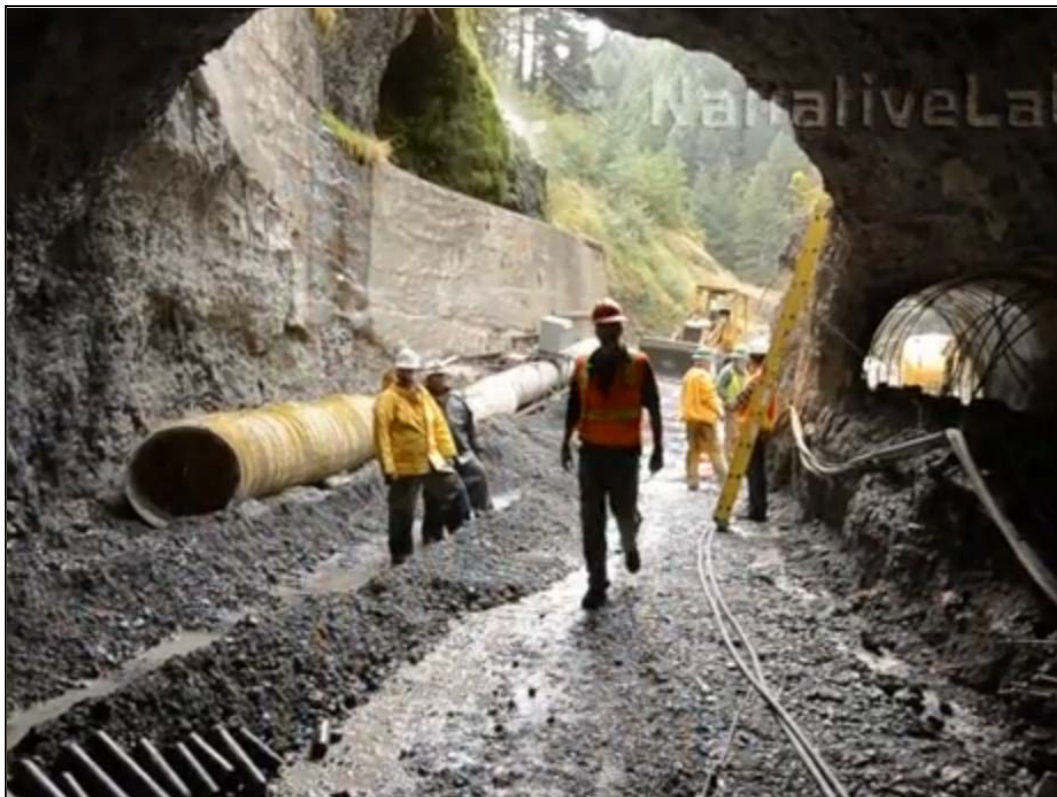
Figure 233: Breach Tunnel (Courtesy of Narrative Lab)

To begin dam removal, in early August 2011 the reservoir was lowered by approximately 10 feet and blasting of a 13-foot by 18-foot tunnel was begun at the base of the dam (Figure 233). The blasting work continued until the tunnel was approximately 15 feet from the upstream side of the dam. During the same time period, workers dredged the sediment immediately upstream of the dam (Time lapse website). No wholesale sediment removal or stabilization was completed, as the river would be allowed to transport the sediment from the former reservoir area. Pre-project modeling estimated that most of the reservoir sediment would be transported as the reservoir drained (Inter-Fluve et al 2011). On October 26, 2011, the final 15 feet of concrete was blasted and the lake spectacularly drained (Figures 234 and 235) in less than 2 hours through the tunnel (Maser and Stampfli 2012).

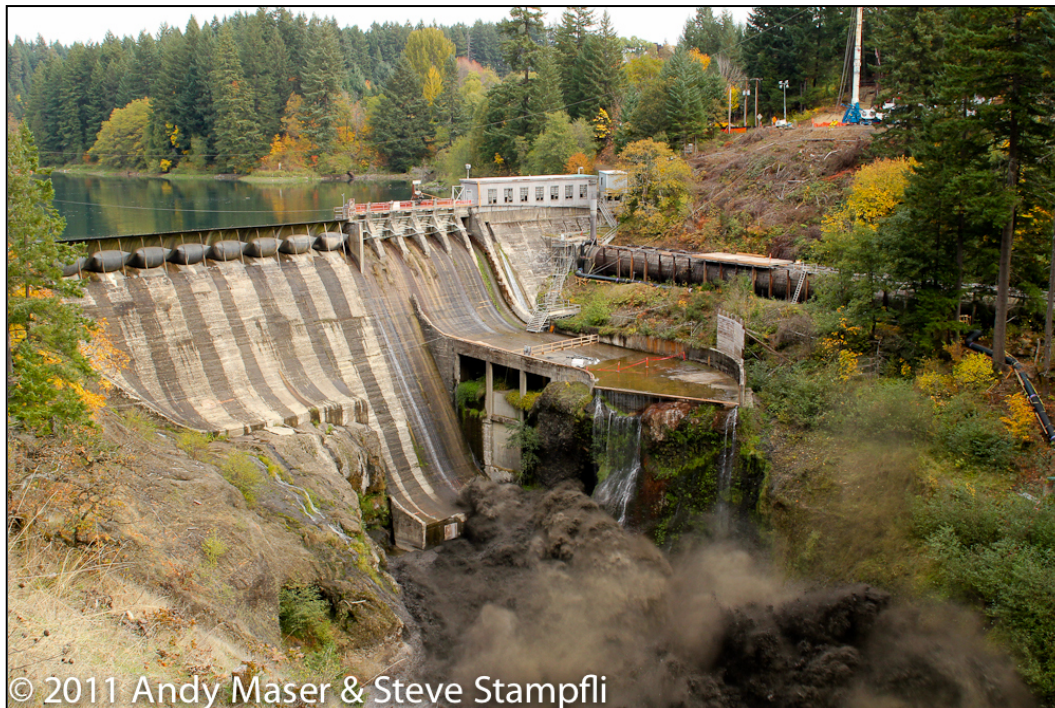
Figure 234: The Breaching of Condit Dam (Courtesy of Andy Maser and Steve Stampfli)

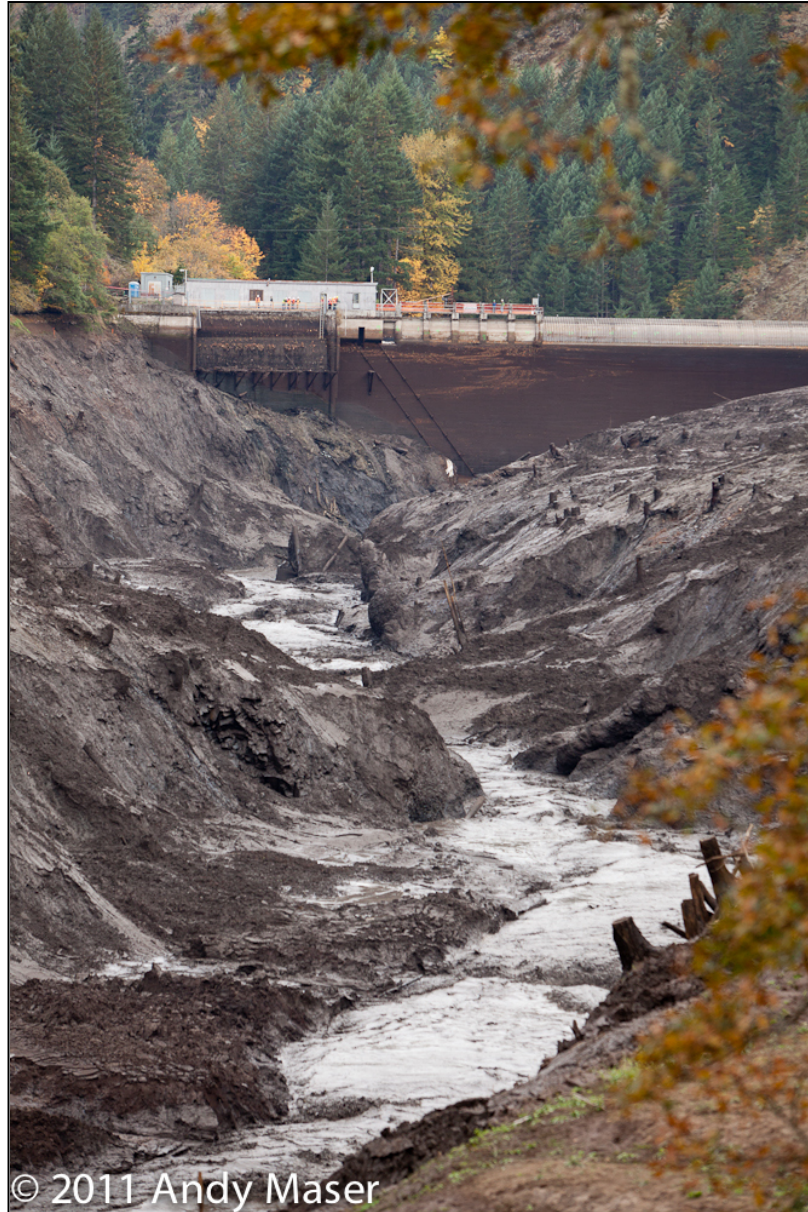
Figure 235: Northwestern Reservoir and Condit Dam after the breach (Courtesy of Andy Maser and Steve Stampfli)

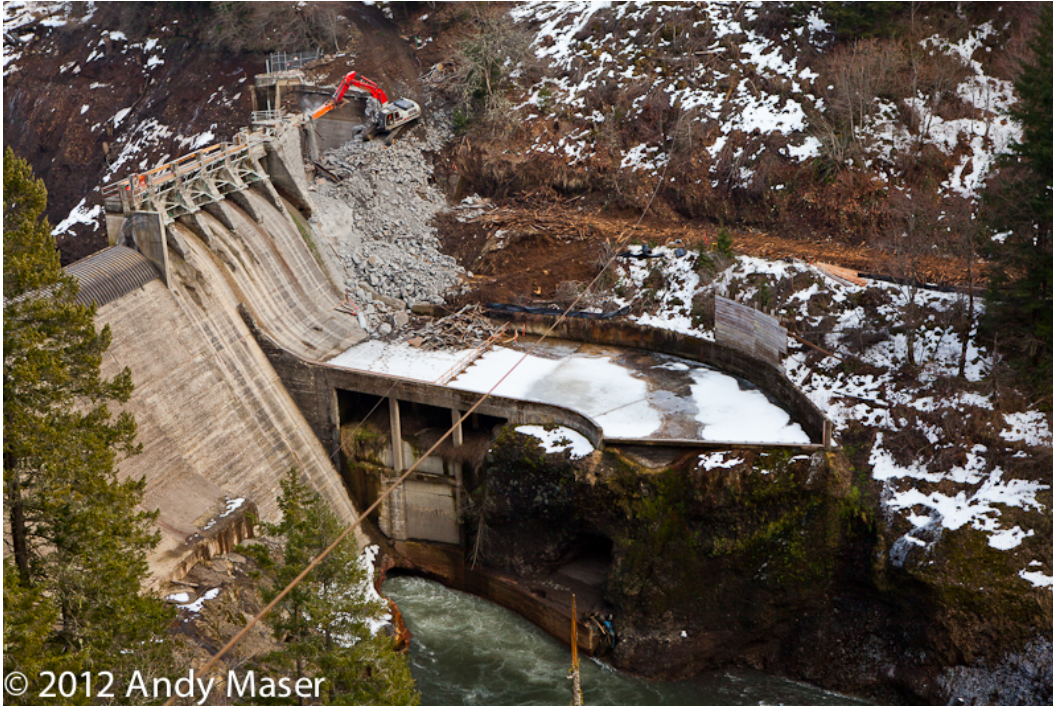
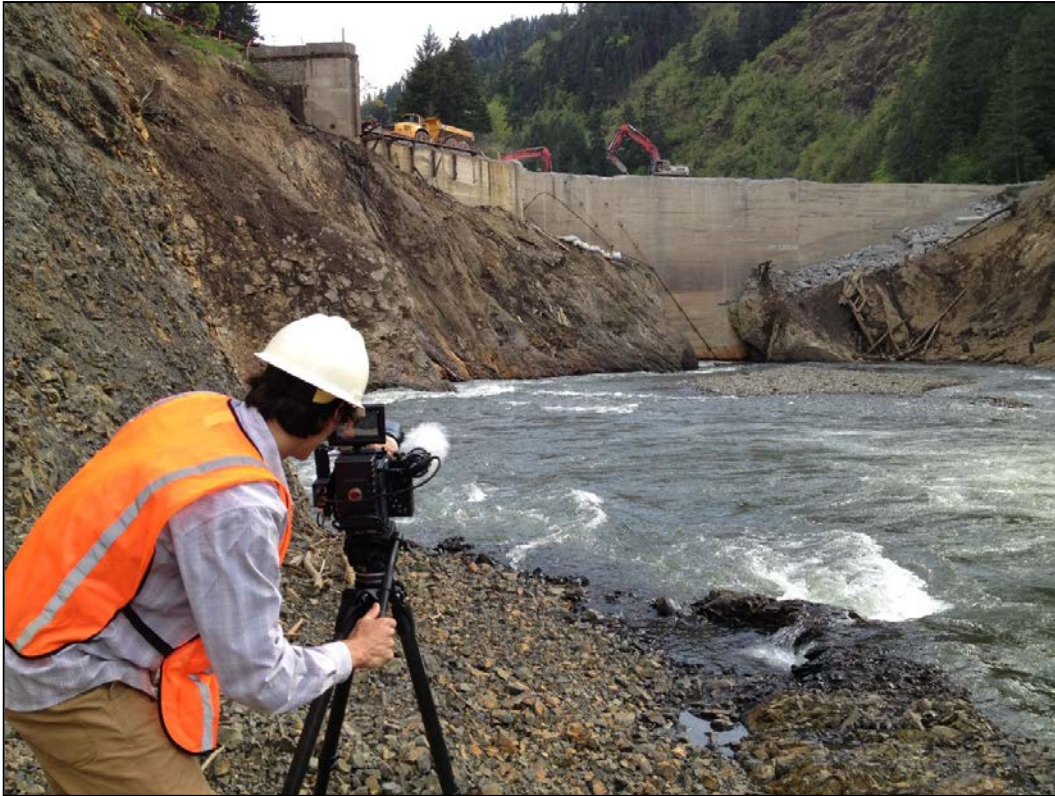
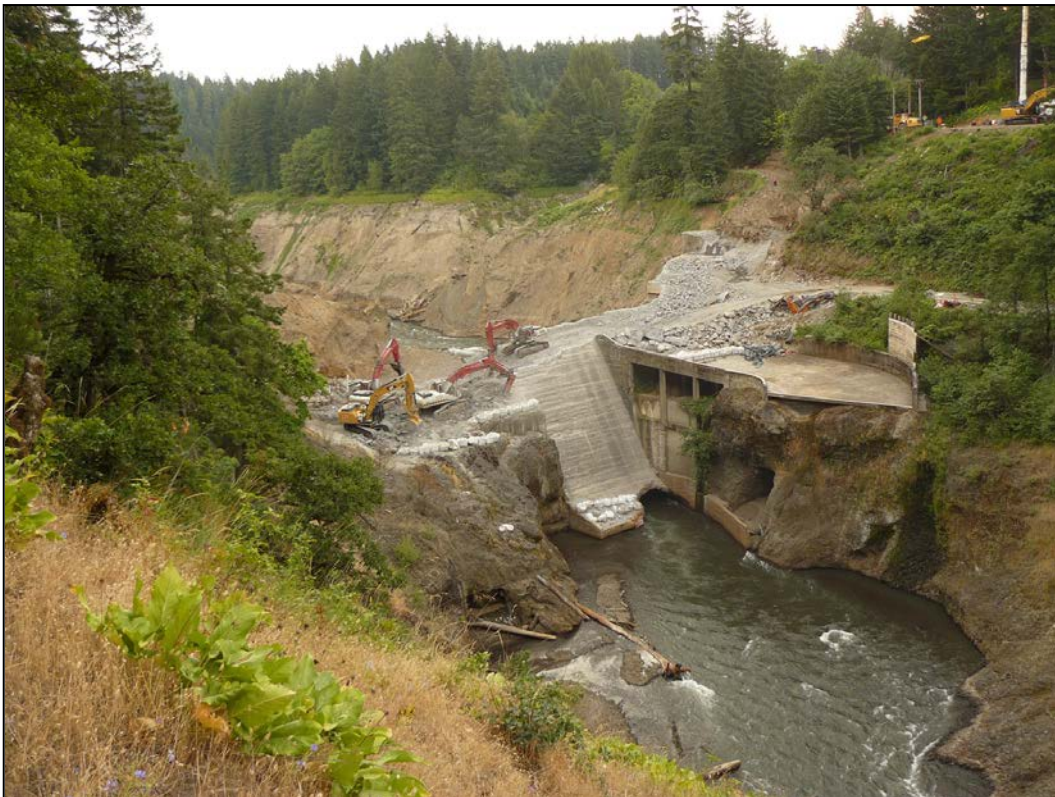
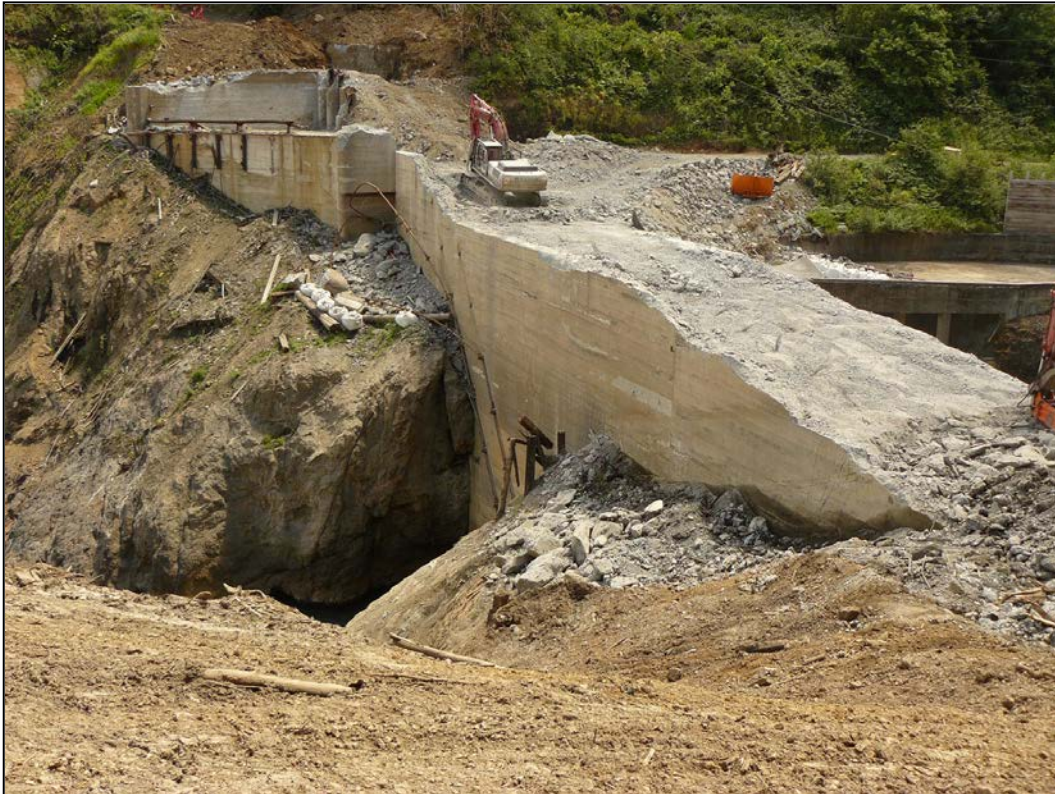
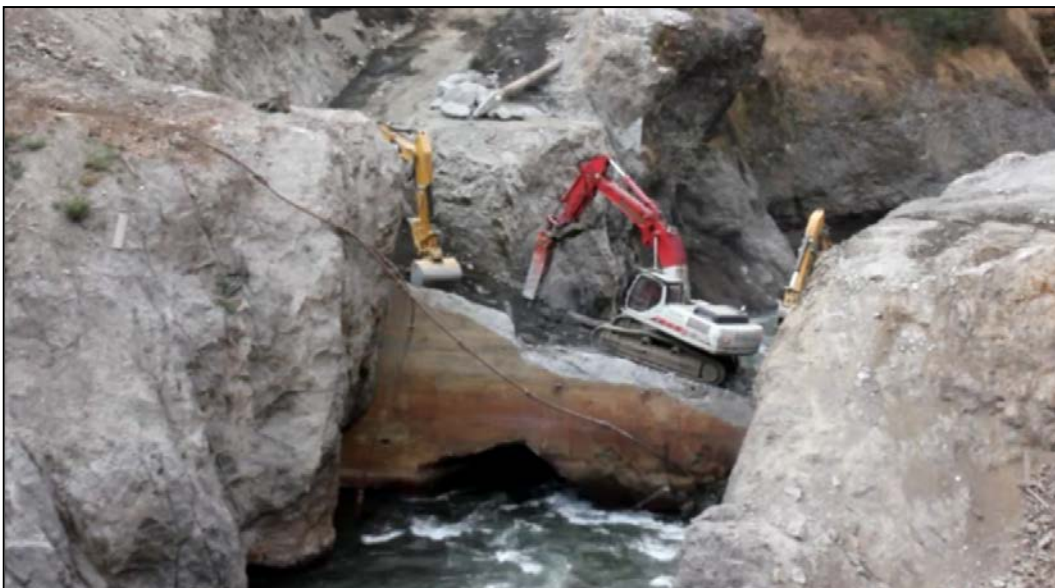
Over the next year, excavators with hydraulic hammers chipped away at the dam from the top down, breaking it down into manageable chunks for loading and hauling (Figures 236 - 241). Once the excavation reached the lower portion of the dam, controlled blasting was used to fracture the concrete into large chunks that were lifted out with a crane's clamshell bucket (Maser and Stampfli 2012).
